## Failure analysis of chrome plated rotor of down-hole drilling motors

Meysam Zarchi

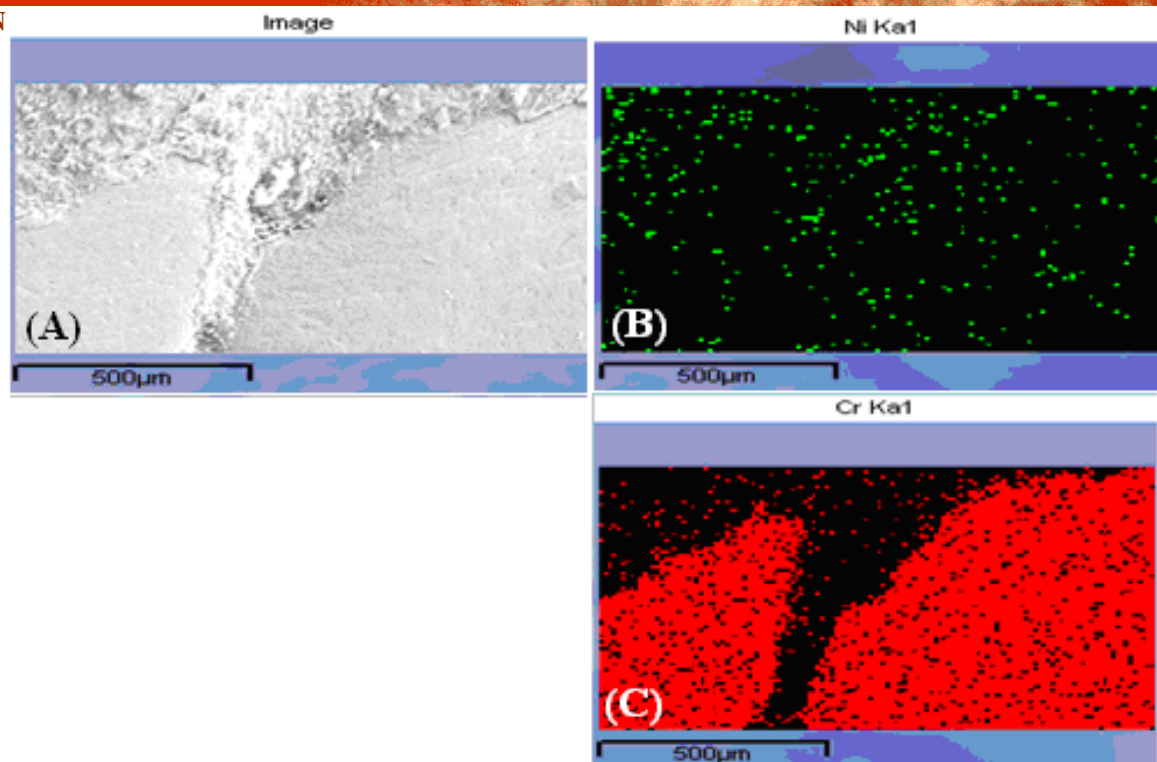
Figure 4. SEM. Microstructure of rotor. A) failed surface;  
B) map of nickel distribution; C) map of chrome distribution.

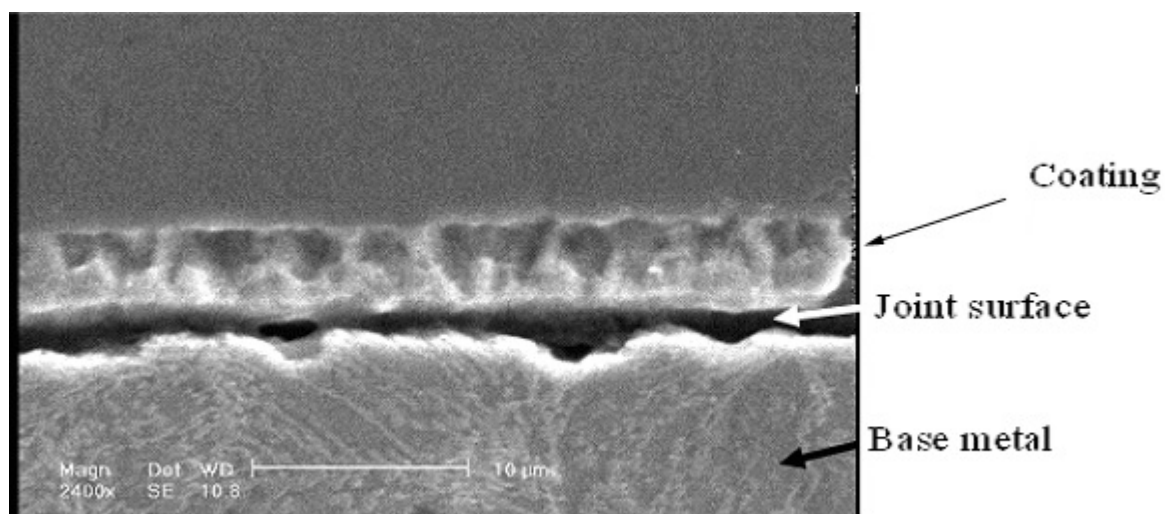
Figure 5. The cross-section of rotor with coating.

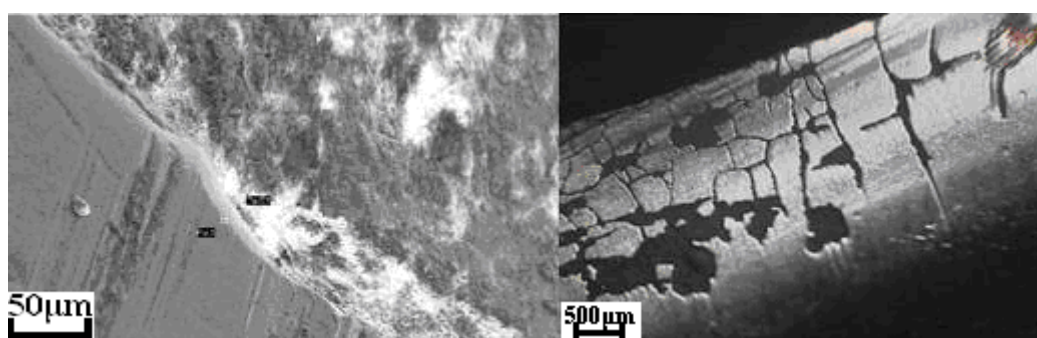
Figure 7. Coating cracks due to friction.

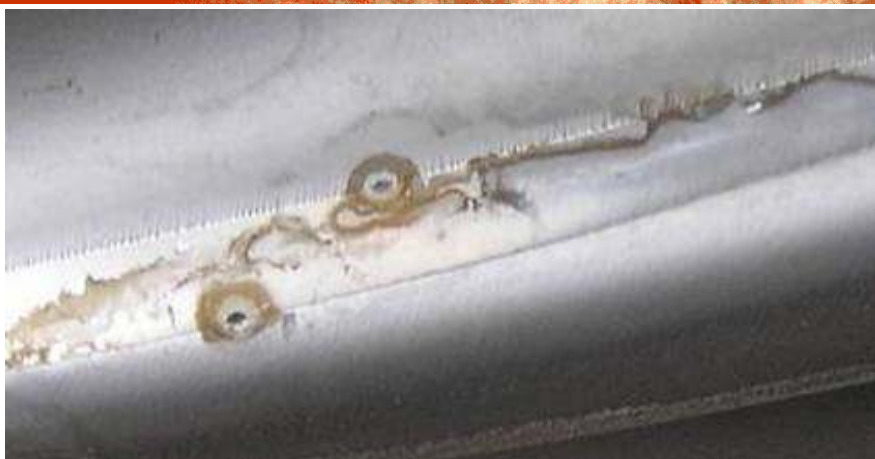
*Figure 9. Surface failures of rotor coated with WC. Friction cuttings and the beginning of hole achieve into the base metal due to coating thinning.*

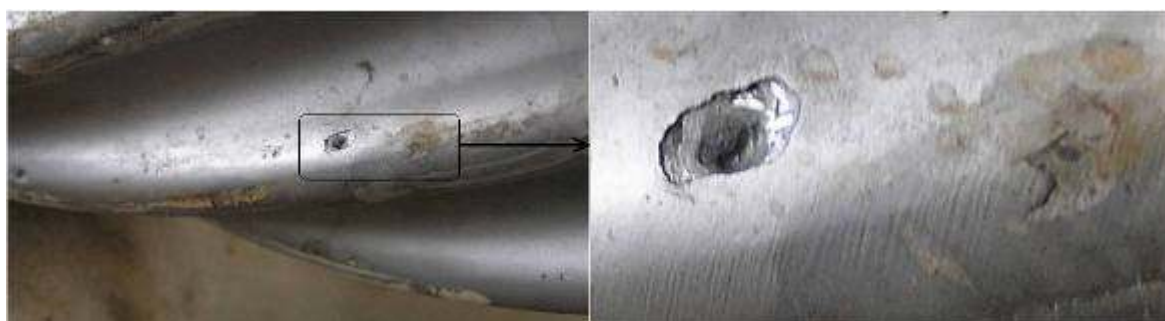
*Figure 10. Surface failures of rotors coated with WC. Friction cuttings, and hole achieve into the base metal as a result of corrosive influence of mud with WC coating. The figure on the right is enlarged detail of the left figure.*
