How to fix Smart Switching Converter PCB problem?

The PCB of the Smart Buck Converter contains two errors:

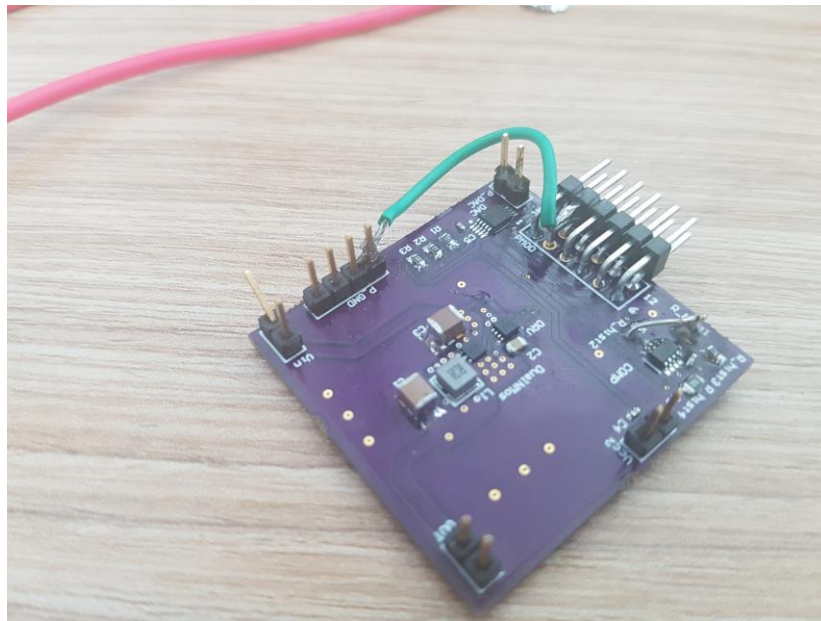
- the PMOD GND pin is not physically connected to the board ground
 - the comparator positive feedback is incorrectly wired
1. The GND problem is very easy to fix: just solder a wire between the PMOD ground PIN and the 1 x 4 board ground pin header (as Figure 1 shows)

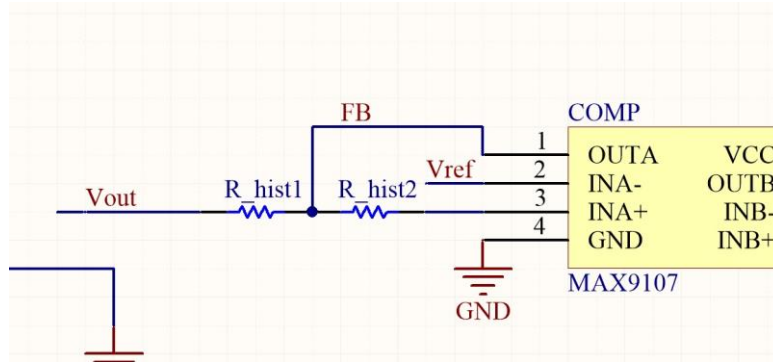
As Figure 2 shows, the R_hist1 and R_hist2 are wrong connected. In this case, R_hist2 has no purpose, because it is in series with the input impedance of the non-inverting input of the comparator.

In order to fix the problem, the right terminal of R_hist2 should be disconnected from IN+ and connected to OUTA. The FB wire should be disconnected from OUTA and connected to IN+.

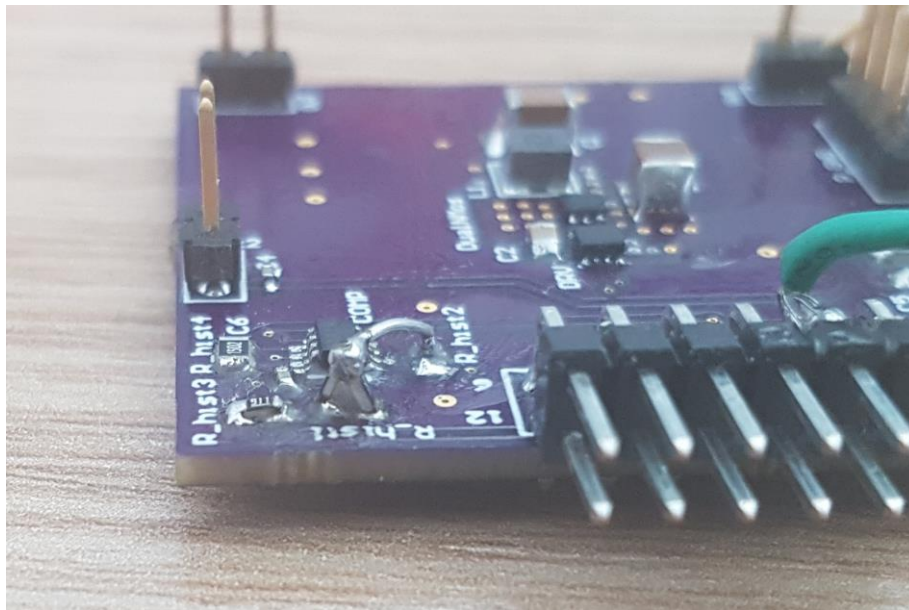
Figure 3

Because this problem is not major one, it can be solved without destroying the PCB.
