Rajshahi University of Engineering & Technology

Experiment No. : 06

Experiment Name : Fatigue failure analysis and case study.

Course No. : MSE 2212

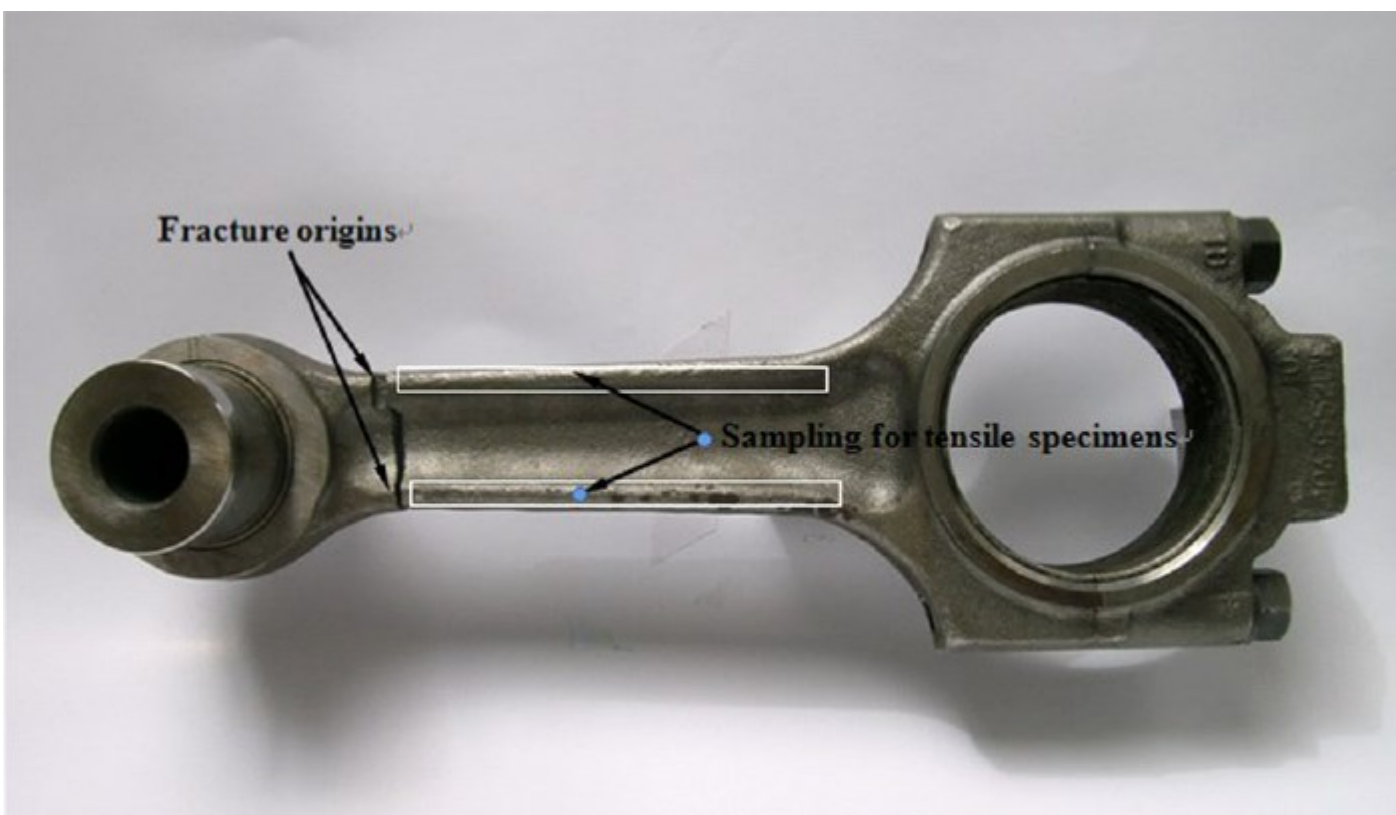
Fig. A : Fractured connecting-rod

The fractured connecting-rod is shown in Fig. A. It can be seen that the transverse fracture occurred at the small head(piston pin end) of the connecting-rod without obvious plastic deformation on the whole connecting-rod. The fracture surface shows silver gray tint (Fig. B. Two smooth zones vertical to the connecting-rod body are on the fracture surface, corresponding to the lower and upper beams of the connecting-rod. Beach marks typical of fatigue fracture were observed on the fracture surface. Tracing the crack-propagation marks, two independent crack origins (marked A and B) were found to be situated at the same side of the connecting-rod. The propagation direction of the initiating cracks is from the “left side” to “right side”. In the middle stage of crack propagation of crack A, the direction of crack propagation inclined upward as shown in Fig. A.

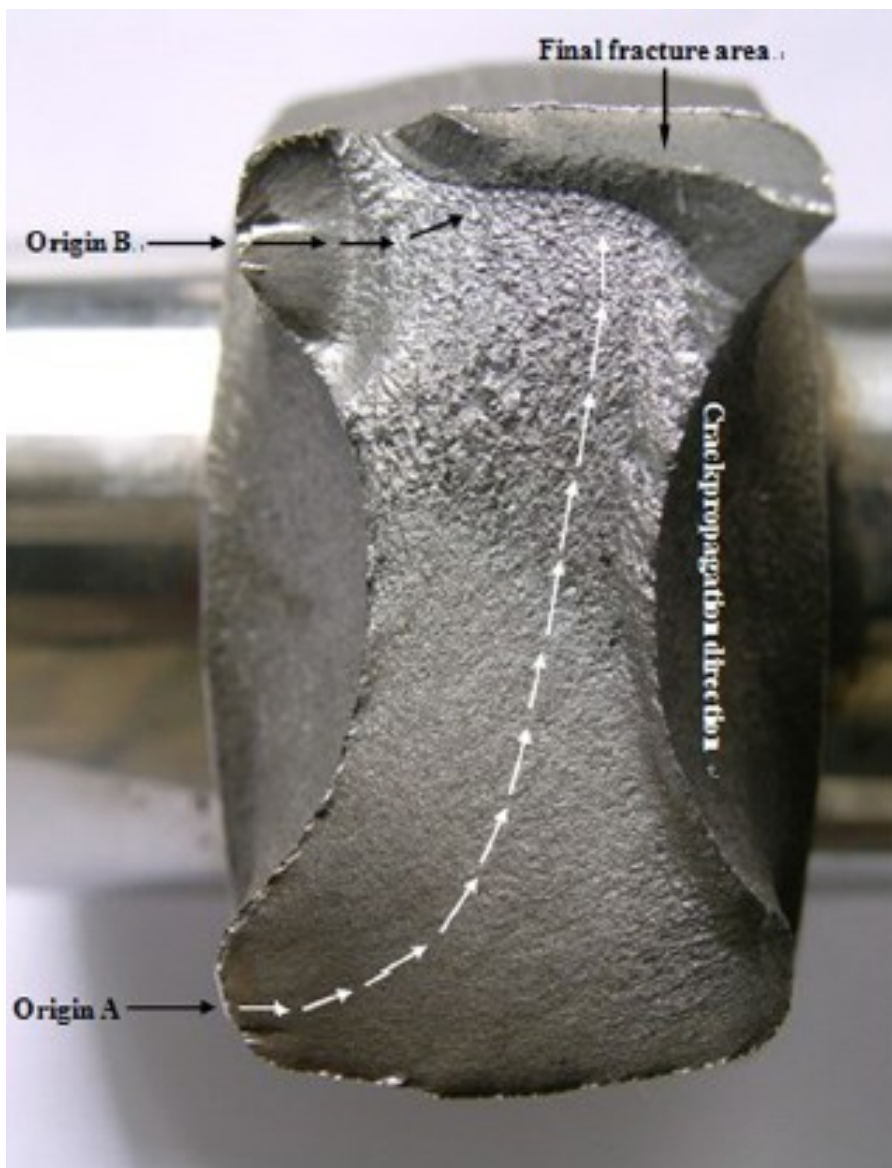
Fig. B : Macro-fracture of connecting-rod

The fracture progressed mainly from the origin A, with origin B playing a secondary role in the failure process. The upper right portion of fracture is final instantaneous overload fracture (as marked in Fig. B) produced when the area of the component which remained uncracked is no longer able to withstand the applied loading.

The smaller instantaneous fracture area indicates that the applied load on the failed connecting-rod is relatively low. The fatigue striations, micro-features of fatigue fracture, were found in the vicinity of the crack origin and crack propagation zone, coexisting with the secondary cracks (Fig. C). Fractographic observation indicates that fatigue is the main failure mechanism of the connecting-rod. In addition, no obvious damage was found on the rod body close to the fracture. The connecting-rod bolts did not become loose.

The above case studies show that fatigue failure is an important failure mechanism in connecting-rod. This problem can be addressed by strict control on heat-treatment process to ensure metallurgical quality of the connecting-rod. Also careful assembly of various components of the engine and close attention to the abnormal running condition of engine will help to avoid the occurrence of abnormal loads.

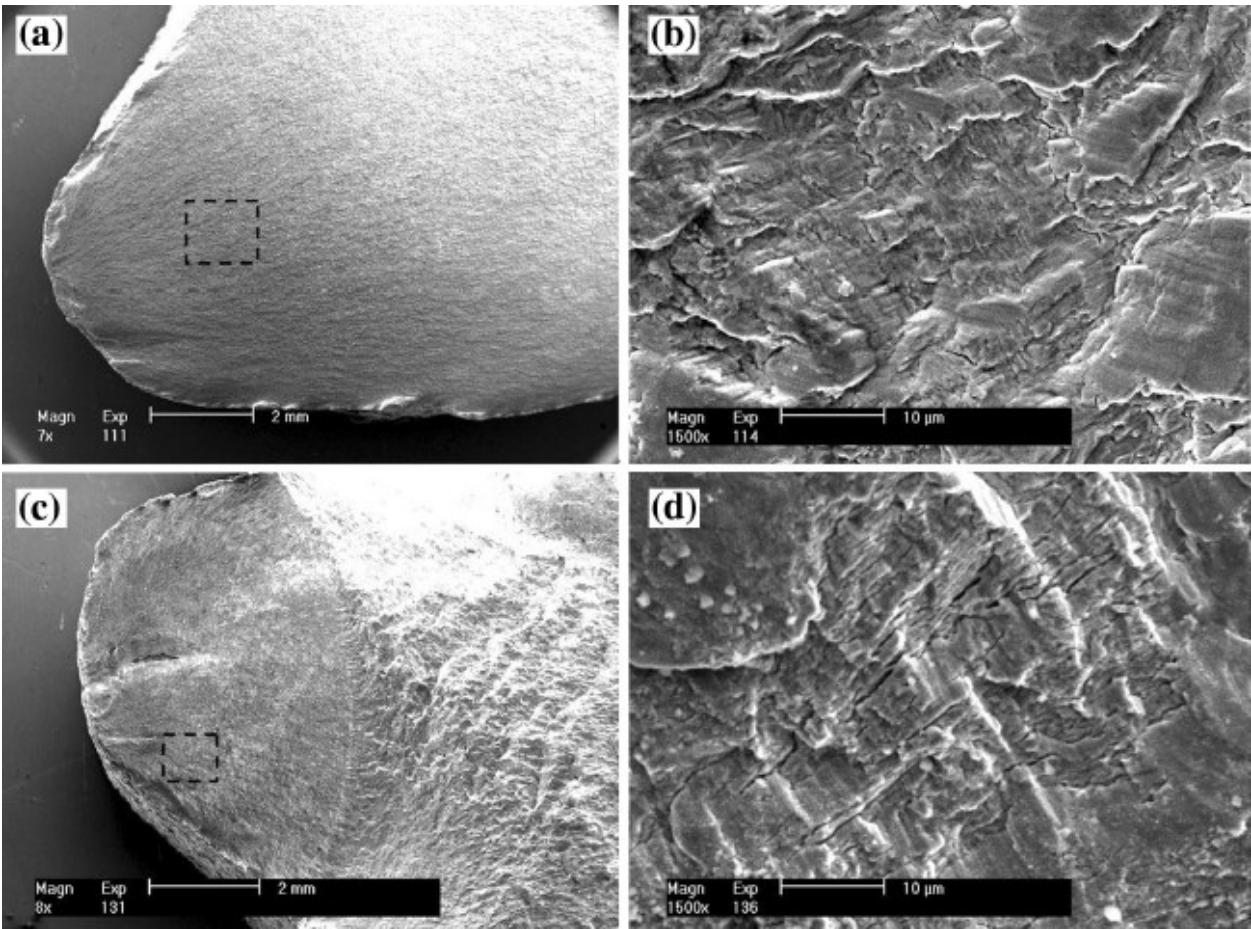
Fig. C : SEM observation on fracture surface: (a) general view on crack origin A, (b) boxed zone in (a) showing fatigue striations and secondary cracks, (c) general view on crack origin B, (d) boxed zone in (c) showing fatigue striations and secondary cracks

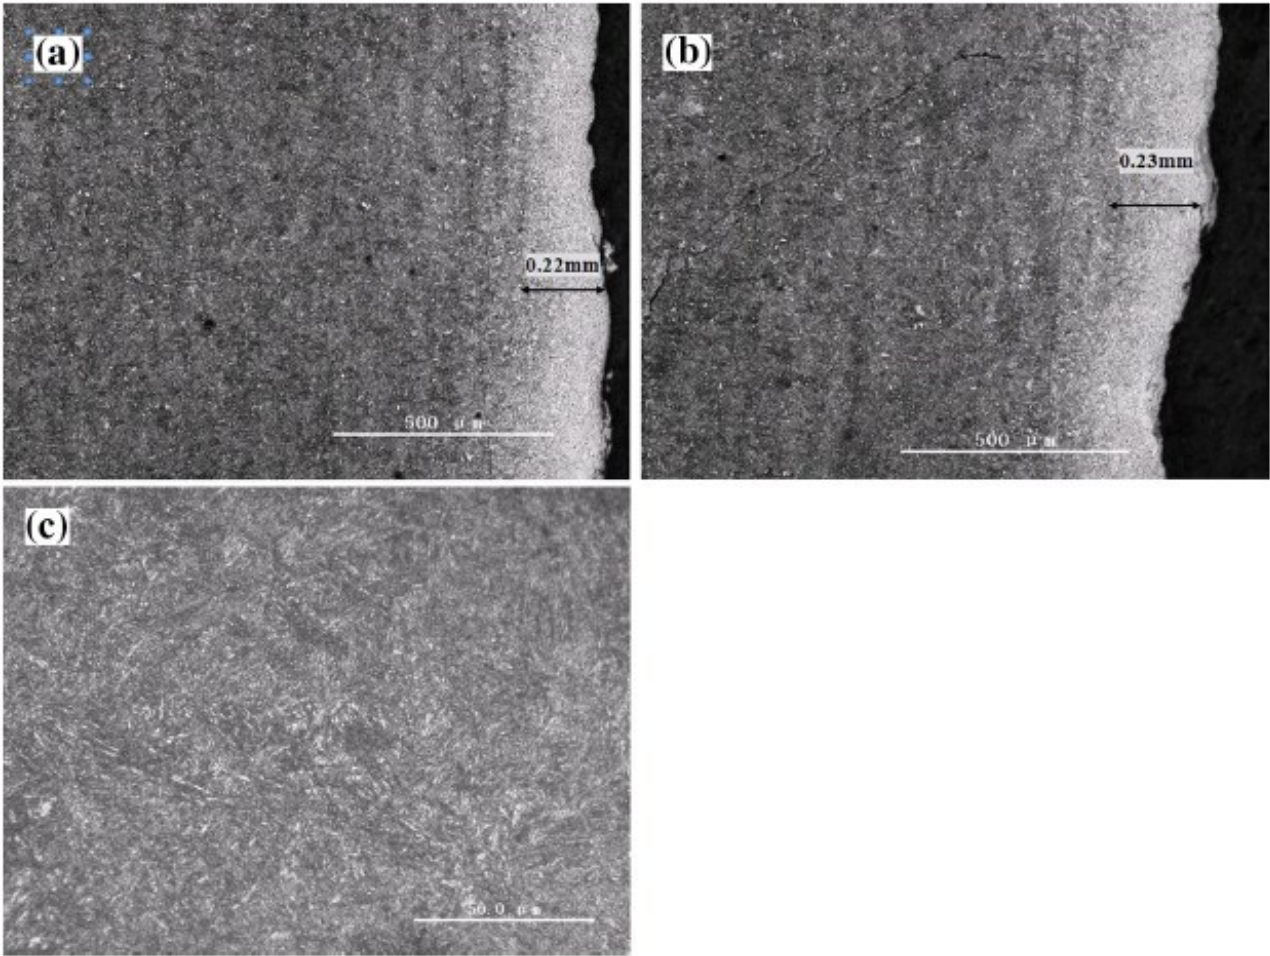
Two cross-sectional specimens adjacent to the two crack origins (locations A and B) were prepared to observe the microstructure (Fig. D). Microstructural analysis revealed a “white layer” on the external surface of the connecting rod, mainly composed of ferrite.

Fig. D: Cross-sectional microstructures of connecting-rod: (a) region A, (b) region B, (c) core

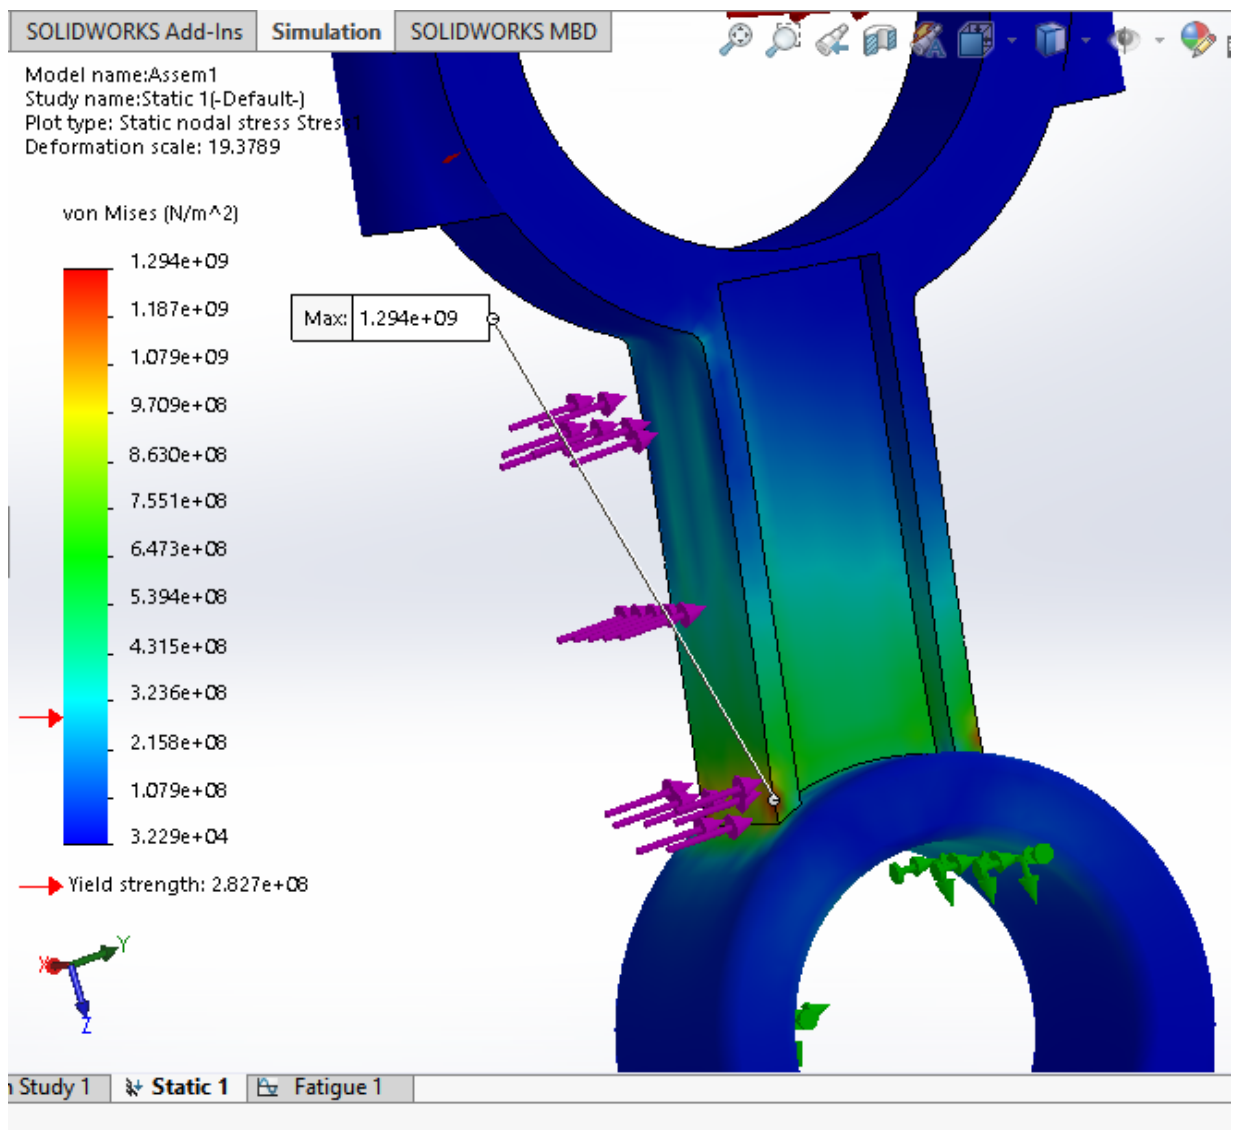
The fillet corners developed the maximum stress so fatigue failure will start form this red area, also note there are some green areas around middle of the extruded cut. These are sharp edges and theoretically we know these points to be stress raisers.

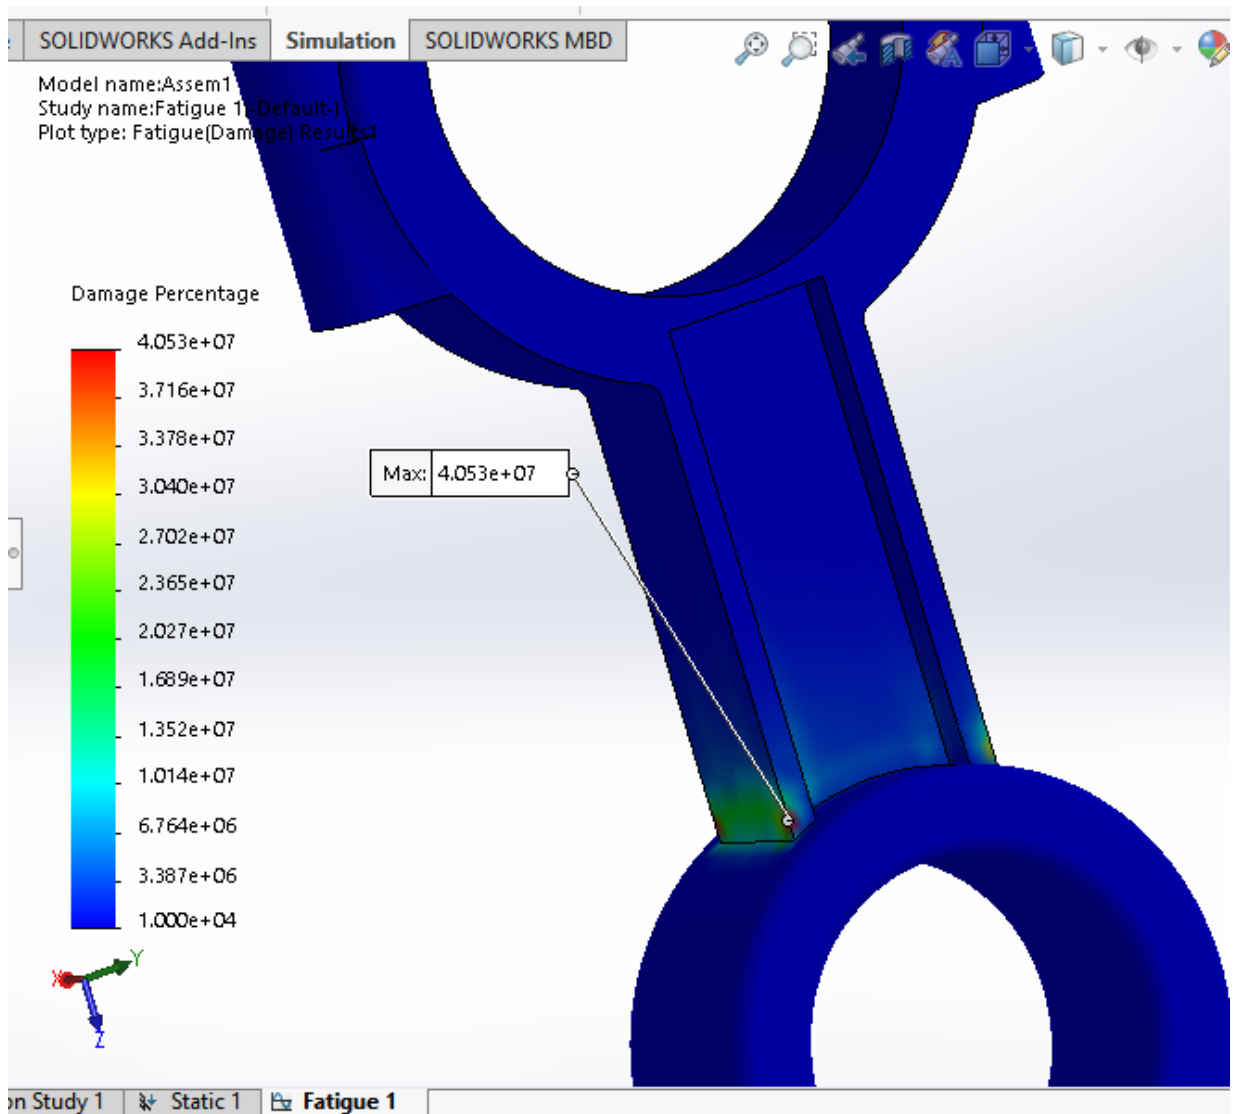
Our connecting rod survived 4.053×10^7 cycles prior fatigue failure. And failure occurred from the fillet corners as we predicted from our static stress simulation results.
