Consortium for Organ
Preservation in Europe

COPE WP2: A multicentre randomised controlled trial to compare the efficacy of ex-vivo normothermic machine perfusion with static cold storage in human liver transplantation

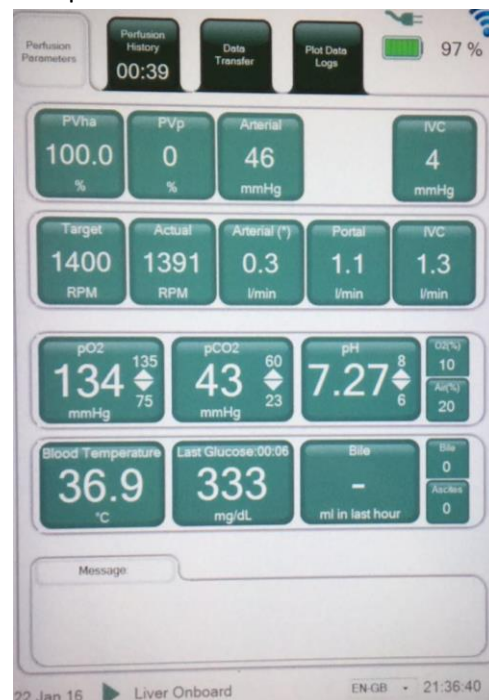
From the start of NMP the approximate flows through the liver were as follows: hepatic artery 300ml/min; portal vein 1.1L/min; IVC 1.3L/min (image right). The pH of the circuit reached 7.3 by 45mins perfusion with lactate falling to 0.4mmol/L by 1 hour perfusion.

However, it was apparent from early in the perfusion that the machine was failing to achieve a target hepatic artery pressure of 65-80mmHg, instead only reaching approximately 45-50mmHg. This in combination with a reported hepatic artery pinch valve closure of 100% (should usually read 88-93%) suggested a possible underlying device problem to account for the failure to achieve satisfactory pressure.

In an attempt to resolve this problem the perfusion was stopped and restarted (this should reset the pinch valve calibration). The cannulae positions were also assessed but appeared satisfactory.

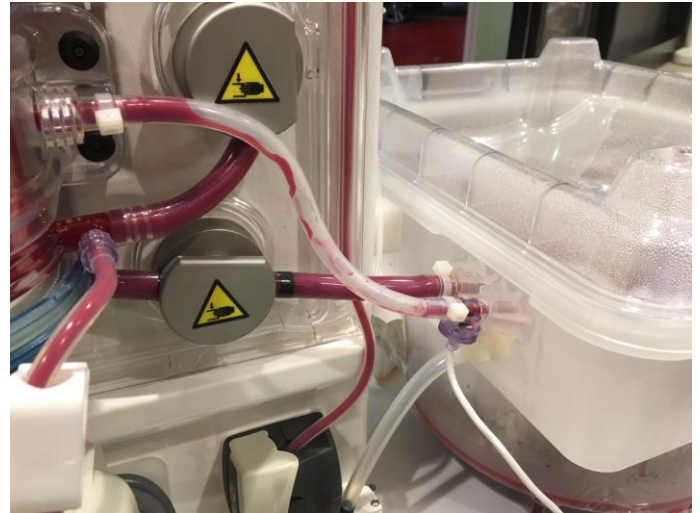
Whilst waiting at the service station the user again examined the perfusion device when a further problem developed where air was noticed in the hepatic artery line (image right). Due to lack of sterile facilities this could not be investigated further at that time and the cause for it is still not known. Shortly after this the replacement ambulance arrived and the journey was completed to Leuven.

From a global experience of more than 150 normothermic liver perfusions using the OrganOx *metra* this is the first such incident of this type to have been reported. The OrganOx *metra* machine from [REDACTED] returned to the OrganOx offices shortly after this incident. Investigations revealed a mechanical fault with the hepatic artery pinch valve. The device has been returned to the manufacturing warehouse for repair according to OrganOx specifications.
