Lexington High School

School Building Committee
Meeting

02.05.2024

Existing Conditions Update

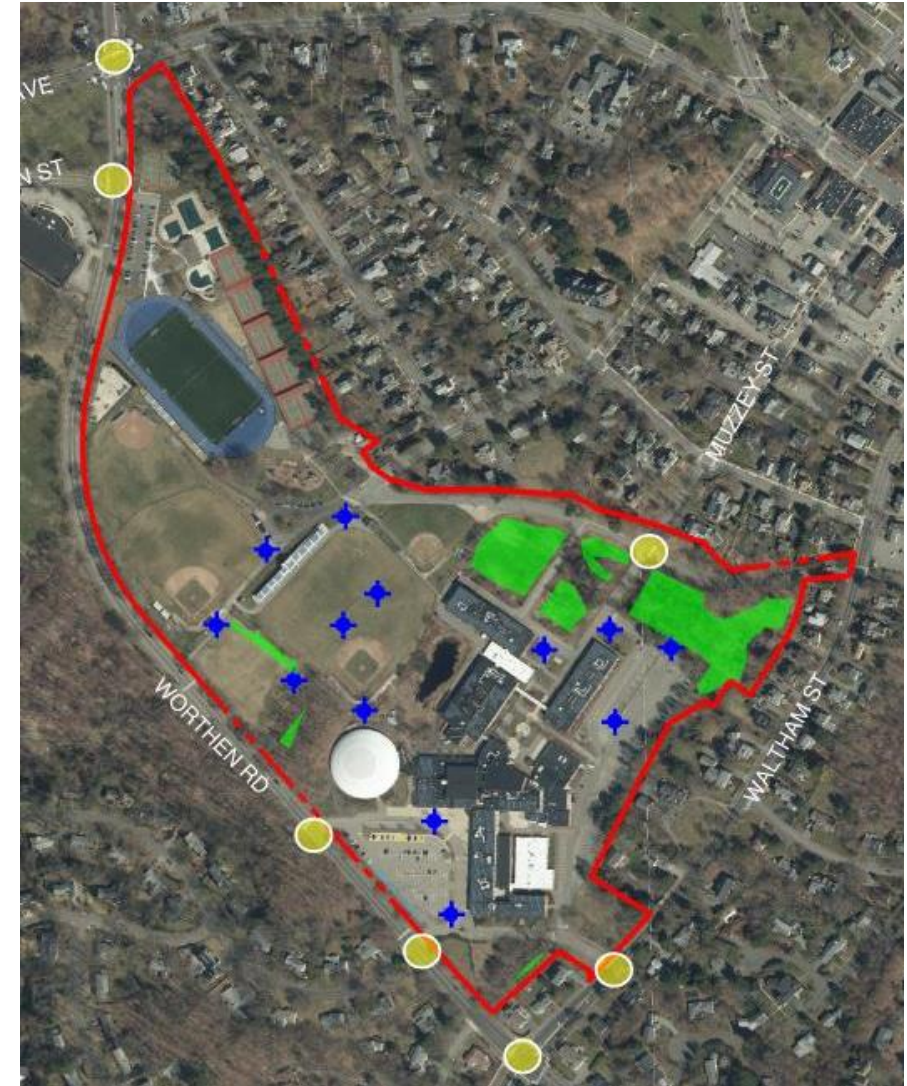
Wetlands: Existing Wetland Resources Flagged

- Wetlands Identification:
 - Wetland Scientist completed field work on 12/15
 - Survey team added exact flag locations
 - Survey expected 2/16
 - Recommendation from Conservation Commission to File an ANRAD (Abbreviated notice of Resource Area Delineation)

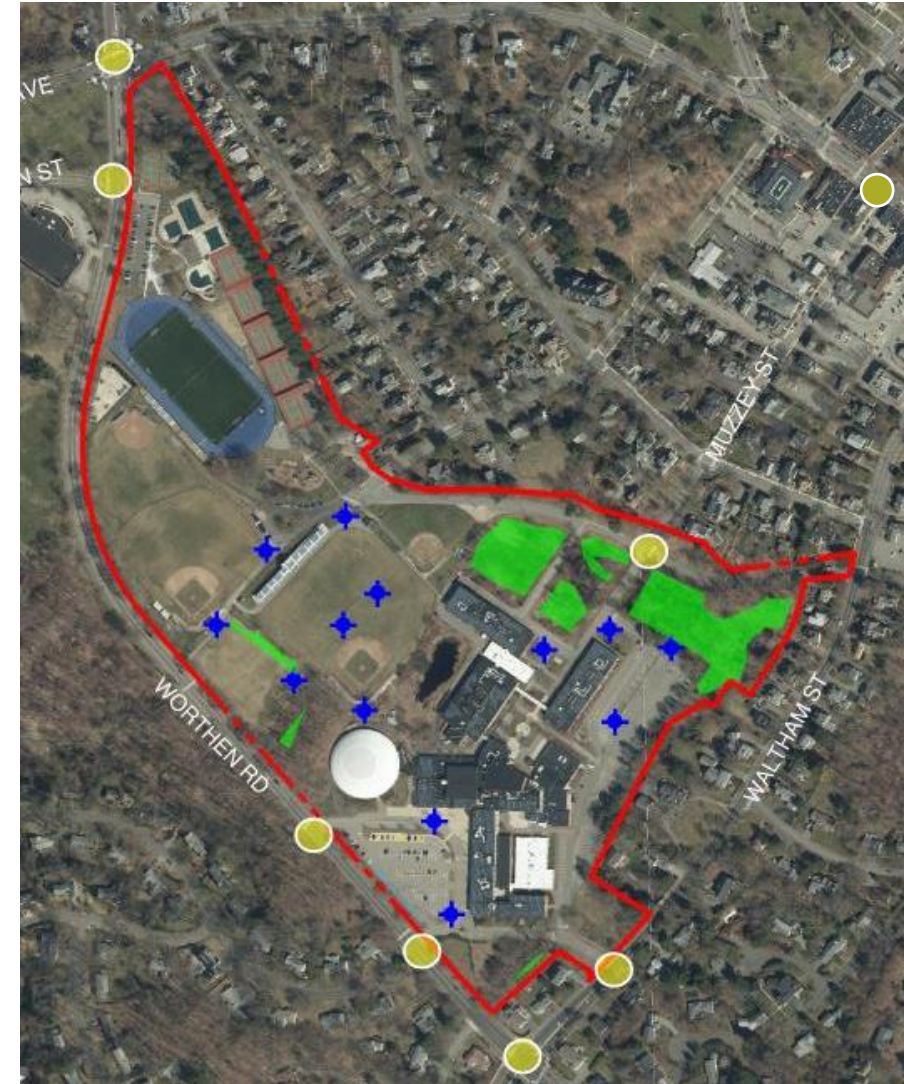
● Geotech: Borings Performed

- Geotech Exploration:
 - Field work completed 12/21 & 12/22
 - Survey added exact boring locations – survey expected 2/16
 - Preliminary report due 2/16
 - Findings:
 - 13 borings completed
 - 10 extended to 20-30 ft deep
 - 3 encountered refusal at 6-7 ft
 - Generally granular fill over native very soft peat/organic deposits
 - Preliminary Analysis:
 - Ground Improvements or
 - Deep foundations necessary
 - Shallow groundwater

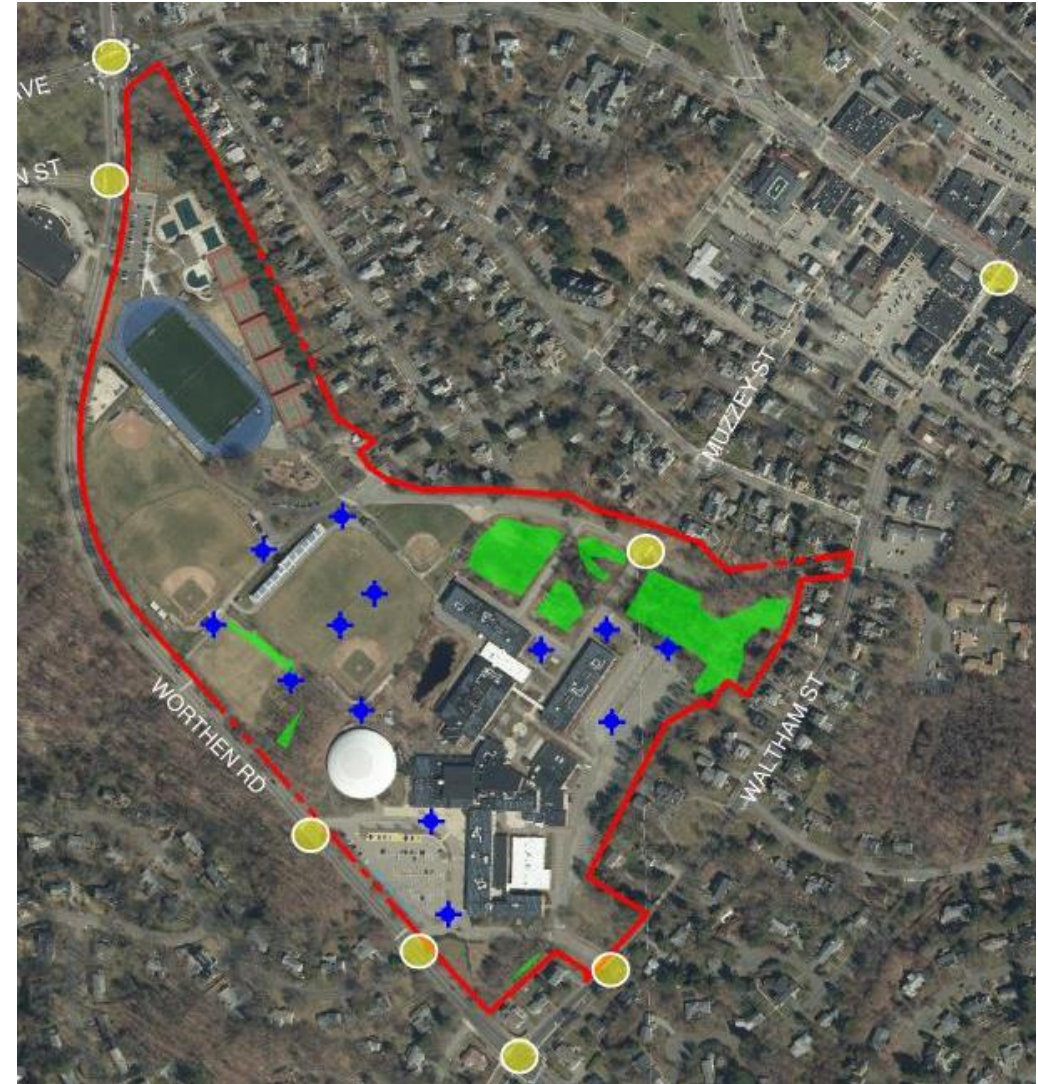
Traffic: Existing Intersections Studied

- Traffic Study:
 - Field work completed 12/14 & 12/15
 - Existing Conditions report complete
 - Findings:
 - Crash data reviewed indicated crash rates lower than District 4 and statewide averages
 - Sight distances are sufficient at vehicular drives
 - 89% parking utilization
 - Signalized intersections studied operate at an acceptable level of service
