## Turbopump Testing Recap

## *Summary*

I (Brendan Morgan) designed/analyzed/machined/welded/integrated one complete turbopump, with serious design work beginning in September 2023 and the first test occurring the night of June 16-17 2024.

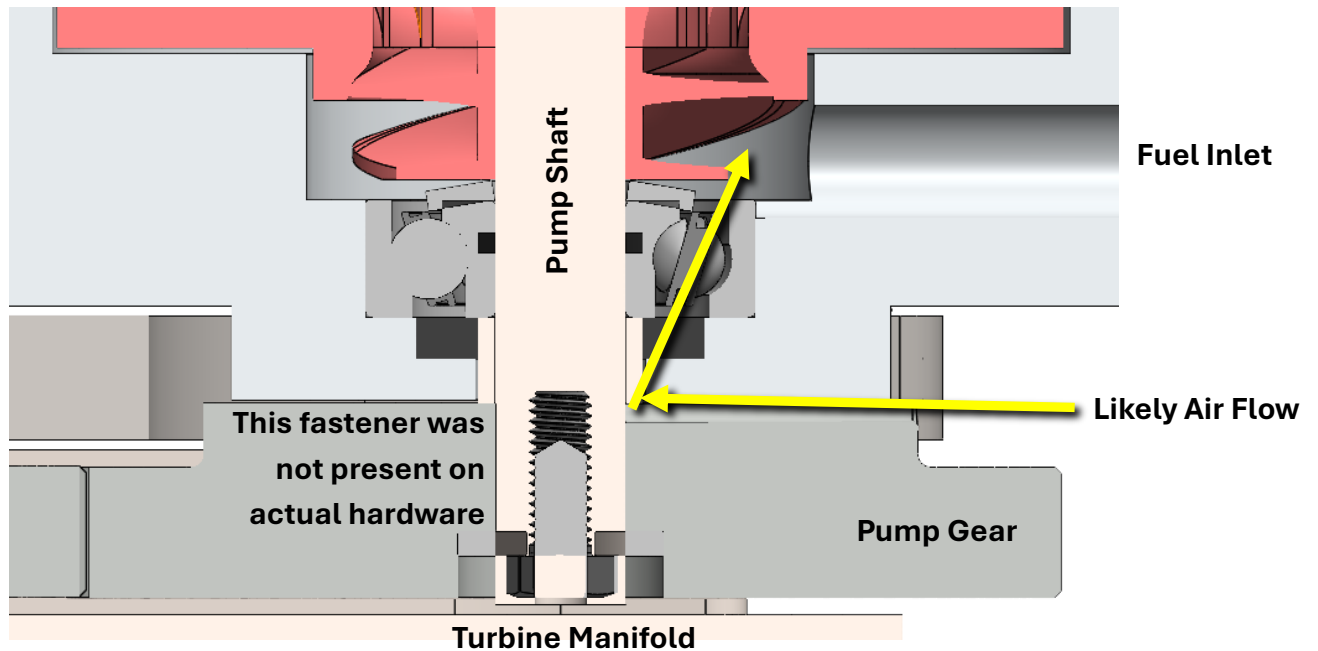
- 1) Fuel pump flow was almost nonexistent compared to lox pump. I am pretty sure this is because it was not properly sealed along its shaft, on the side close to the inlet and inducer. This is really the only relevant difference I can think of between the two pumps that could cause this. It could have been aspirating a lot of air into its inlet, more than water – maybe there was a high-pressure stream of air coming out the outlet but it's impossible to know from the video.

My intent was to put packing seals in the pictured gap, but because it rests against the bearing it jammed the balls when I tried this; I was not able to rotate the shaft by hand at all. I opted to not put any seal at all here because of lack of time and naively hoping that the clearance between the shaft and hole was small enough to kinda seal it. I knew water was going to leak out before the test started (which it did at a very slow dribble that doesn't really affect anything), but I hadn't thought about the fact that air would leak in during the test, in the opposite direction.

So that's a simple design oversight – I'm thinking now I may be able to correct this by adding a small, specifically dimensioned washer of some kind that separates the bearing from the packing seals, and adding a packing seal back in. Or I may switch the open ball bearing to a sealed ball bearing and take the hit on max shaft
