Turbopump Testing Recap

Summary

I (Brendan Morgan) designed/analyzed/machined/welded/integrated one complete turbopump, with serious design work beginning in September 2023 and the first test occurring the night of June 16-17 2024.

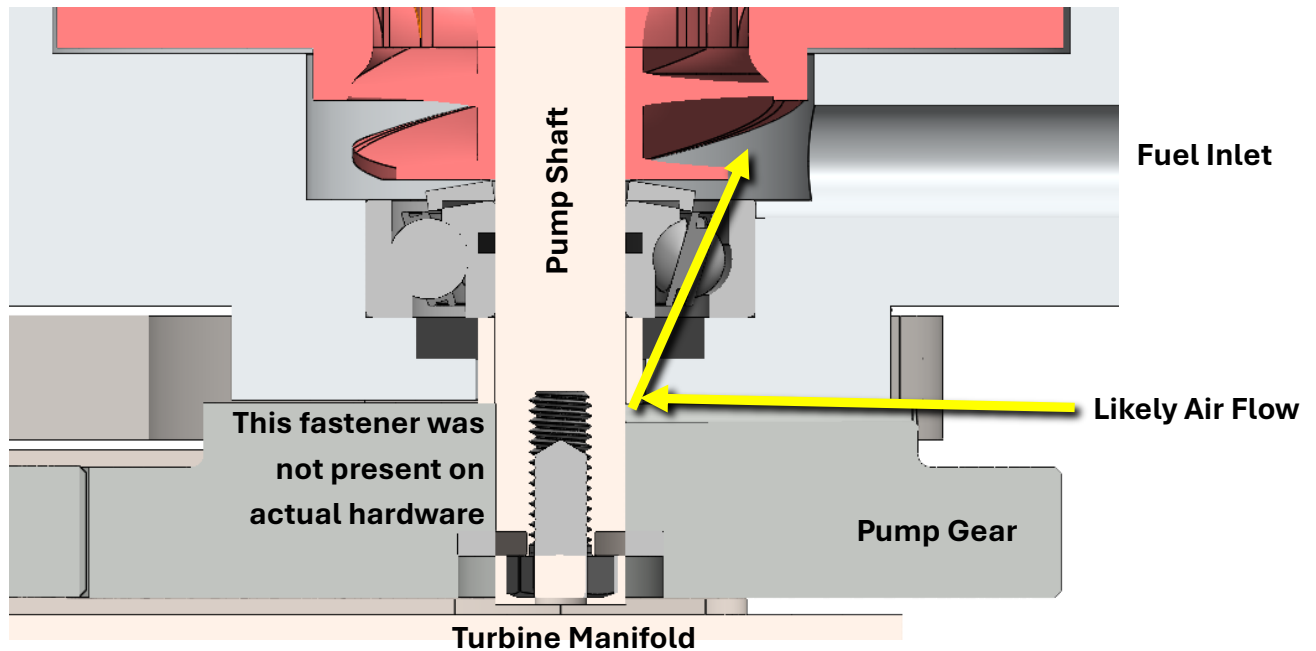
- 1) Fuel pump flow was almost nonexistent compared to lox pump. I am pretty sure this is because it was not properly sealed along its shaft, on the side close to the inlet and inducer. This is really the only relevant difference I can think of between the two pumps that could cause this. It could have been aspirating a lot of air into its inlet, more than water – maybe there was a high-pressure stream of air coming out the outlet but it's impossible to know from the video.

My intent was to put packing seals in the pictured gap, but because it rests against the bearing it jammed the balls when I tried this; I was not able to rotate the shaft by hand at all. I opted to not put any seal at all here because of lack of time and naively hoping that the clearance between the shaft and hole was small enough to kinda seal it. I knew water was going to leak out before the test started (which it did at a very slow dribble that doesn't really affect anything), but I hadn't thought about the fact that air would leak in during the test, in the opposite direction.

So that's a simple design oversight – I'm thinking now I may be able to correct this by adding a small, specifically dimensioned washer of some kind that separates the bearing from the packing seals, and adding a packing seal back in. Or I may switch the open ball bearing to a sealed ball bearing and take the hit on max shaft
