06/06/25
Wesley
Cochran

D0PTC I2C Bus Integration

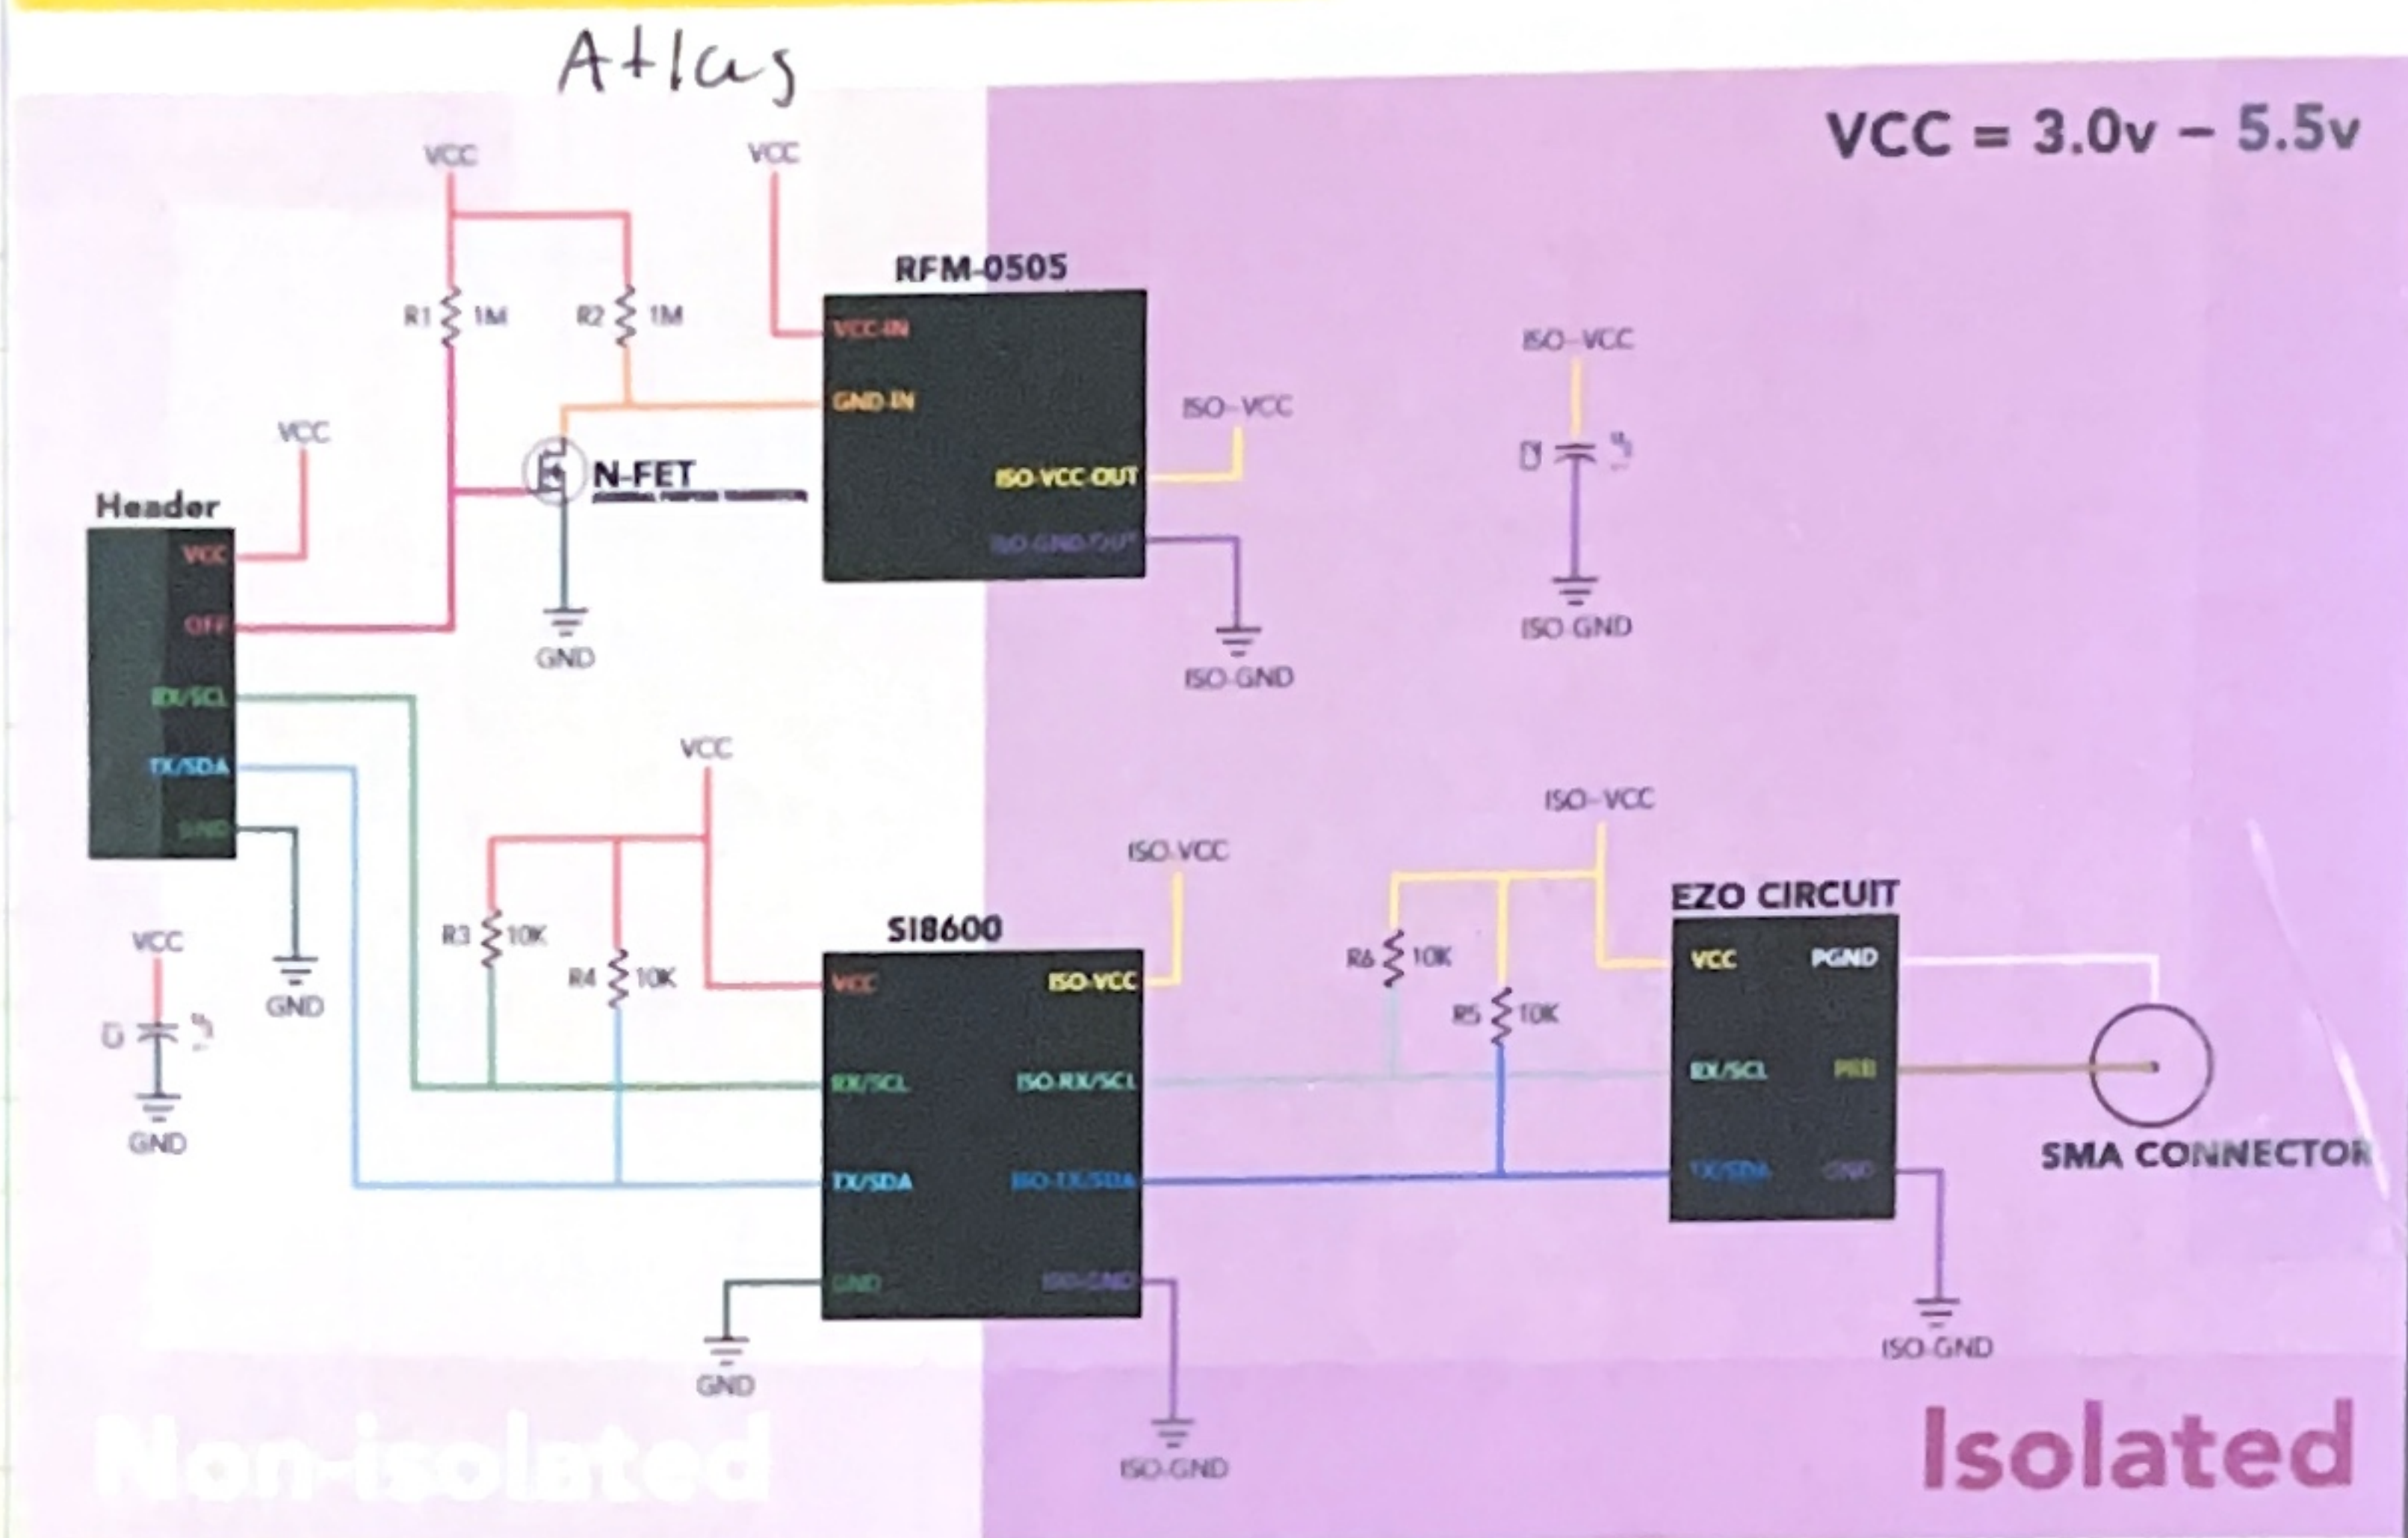
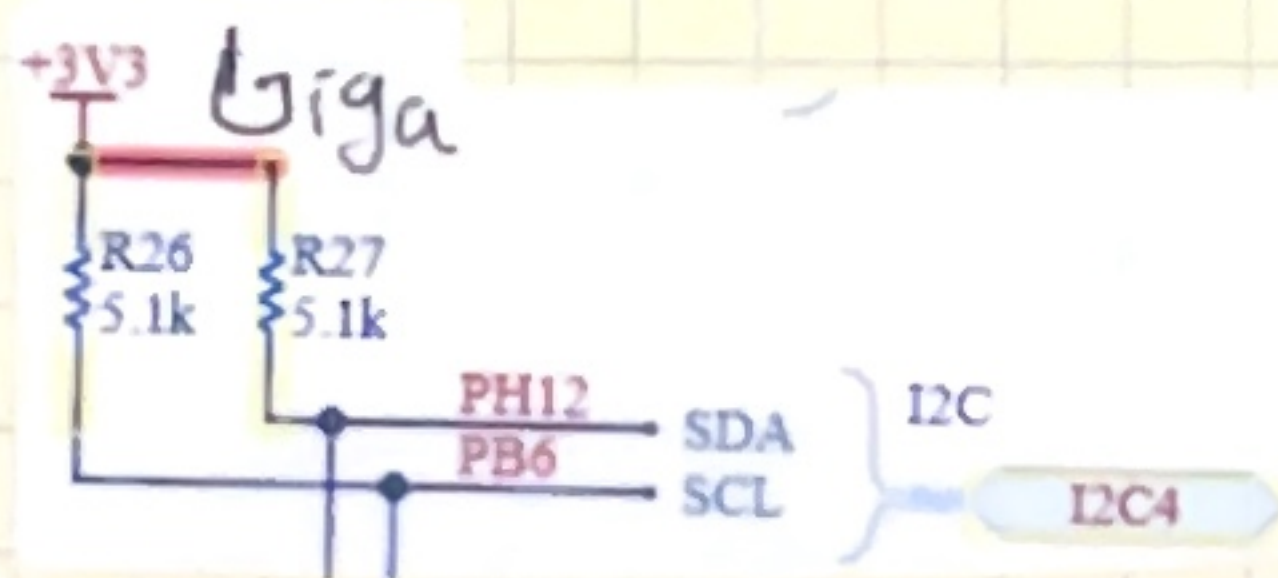
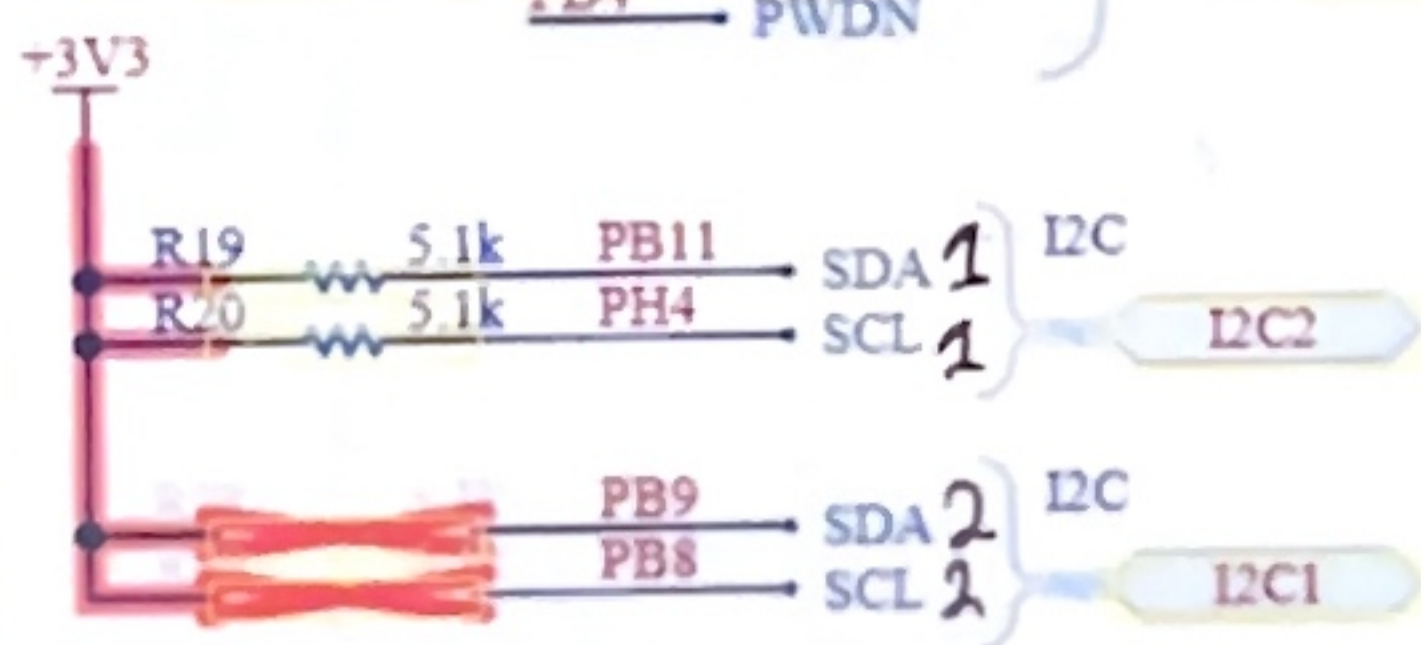
Isolated ground is different from non-isolated ground, these two lines should not be connected together.

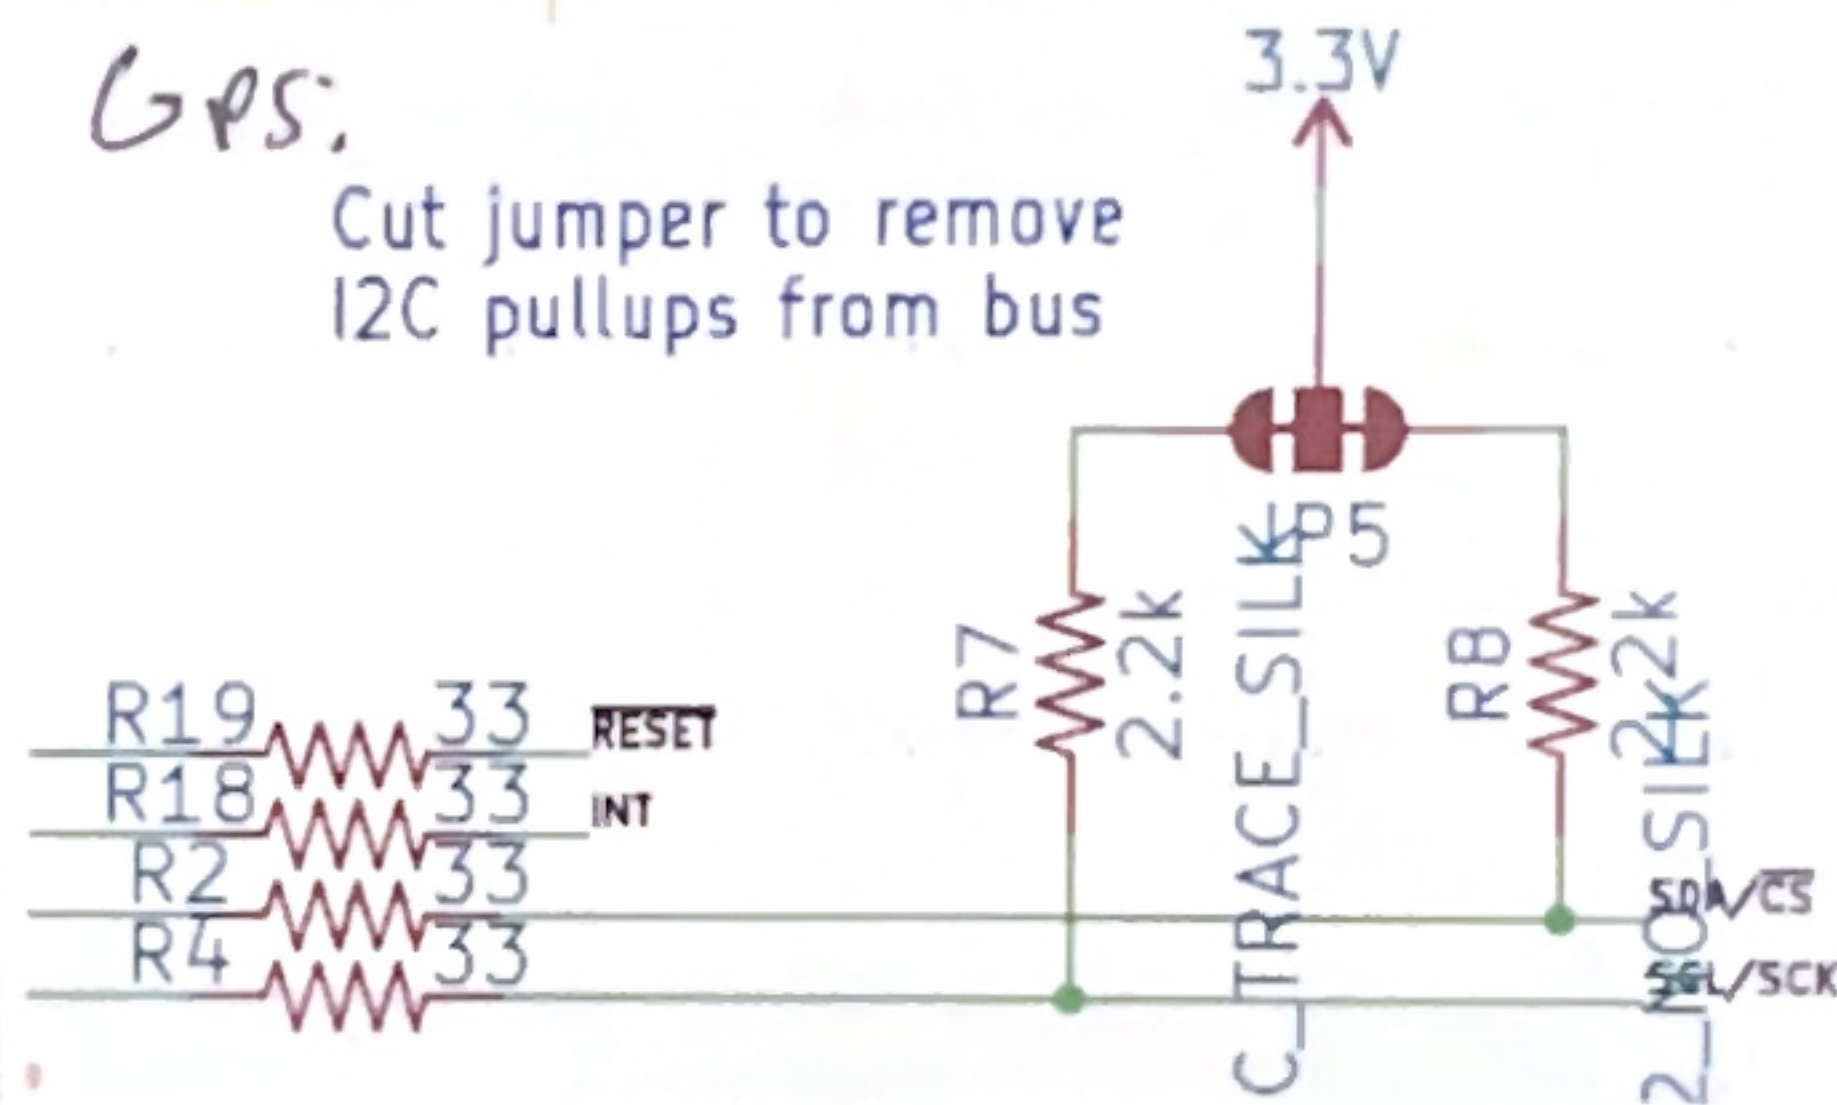
GPS:

Pull up Resistor Notes:

Cut jumper to remove
I2C pullups from bus
