Aviation Investigation Preliminary Report

Location:	Shaktoolik, AK	Accident Number:	ANC23FA042
Date & Time:	June 16, 2023, 11:35 Local	Registration:	N91361
Aircraft:	Cessna 180	Injuries:	2 Fatal
Flight Conducted Under:	Part 135: Air taxi & commuter - Non-scheduled

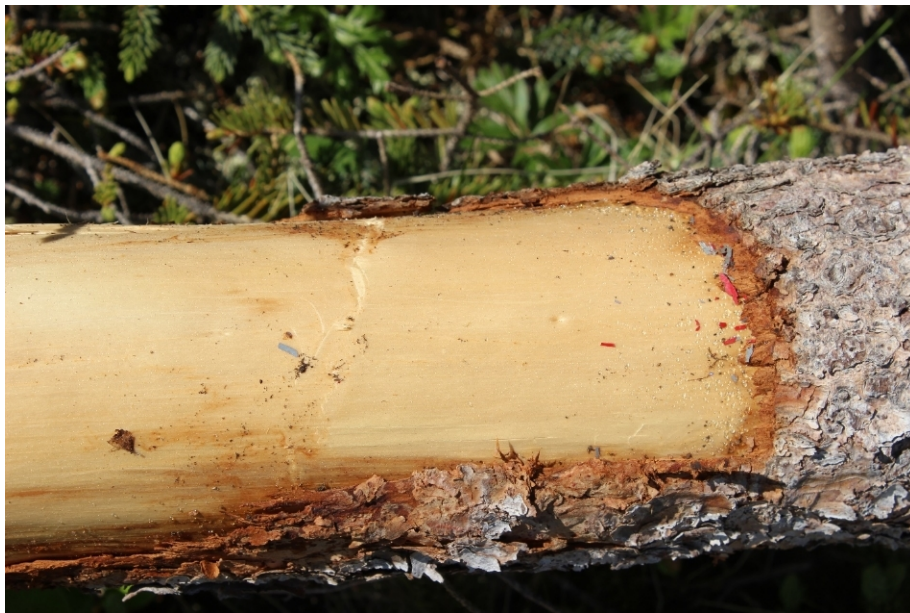
Examination of the airstrip revealed a small cluster of trees about 2/3 of the distance from the departure end on the runway’s left side, and downslope. One 12 ft tree, about 4 inches in diameter, was fractured about 4 ft from its base. The separated portion of the tree was found next to its trunk and displayed fragments of red paint that matched the accident airplane’s paint color.

Figure 1 View of the fractured tree with fragments of red paint.

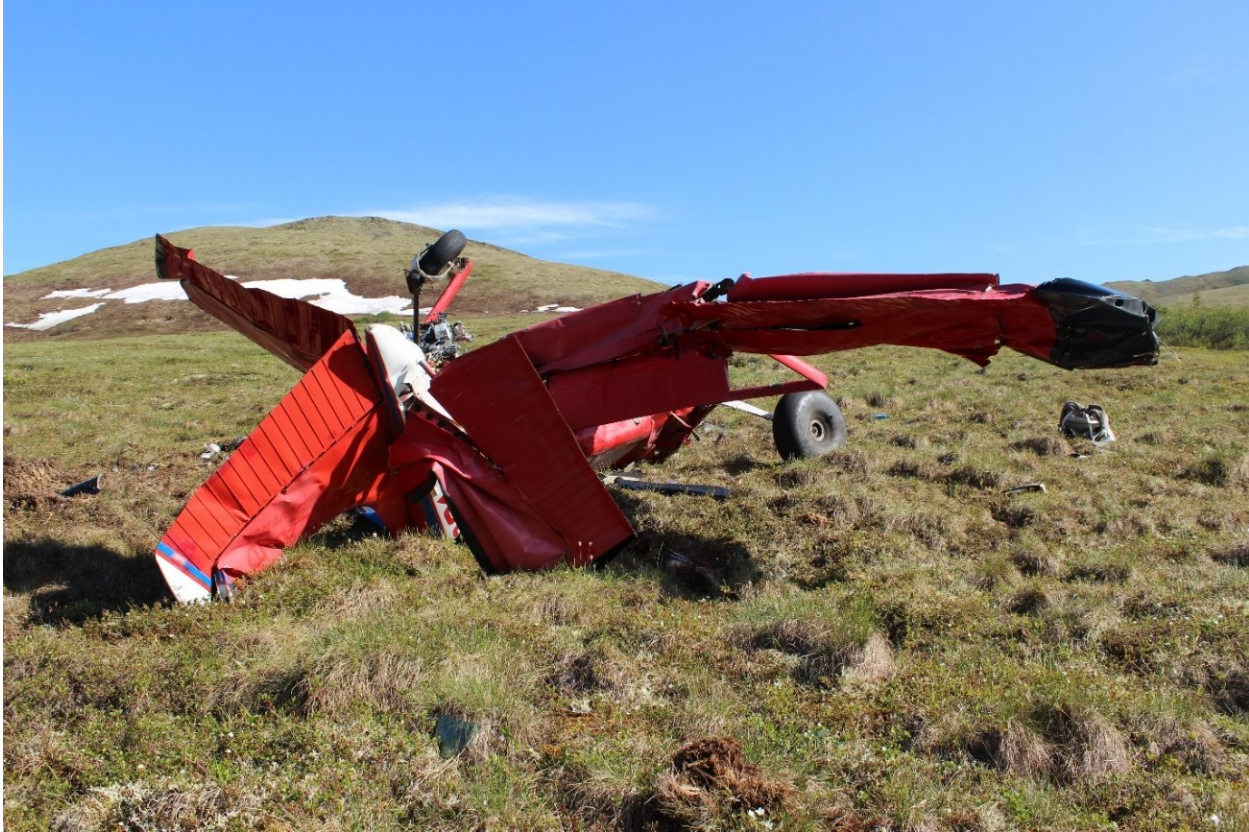
Examination of the wreckage revealed it impacted tundra in a steep nose-down wings level attitude about 1,200 ft. from the broken tree. The wings were displaced by impact, the right wing leading edge was uniformly crushed aft along its span. The upper and lower wing skins were crushed aft in compression. Flight control continuity was established through several breaks to the flight control surfaces. All breaks and separations were consistent with impact and overstress failure. The engine was separated from the airframe and came to rest inverted behind the left wing. The propeller hub was fractured, and the propeller blades were separated from the hub.

Figure 2 View of the airplane where it came to rest.
