ST. ADALBERT'S
CATHOLIC CHURCH

Location: St. Adalbert's Catholic Church
Window: #1
Panels: A-F
Date: 12/15/23
Conservators:
Gabe Goertz, Abby Meyer, Christina
Sieben, Nico Villareal, Nathan Walz

Window 1
Pre-Conservation
Diagrammatic Documentation

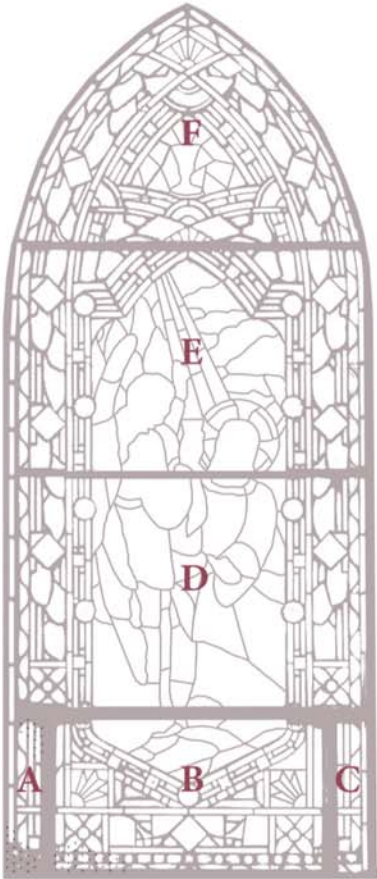
DIAGRAM
1.2

Surface dirt noted on panel A.
