ST. ADALBERT'S
CATHOLIC CHURCH

Pre-Conservation

Location: St. Adalbert's Catholic Church
Window: #27 (1)
Panels: A-C
Date: 12/15/23
Conservators:
Gabe Goertz, Abby Meyer, Christina Sieben,
Nico Villareal, Nathan Waltz

Window 27 - I
Pre-Conservation
Diagrammatic Documentation

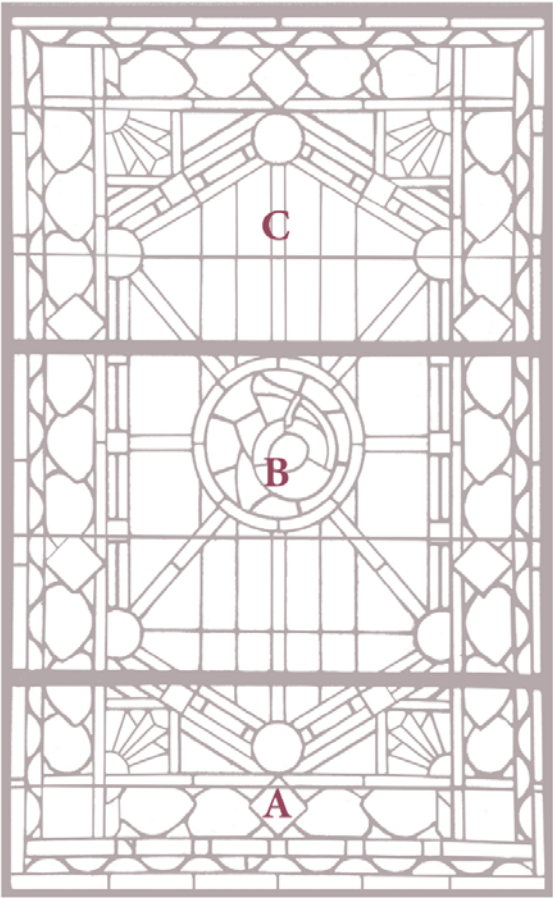
DIAGRAM
14.1

No glass condition damage to note.
