ST. ADALBERT'S
CATHOLIC CHURCH

Location: St. Adalbert's Catholic Church
Window: #27 (1)
Panels: A-C
Date: 12/15/23
Conservators:
Gabe Goertz, Abby Meyer, Christina Sieben,
Nico Villareal, Nathan Waltz

Window 27 - I
Pre-Conservation
Diagrammatic Documentation

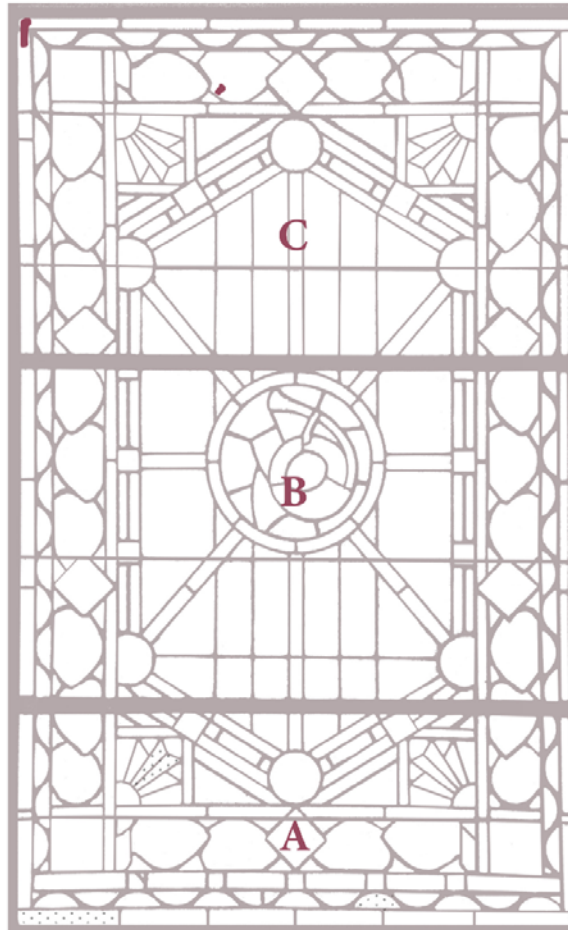
DIAGRAM
14.2

Window is generally dusty/dirty. Candle wax on horizontal lower purple rectangle glass piece and center cyan blue half oval piece; buildup between stained glass and plexiglass cavity ; surface dirt on exterior orange and yellow sun pieces
