ST. ADALBERT'S  
CATHOLIC CHURCH

Location: St. Adalbert's Catholic Church  
Window: #27 (1)  
Panels: A-C  
Date: 12/15/23  
Conservators:  
Gabe Goertz, Abby Meyer, Christina Sieben,  
Nico Villareal, Nathan Waltz

Window 27 - I  
Pre-Conservation  
Diagrammatic Documentation

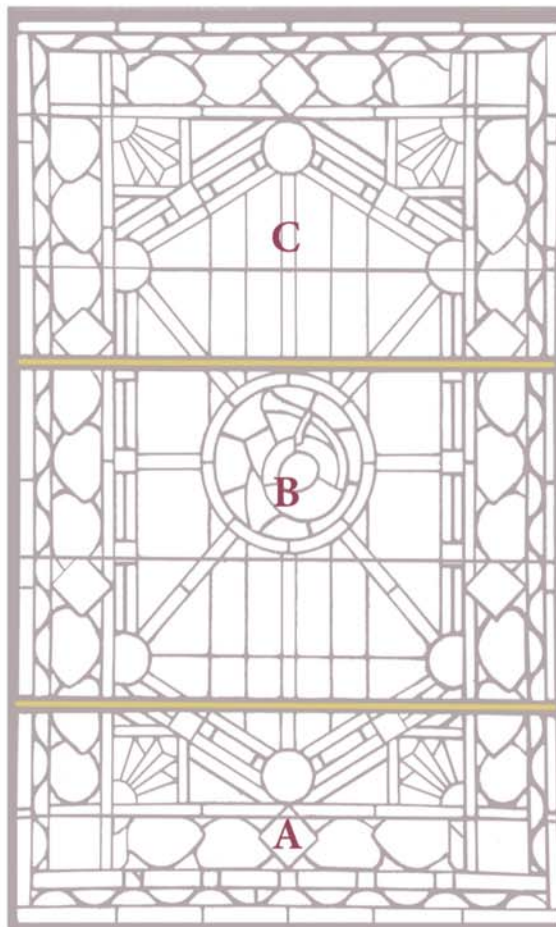
Mending led on bottom left orange square piece.
