ST. ADALBERT'S
CATHOLIC CHURCH

Pre-Conservation

Location: St. Adalbert's Catholic Church
Window: #27 (1)
Panels: A-C
Date: 12/15/23
Conservators:
Gabe Goertz, Abby Meyer, Christina Sieben,
Nico Villareal, Nathan Waltz

Window 27 - I
Pre-Conservation
Diagrammatic Documentation

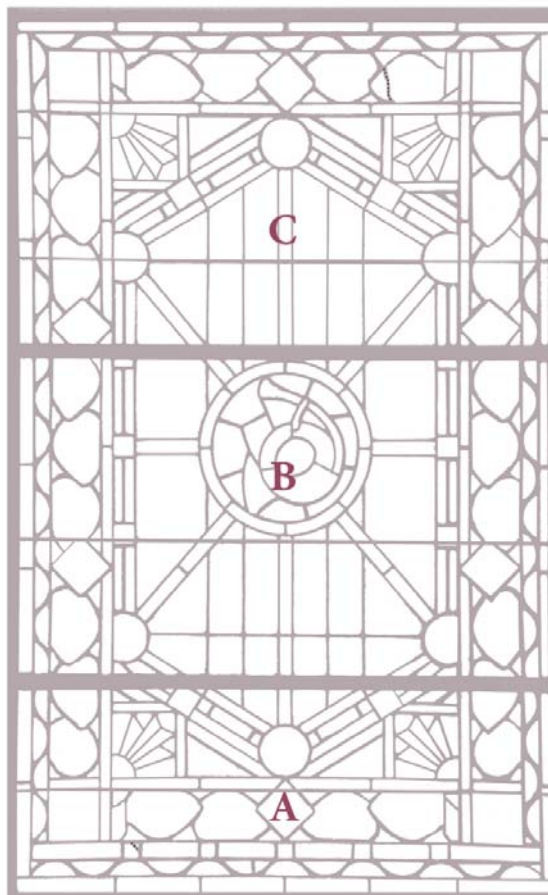
DIAGRAM
14.5

No previous restorations.
