SCHEMPP-HIRTH Flugzeugbau GmbH. Kirchheim/Teck	Appendix to Technical Note No. 360 - 21 / No. 863 - 9	Page No: 1 No of pages: 10
---	--	-------------------------------

Working Instructions for inspection of the spar cap and spar web

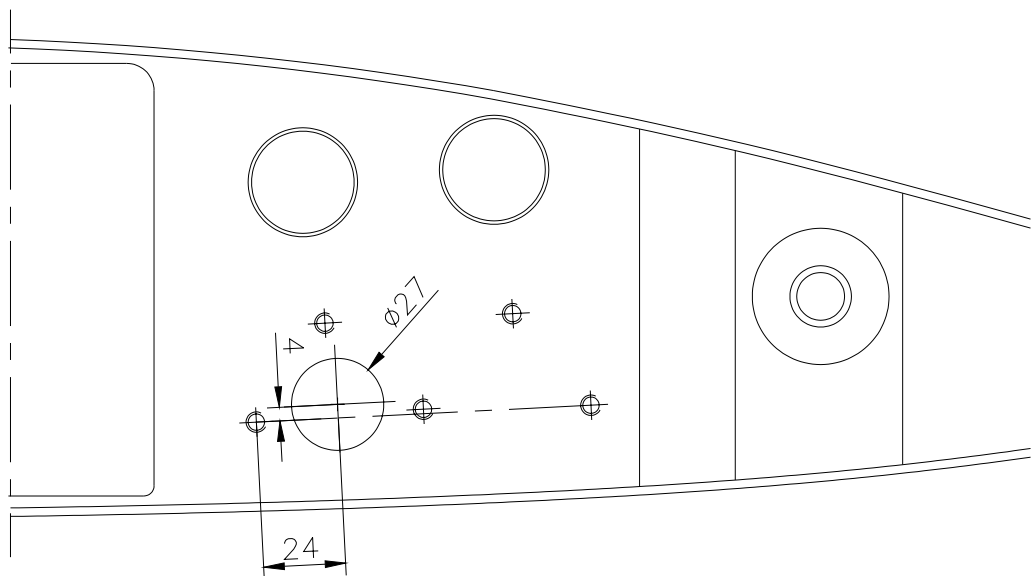
inspection opening in the root rib
(starbord root rib is shown, laterally
reversed on the port root rib)

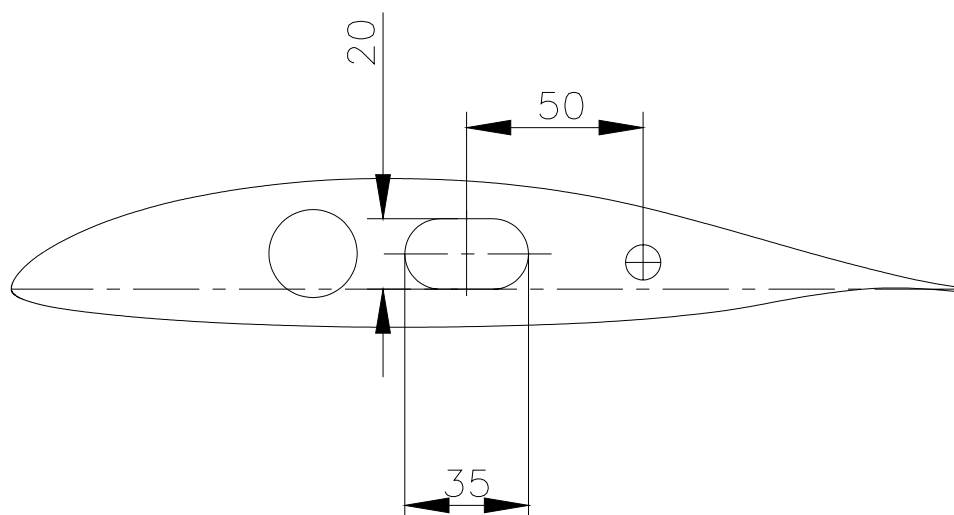
inspection opening in the outer wing rib
(only for aircrafts with winglets)

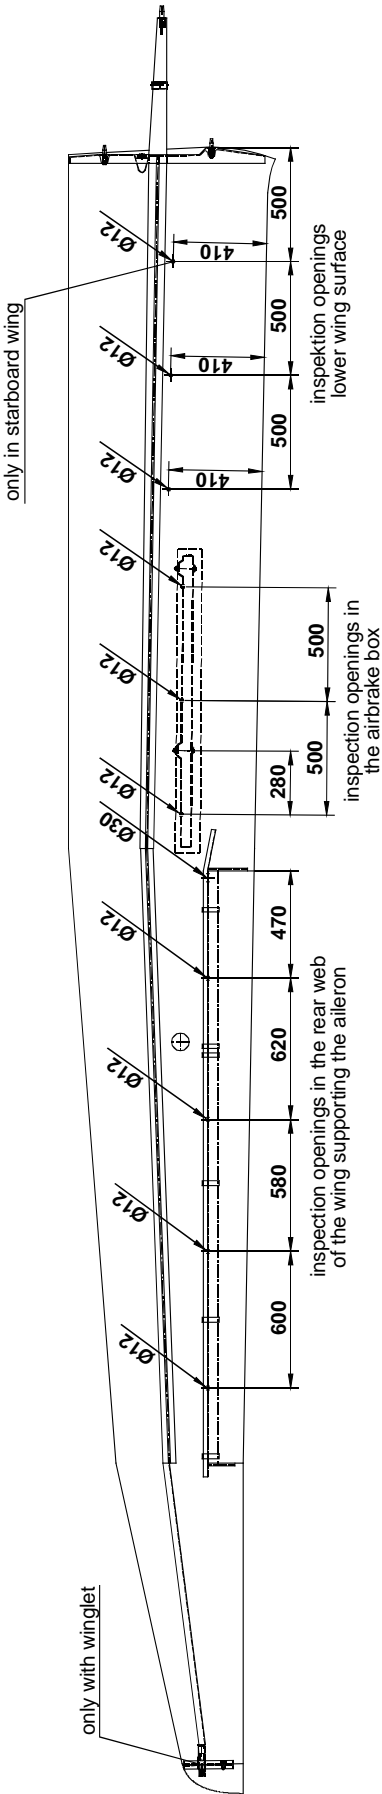
Starboard Discus-Wing
(bottom view)

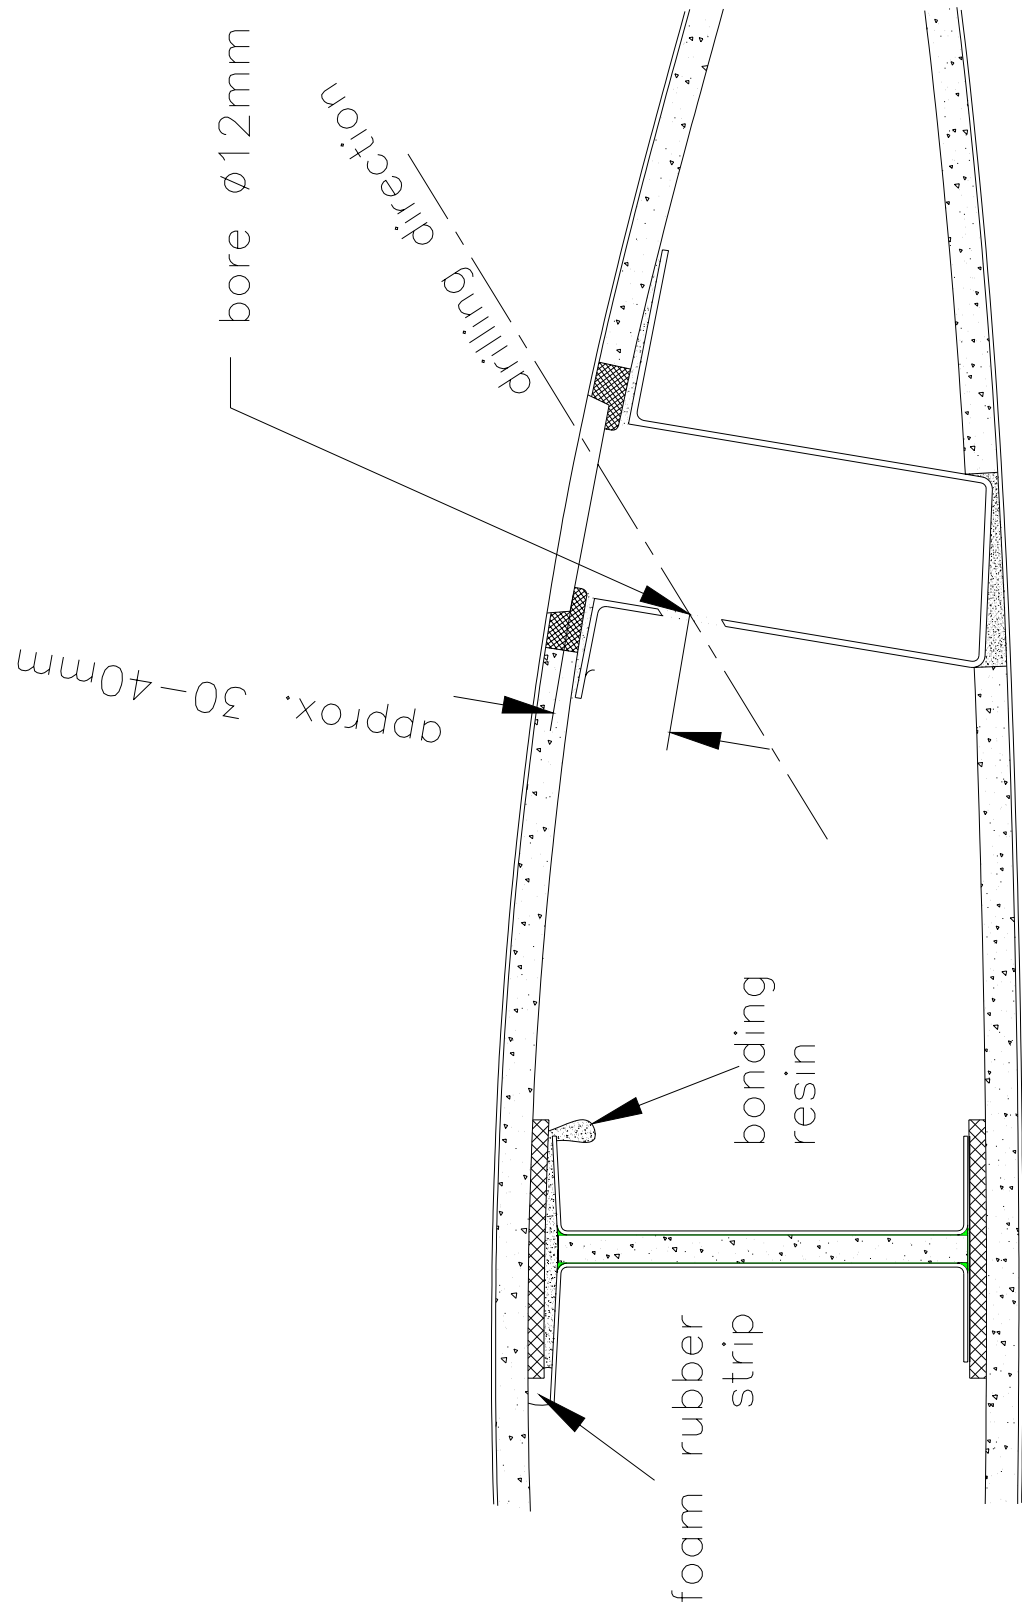
Wing cross section in the airbrake area

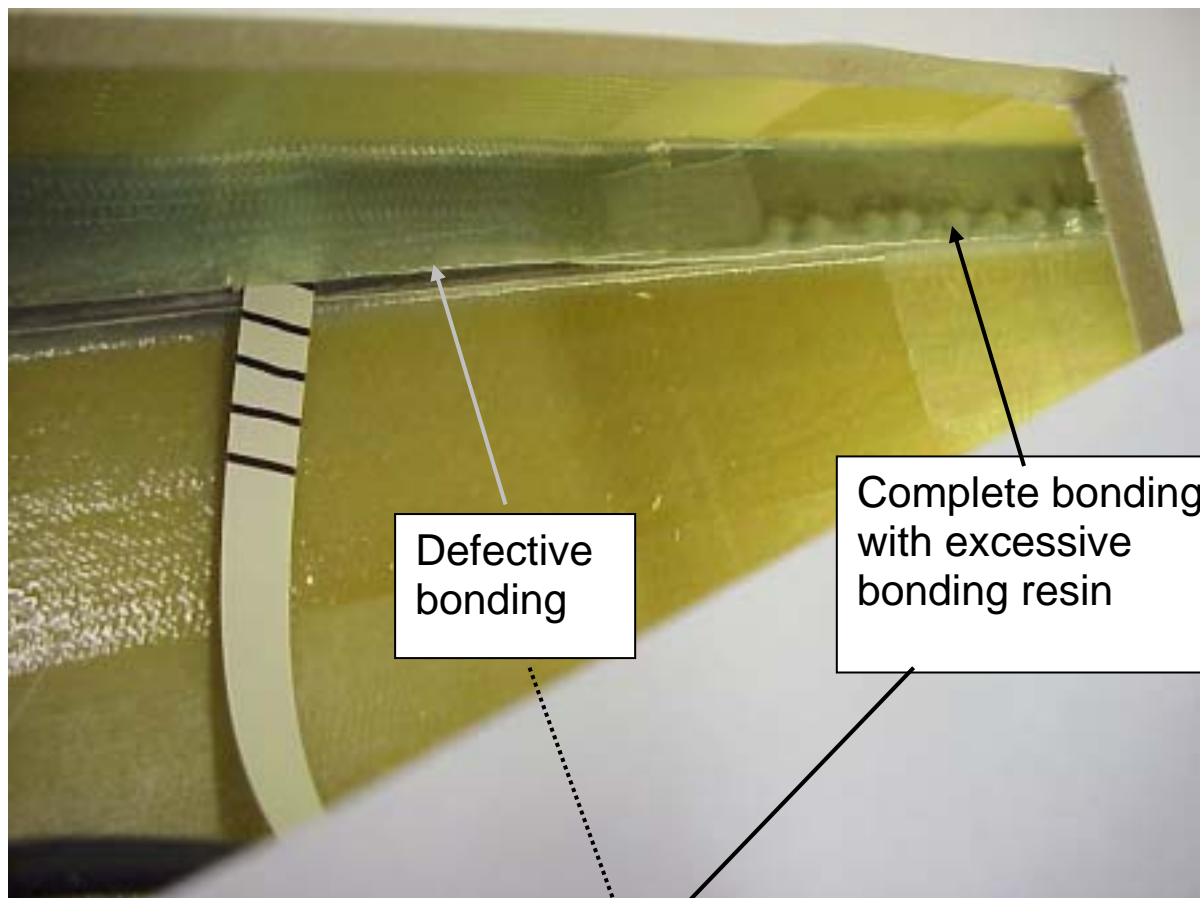
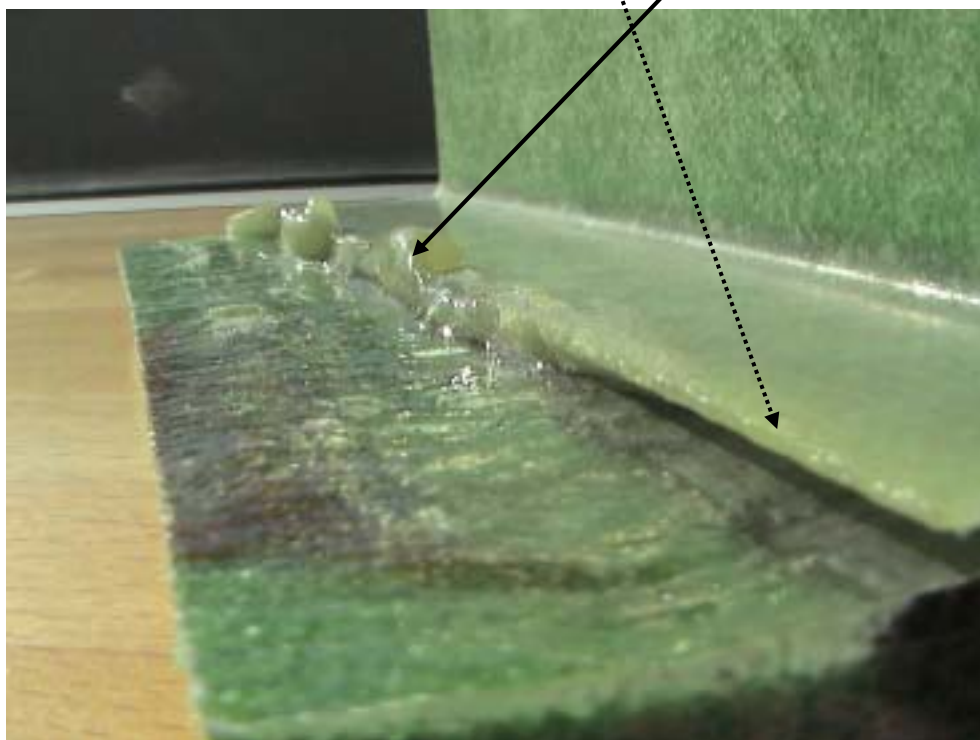
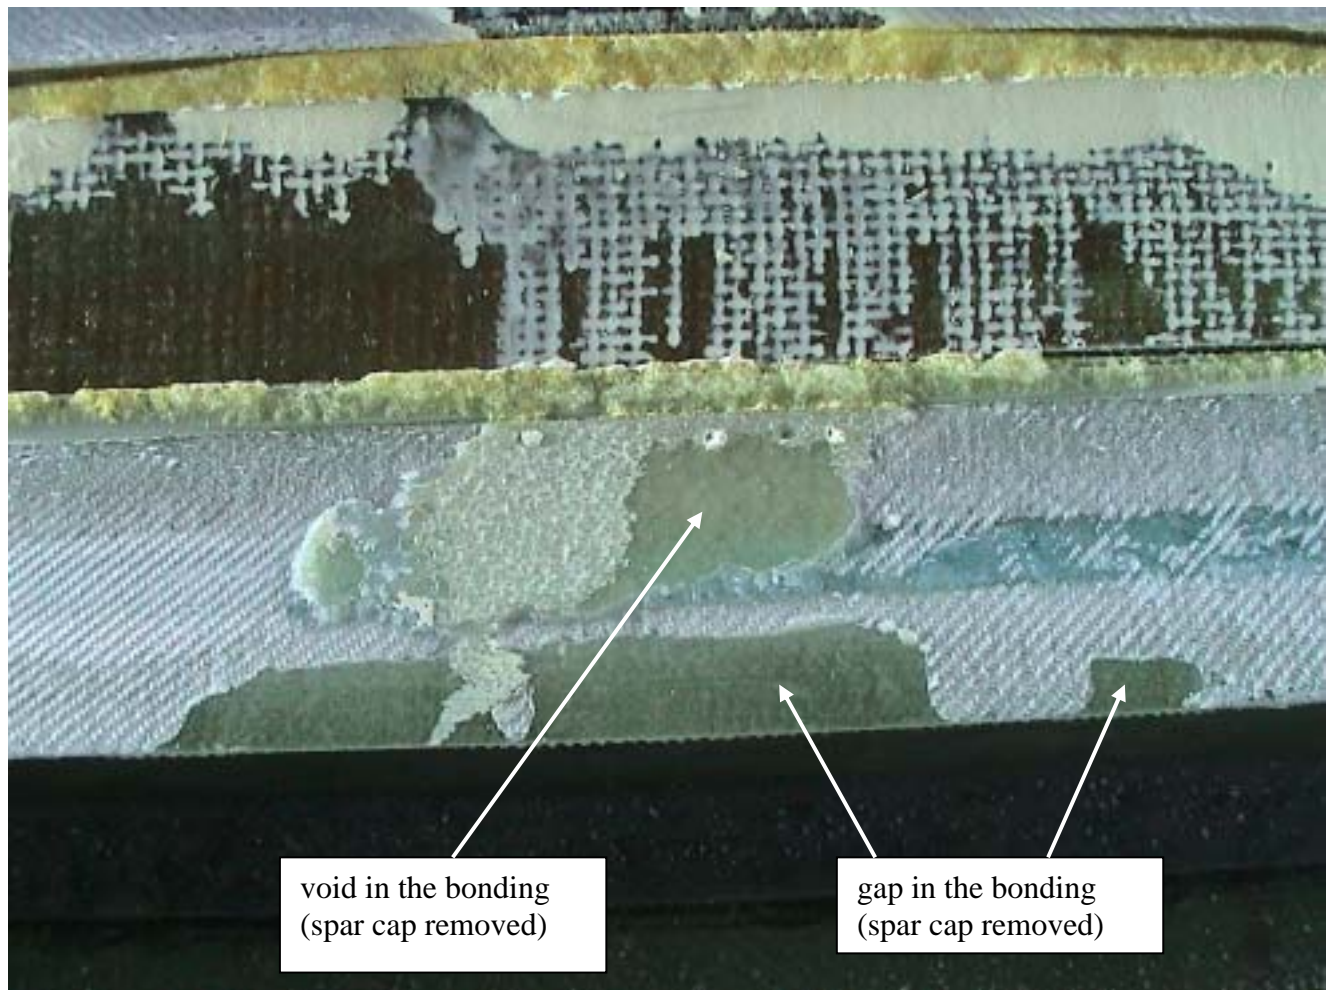
- a complete bonding with excessive bonding resin, see page 9
- a defective bonding – insufficient bonding resin, see page 9 and 10

When identifying the area of the gap, always investigate the extension of the void in span wise direction. Some photos on page 9 and 10 show examples of defects in the bonding.

Defects have to be repaired according the instructions on page 4 and 5.
