High Test Peroxide Incident at Stennis Space Center

R. Ross, D. Sewell, M. Cockrell

Propulsion Test Directorate, Building 4010
NASA John C. Stennis Space Center, MS 39529
Telephone: (228)688-2320, Fax (228)688-1485, Robert.Ross@ssc.nasa.gov

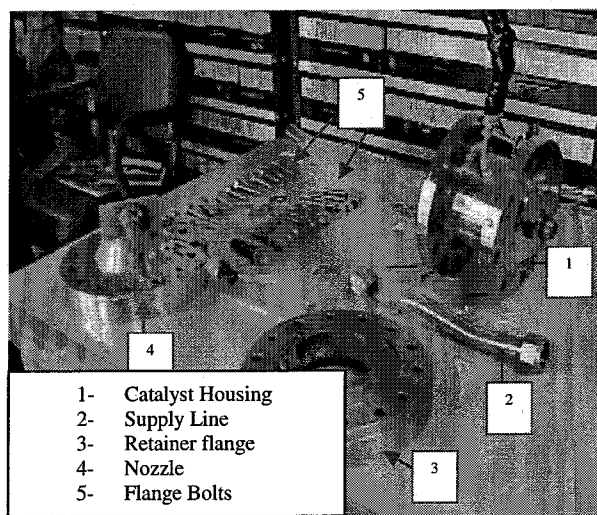
Figure 1: Test Hardware Overview

The event occurred approximately one second into the test following the completion of a successful test. Damage to the facility included rupturing a one inch diameter stainless steel supply line rated for 29 MPa (4200 PSI) and the destruction of a pre-valve rated for 20.7 MPa (3000 PSI) service. For the test article, fourteen 1.27 CM (0.5 inch) diameter stainless steel bolts failed in tension and a portion of the test article (~ 7.3 Kg or 16 Lbm) was ejected thirty meters from the test stand. Figures 1-4 show post test photographs of selected hardware.
