Lessons from Hurricane Katrina Storm Surge on Bridges and Buildings

Article in *Journal of Waterway Port Coastal and Ocean Engineering* · November 2007

DOI: 10.1061/(ASCE)0733-950X(2007)133:6(463)

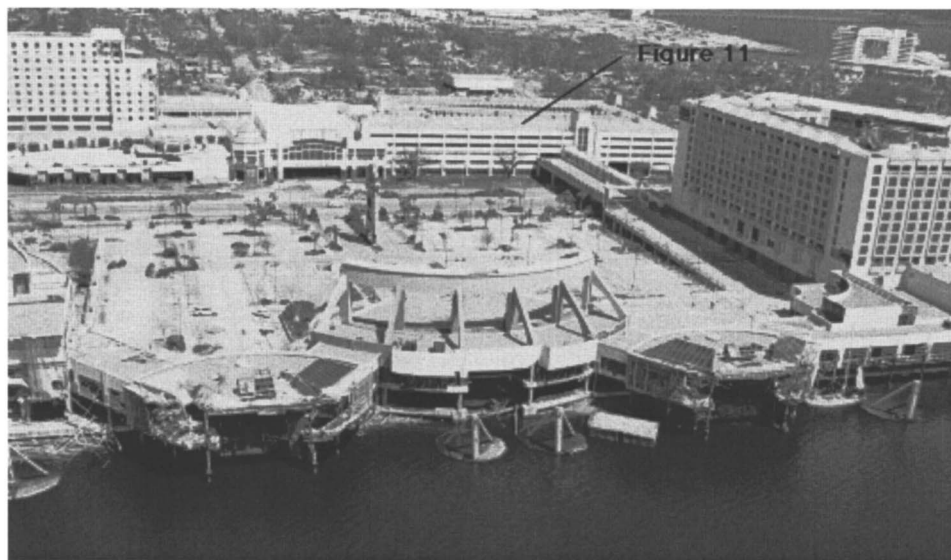
Fig. 2. Grand Casino, Biloxi, with inland parking garage that suffered collapse of the second-level double-tee floor system (Fig. 11) (Photo courtesy of U.S. National Oceanic and Atmospheric Administration/Department of Commerce)

(Fig. 2). In these cases, hydrostatic uplift due to buoyancy is likely the major factor causing failure of the slab system.

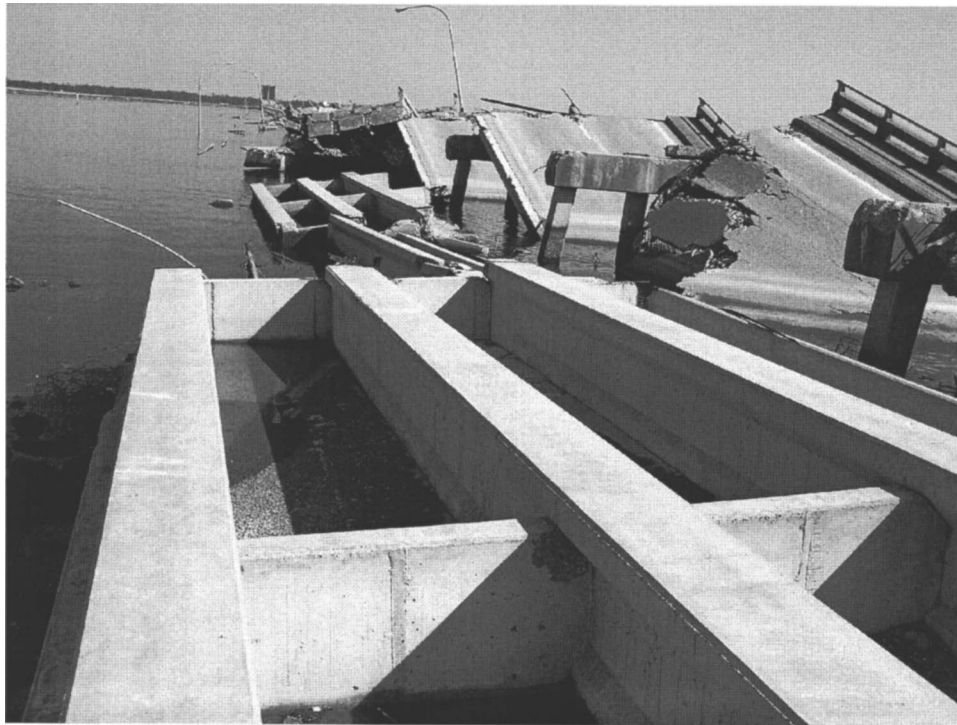
Fig. 3. Girders, bridging, and bulkheads potentially trap air below deck of US 90 highway bridge over Biloxi Bay

that these segments were very nearly buoyant once submerged (Fig. 3). Fig. 4 shows the dimensions of a typical cross section of the bridge deck as measured on site, and Fig. 5 outlines the buoyancy calculation performed on this cross section, including the effects of air compressibility.

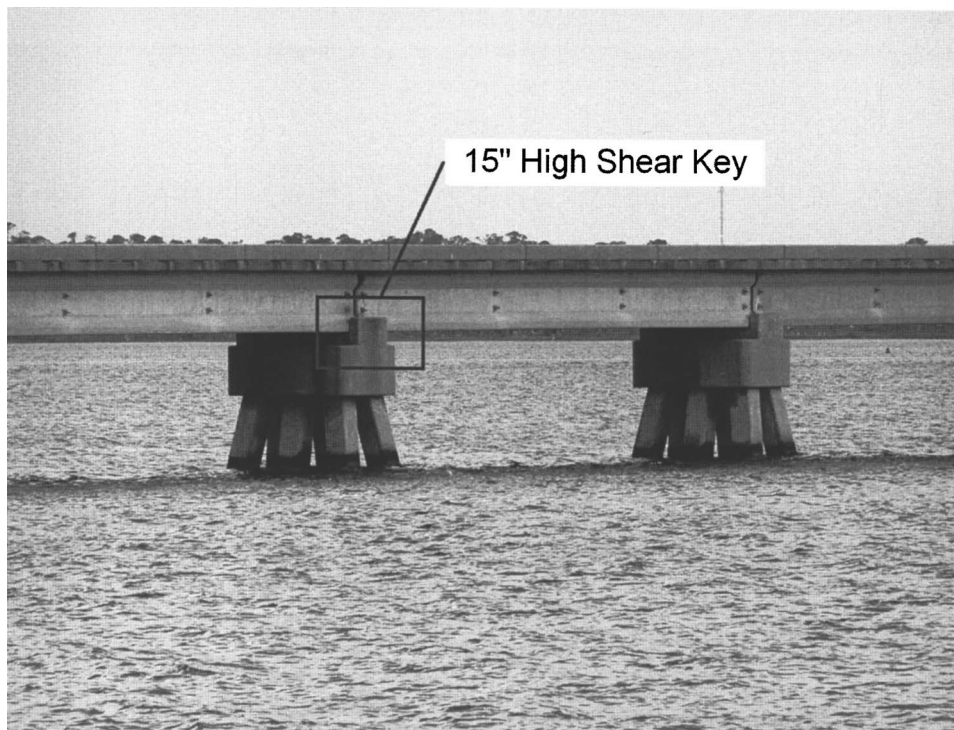
Fig. 9. Railroad bridge over Biloxi Bay with close-spaced girders and large concrete shear keys (1 in.=25.4 mm)

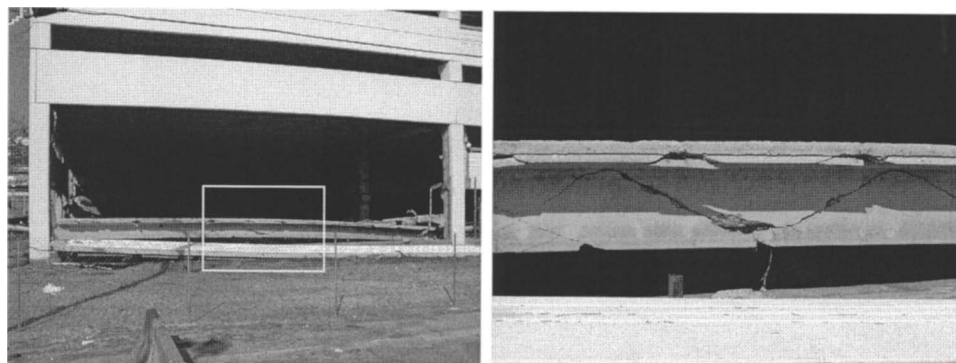
Since the double-tees are designed for gravity load over a simply supported span, they are extremely weak in negative bending. There is typically a light mesh reinforcing in the top flange and topping slab, which are now the tension zone, while the base of the webs is very thin, and the webs now become the compression zone. In addition, the prestressing tendons are located so as to produce uplift intended to balance much of the original unsubmerged dead weight. The combination of uplift due to hydrostatic and prestress effects was sufficient to cause severe cracking of the

webs and top slab and crushing of the concrete at the base of the webs at midspan (Fig. 11). For structures close to the shoreline, wave-induced hydrodynamic uplift and lateral loads would have added to the stress on these sections. In many cases, the negative bending failure resulted in dislocation of the double-tee ends from their supports, resulting in collapse of the floor system.

Fig. 11. Double-tee negative bending failure—parking structure in Biloxi

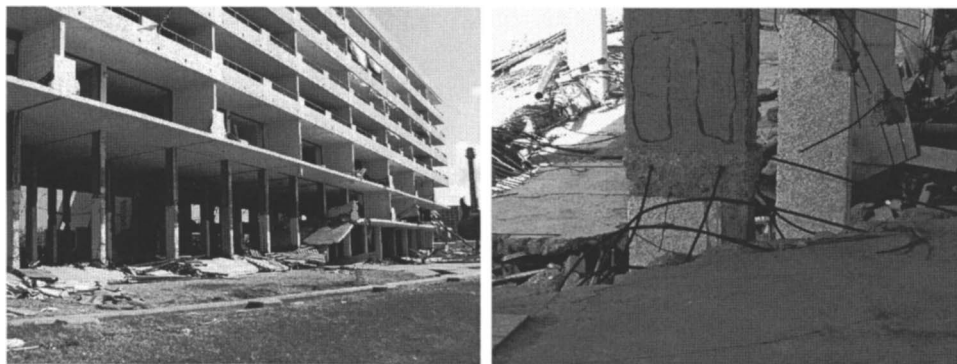
A net uniform upward pressure of 15.9 to 23.8 kN/m² (335 to 502 psf) on the tributary area of slab is required to reach this shear capacity. Because the submerged self-weight of the concrete slab is 2.73 kN/m² (57 psf), the total upward pressure required to cause punching shear failure under direct shear at a slab-column connection would be 18.6 to 26.5 kN/m² (392 to 559 psf) on the soffit of the slab. Based on the hydrodynamic uplift estimated using Eq. (2), this would require a wave height of 1.85 to 2.64 m (6.1 to 8.7 ft) when the surge level was at the bottom of slab elevation of 2.74 m (9 ft) above grade. The maximum unbroken wave height that could occur in this water depth is

approximately 2.1 m (7 ft), which is within the range required to produce punching shear failure of the slab. This analysis has assumed that the uplift does not induce bending moments at the slab-column connection, which would further reduce the punching shear capacity. In reality such bending moments would exist due to the large cantilever balcony slab protruding toward the ocean.

Fig. 13. Flat slab punching shear failure due to hydrodynamic uplift

If these connections had been provided with integrity reinforcement in the form of continuous slab bottom reinforcement passing within the column cage, the total collapse of the floor might have been prevented, even though many of the connections would likely still have suffered punching shear failures. Integrity reinforcement is required by the ACI 318-05 building code for new concrete flat slab construction, but was not required by codes in force when this building was constructed.

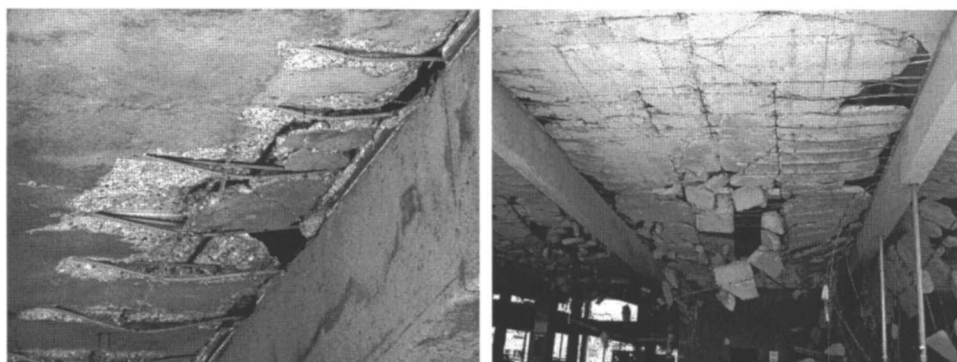
and Casino suffered significant damage and partial collapse of the second-floor bays adjacent to the coastline. It is suspected that hydrodynamic uplift loads on the slab resulted in shear failure of the slab at the supporting beams (Fig. 14) and shear failure at the ends of some of these beams (Fig. 15). The spalling of concrete cover at the epoxy-coated bottom reinforcement in the slab indicates that failure was due to uplift and not downward loads (Fig. 14).

Fig. 14. Uplift-induced shear failure of a posttensioned one-way slab

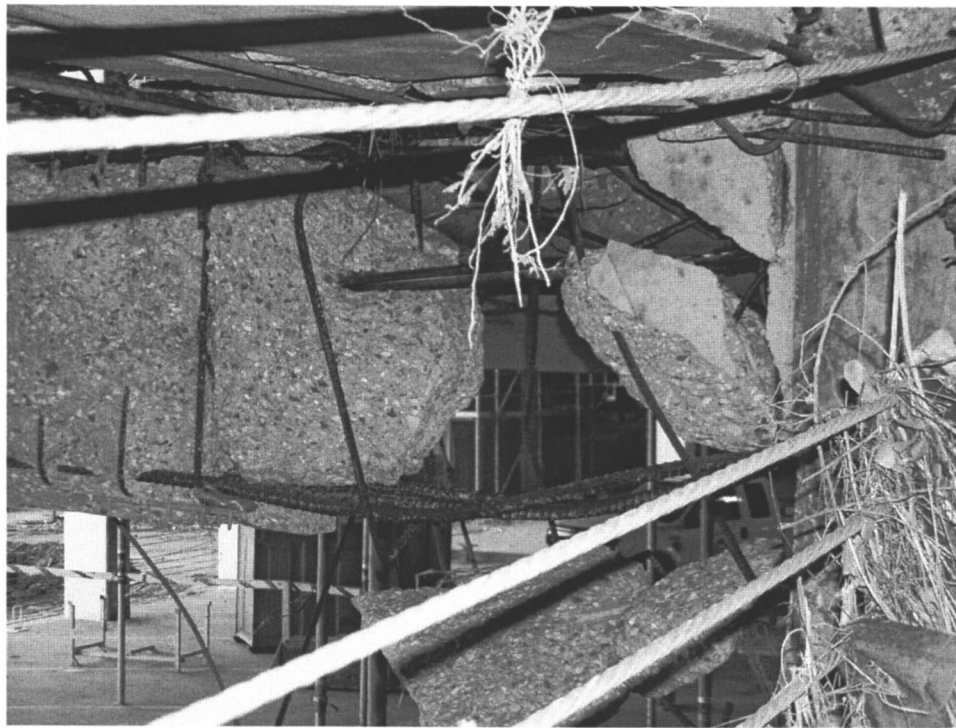
Fig. 15. Shear failure of posttensioned beam supporting one-way posttensioned slab

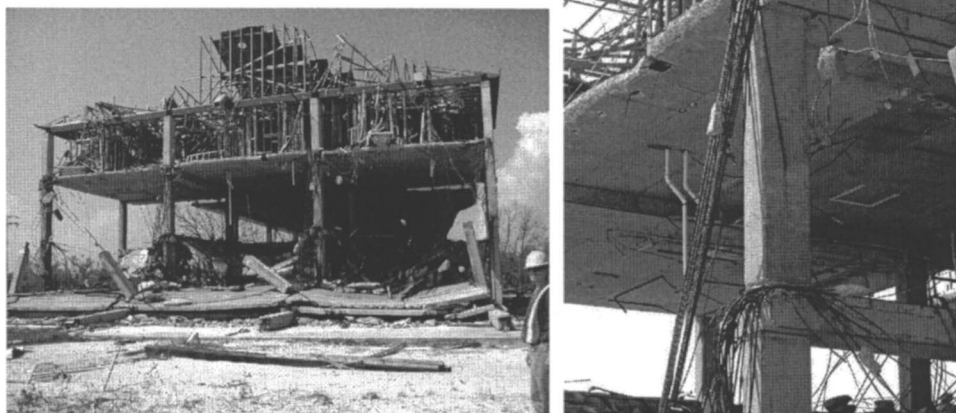
Fig. 16. Partial collapse of concrete building frame under construction

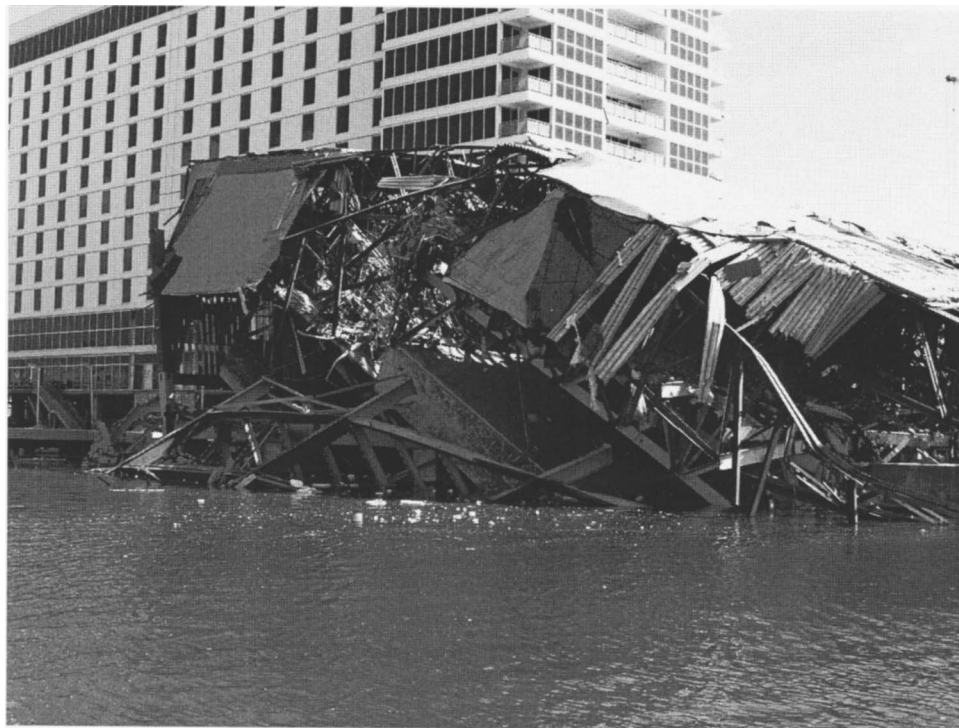
The Hard Rock Casino was located on adjacent floating barges oriented parallel to the shore. The casino was enclosed in a fixed “shell,” which was presumably designed to resist wind loads. The exterior shell collapsed onto the casino, virtually demolishing it (Fig. 18). The Hard Rock Casino was the most severely damaged of all the casinos surveyed. At least three plausible failure mechanisms can be identified. First, excessive vertical motion of the

barges could have exceeded the clearance between the casino and the fixed roof, inducing collapse. The surge was estimated at approximately 6–7.5 m (20–25 ft), and this may not have been accommodated in the design. A second scenario is that the roll induced by the waves caused the top part of the casino to impact the columns of the shell, resulting in progressive collapse. The third and most likely scenario is that the surge and waves elevated and pushed the barges inland, causing the inland columns of the exterior shell to fail. With the frame resistance gone, the wind, surge, and waves then pushed the seaward columns back, and the entire system collapsed. The racking of the barges, as shown in Fig. 18, supports this hypothesis, as do other pictures that show the shore side of the first barge resting on the second floor of the shore-based structure, as well as the failure of the seaward columns.

Fig. 18. Hard Rock Casino barges enclosed by fixed exterior steel structure

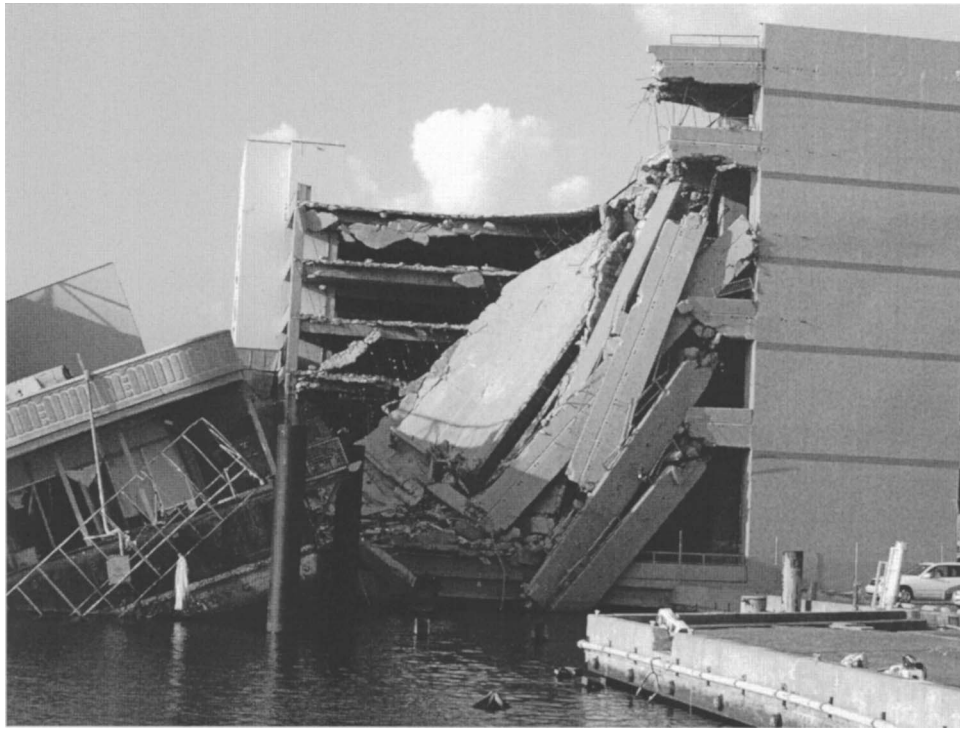
Another example of relative motion resulting in significant collapse is the Isle of Capri casino and parking structure (Fig. 19).

Fig. 19. Progressive collapse of parking structure due to barge impact damage to lower-level columns

It is clear that the pounding of the barge-mounted casino on the columns of the parking structure resulted in partial progressive collapse. It is unlikely that the light-frame superstructure could have caused the collapse of the concrete columns. It is more likely that the barge hull, which was located very close to the

exterior columns, slammed into the columns as a result of increase in elevation, roll, and/or yaw. The floor system, consisting of posttensioned one-way slabs supported on long-span, posttensioned beams, was unable to prevent progressive collapse without the column support. The relative positioning of the collapsed

spandrel beams indicates that the middle floors likely collapsed first. The long span of the slab could not be supported without the column, causing the upper floors to collapse and then finally the lower floors. Note the mooring piles, which were inadequate to prevent the destructive impact.

also have been designed to resist progressive collapse so that damage to a few columns would not result in disproportionate collapse of the floor slabs.

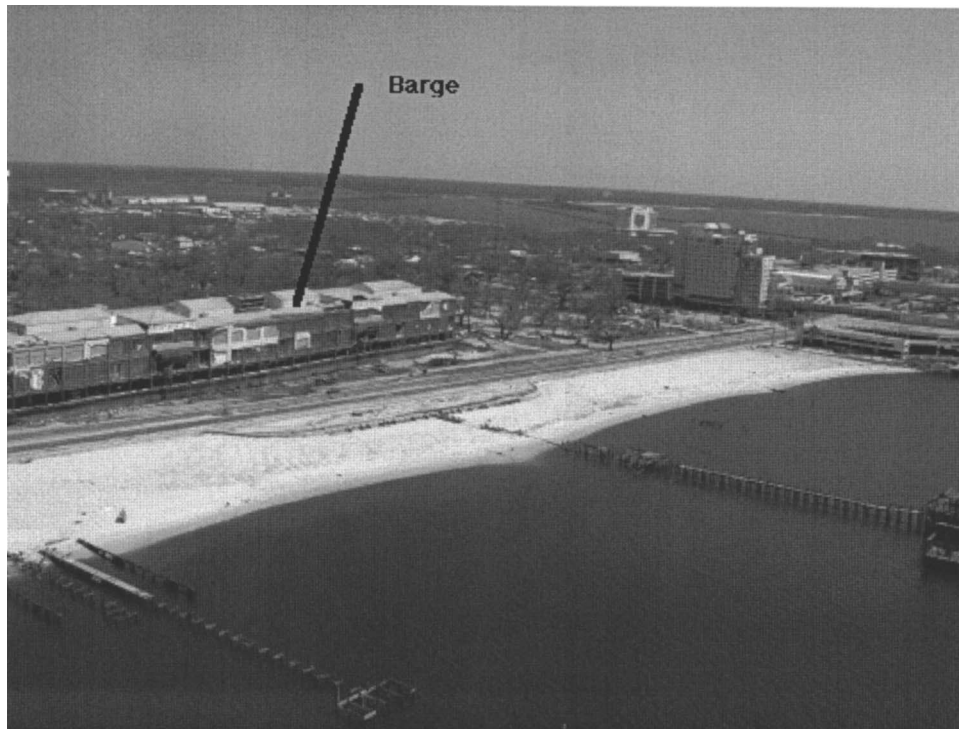
Fig. 20. Larger Grand Casino Biloxi barge transported alongshore and inland by Hurricane Katrina (Photo courtesy of U.S. National Oceanic and Atmospheric Administration/Department of Commerce)

The Grand Casino Biloxi consisted of two barge-mounted, multi-story casino structures. These broke free from the dolphin mooring system and were transported a substantial distance onshore (Fig. 20). The smaller, three-story casino barge was approximately 39 m (100 ft) wide, and 60 m (200 ft) long and had a draft

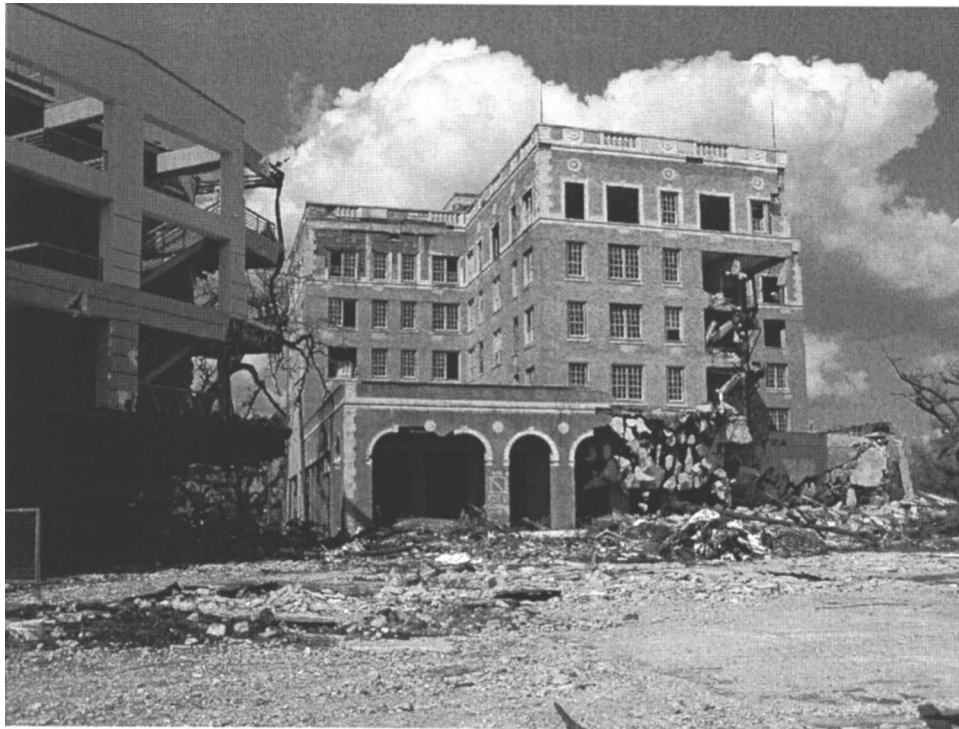
Fig. 21. Damage to cast-in-place reinforced concrete building caused by impact of adjacent barge

An example of impact is clearly demonstrated by the collision of the Grand Casino barge with the Tivoli Hotel (Fig. 21). The 2.4 m

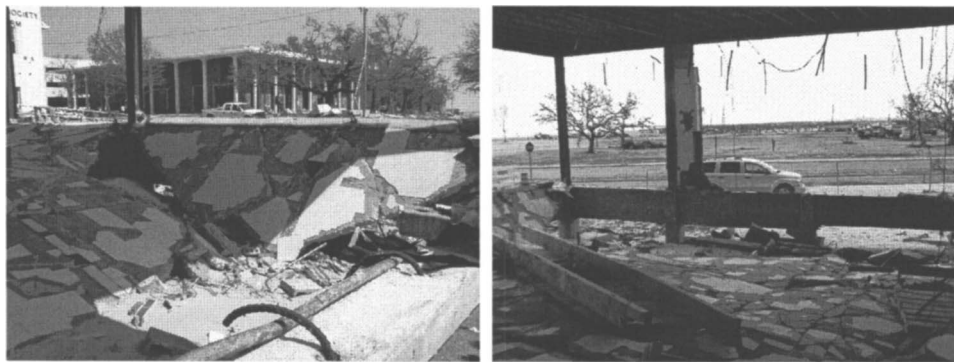
Fig. 23. Liquefaction-induced scour under fill-supported first-floor slab

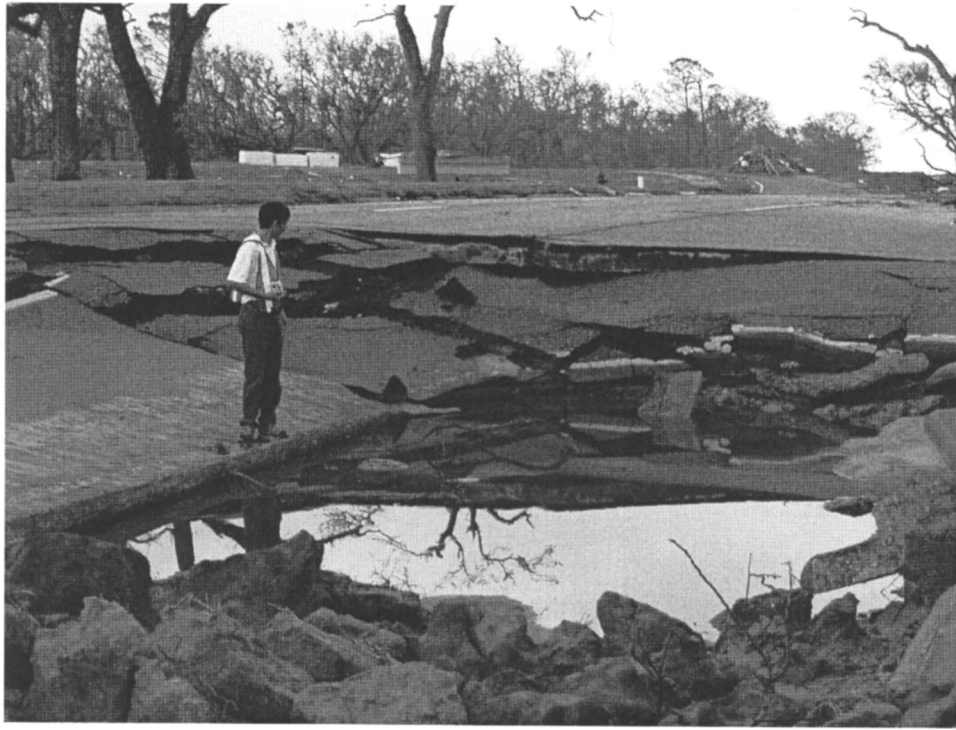
to prevent shear-induced scour and postpone the point at which liquefaction occurs. Nevertheless, the supporting sandy soil or backfill is still susceptible to liquefaction-induced scour, particularly during wave drawdown or ebb surge. Once the supporting soil liquefies and is carried away by the flowing fluid, the thin floor slab or highway pavement, which initially rested on the soil, will collapse, which may eventually lead to total collapse of the structure. Numerous examples of liquefaction-induced scour under floor slabs and footings were observed throughout the Mississippi coastline. Sinkhole-like craters also were observed in many locations along the coastal highways due to drawdown and wave-induced liquefaction of the subgrade below the pavement (Fig. 24).

Fig. 24. Sinkhole-like crater left by scour of liquefied subgrade below coastal highway

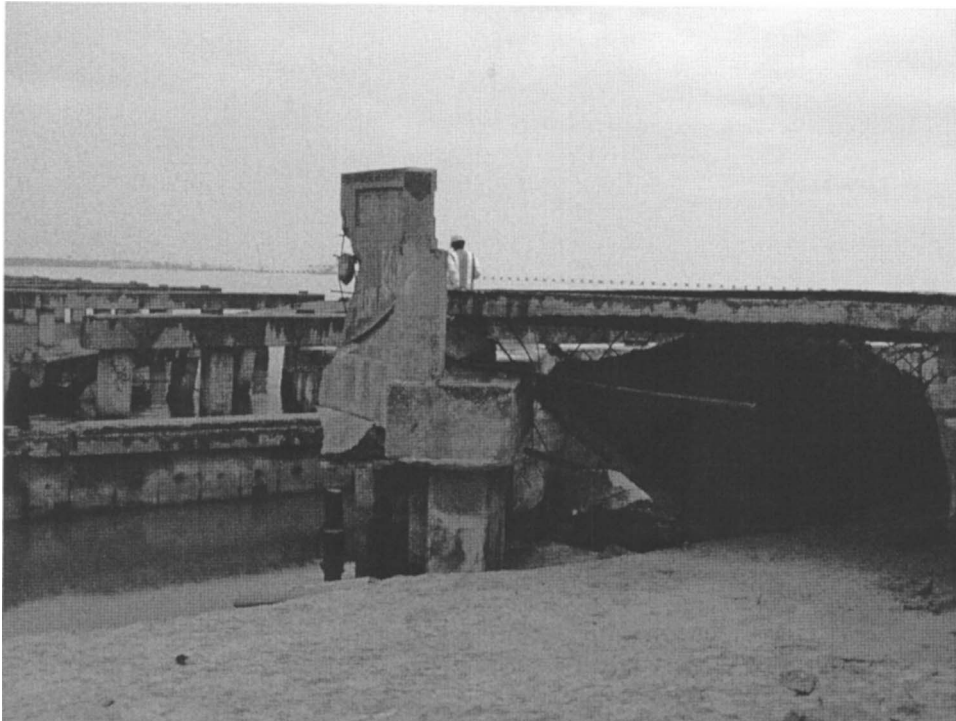
Fig. 25. Up to 4.5 m (15 ft) of scour around abutment exposing piles below abutment

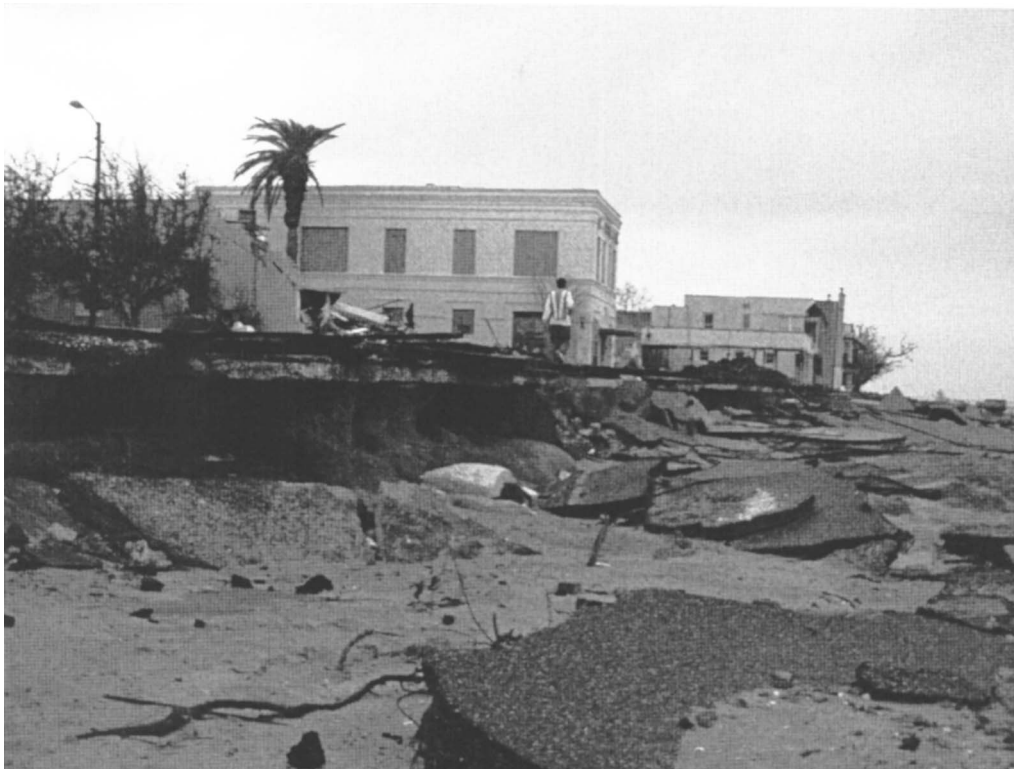
Fig. 26. Complete scour of Beach Boulevard in Bay St. Louis

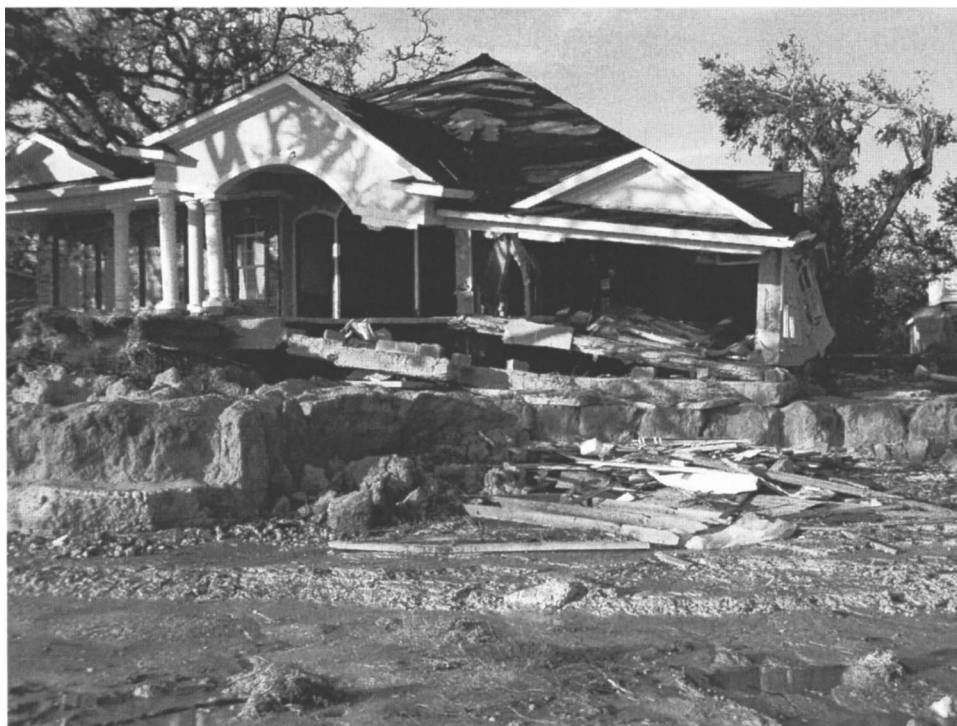
Fig. 27. Scour under foundations leading to partial collapse of residence

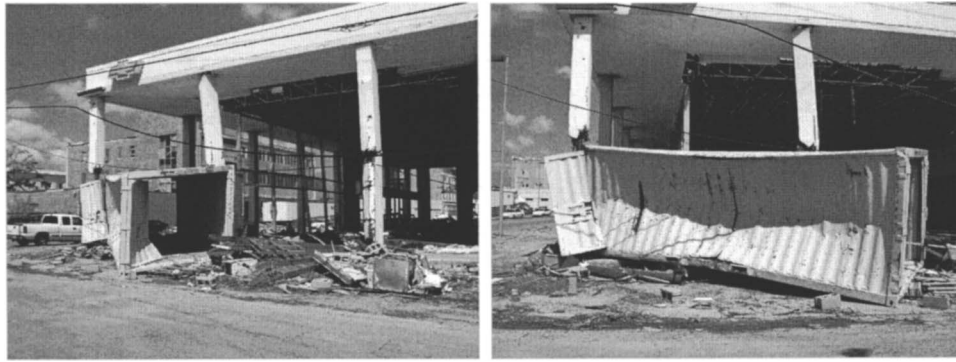
Fig. 28. Empty steel shipping container lodged against columns supporting roof

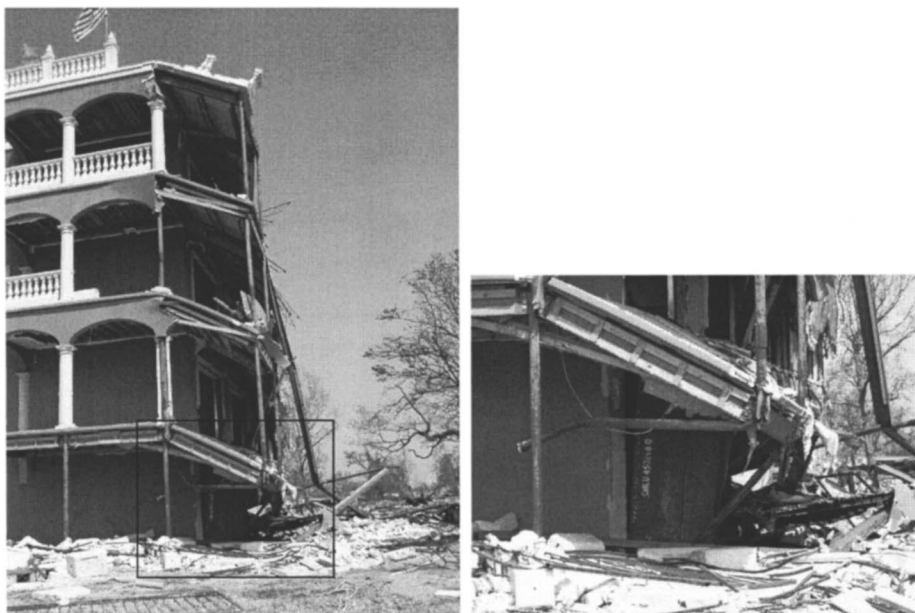
Fig. 29. Shipping container damage to steel pipe columns supporting balconies

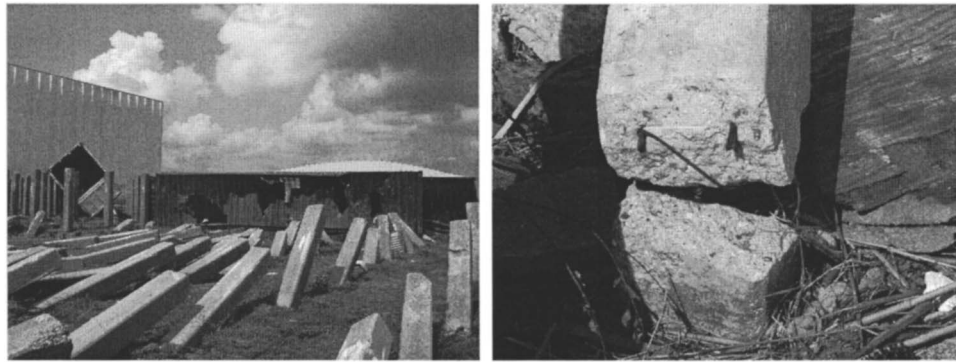
Fig. 30. Bending failure of piles due to shipping container impact and damming effect
