IMPACT OF 2008 HURRICANE IKE ON BRIDGE INFRASTRUCTURE IN THE HOUSTON/GALVESTON REGION

Matthew Stearns¹, Jamie E. Padgett^{2*}

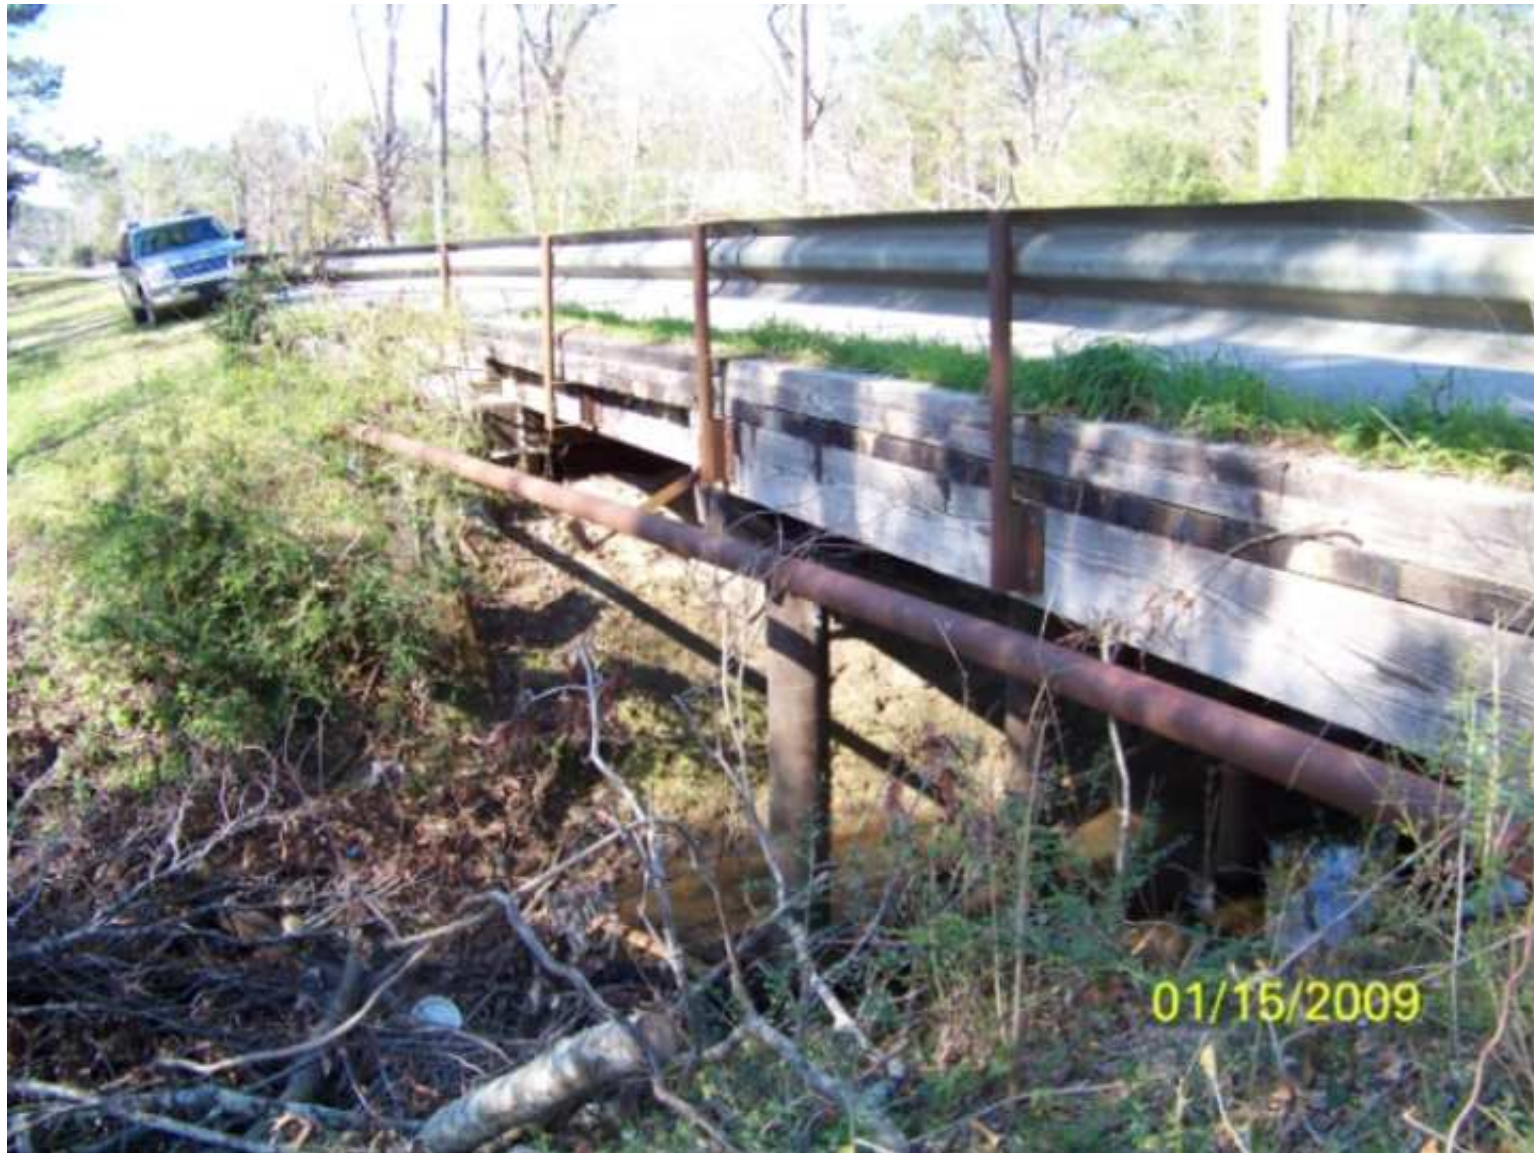
Figure7a

In Galveston Bay near Port Bolivar, the 7th Street Bridge was completely washed away by the storm surge, which at this location was 12.9 feet with 3.1-foot waves based on hindcast storm data (Dawson and Proft, 2010). The timber-supported bridge deck was displaced completely off the timber support structure, as shown in Figure 7. The bridge deck and the support bent connections were inadequate to resist the uplift forces, and they were ripped from the support columns, detailed in Figure 7.
