## Fire Risk Assessment

General Information										
Address of premises:		Chemistry, Cantocks Close, Bristol, BS8 1TS.								
Assessor / job title:		Sylwester Rzeminski								
Date of fire risk assessment:		24 July 2025.								
Date of previous fire risk assessment:		24/06/2025.								
Suggested date of next review: (based on risk level indicator)		20/01/2026								
Building risk profile (A, B, Ci, Cii)		A2, B2.								
Risk Level Indicator										Total points score
		0-99		100 – 399		400 – 699		700 – 999		1000+
(a) Hazard(s) total =	Trivial		Tolerable	11	Moderate	27	Substantial	2	Intolerable	
(b) Points award	1 point		5 points		20 points		50 points		100 points	
Points total (a x b)			55		540		100			
<b>695</b>

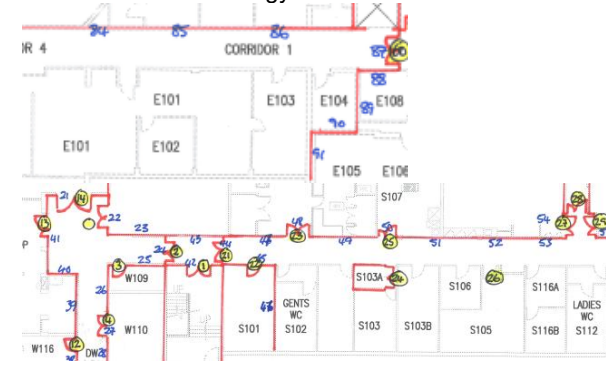
EMERGENCY ROUTES AND EXITS			
Dead end corridors and basements	COMMENTARY	EXISTING CONTROL MEASURES	FIRE RISK
<p>Items to consider:</p> <p>Are they covered by automatic detection or fire resisting construction and fire doors?</p> <p>No. of stairways serving the basement, whether the stairway also serves upper floors, how it is separated from the other escape routes?</p>	<p>Record any findings within the building ensuring you identify potential fire hazards and risk areas within the premises</p> <p>Main chemistry building off lift foyer area office/labs within office areas.</p>	<p>Record systems and procedures in place including training and information given.</p> <p>If action is needed record this in the action log.</p> <p>All floors have fire detection; however, action elsewhere considers if the L2 standard is achieved.</p> <p>Observations of the plans provided, "marked up plans" indicate inner rooms and dead ends, corridors that are used as a means of escape with fire walls to one side only, (examples below) these appear to be in part unprotected routes, 30 minute walls and doors may not be provided, and detection may be insufficient, a review of the fire strategy will attend to this matter.</p>

<p>Action 19 raised below.</p>	<p>Control/condition satisfactory? <b>Yes/No</b></p> <p>No.</p>

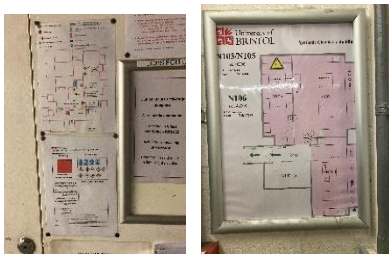
<p>Top floor of synthetics, repair the ceiling to provide a protected route, reduction in fire spread to the roof void.</p>	RM	<p>Request send 10Apr 1375386</p> <p>23/07/25 chased</p>		
6	T	<p>Site plans showing key hazard areas with assist for emergency response. Some labs observed with location plans, gas cylinder locations and extinguisher positions etc.</p>

<p>The provision of lab plans as good practice should be extended throughout.</p>	Sally Hobson

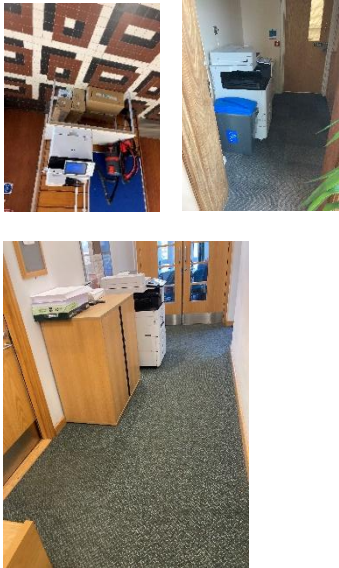
21	M	<p>Corridors are used as locations for printers and storage as a means of escape this potentially obstructs the route, and the routes should be cleared of items.</p>

<p>(Action from the previous report.)</p>	<p>The production of a retrospective fire strategy will inform all of the designated fire exit routes. These will then be required to be kept sterile. Photocopier and other ignition sources will need to be relocated, identify suitable alternative locations/ enclosures in the interim. The corridor clear width should be the same as the exit door width in order to retain the exit capacity. The site will have to put in place suitable ongoing management procedures to clear any items from escape routes.</p>	Charlotte Edom-Hodge			
22	T	<p>Insufficient fire exit directional signs at the far end of synthetics basement plant room.</p>

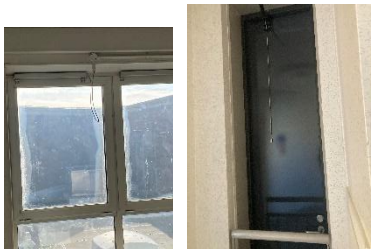
26	M	<p>In the stairwell, a window opener observed – it is not known if this is a smoke ventilation device, confirm and maintain. Ceiling void hatches observed, it is not known if these are smoke ventilation devices, confirm and maintain. Some observed to be open. Top hung panel observed in the WC corridor, it is not known if this is a smoke clearance device, confirm and maintain.</p>

<p>The provision and operation of smoke control systems should be confirmed, the fire strategy will seek to detail these smoke ventilation systems, they will require testing and maintenance. The compliance team has no record of these on their system so this will need to be added.</p>	Leighton Rawlinson			
27	T	<p>West Block fire staircase is secured, the balance between security and a person being trapped in the stairwell should be considered. Fail safe security systems may be more appropriate.</p>	<p>Fail safe security systems to be provided to the West Block fire staircase. This will permit occupants of the stairwell – for example engineers in the roof plant room, to access and exit the stairwell as necessary rather than holding open the fire door with a strap.</p>	Tony Blundal

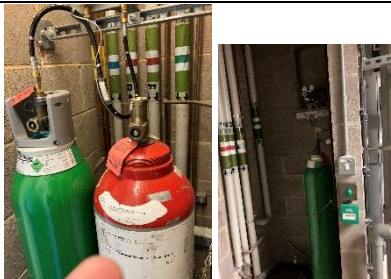
34	T	<p>Zetasafe gas manifold inspection regime, 19/09/20204 fail reports, confirm remedial works complete.</p>	<p>To the gas manifold systems, confirm remedial works are complete.</p>	Paul Nicolau

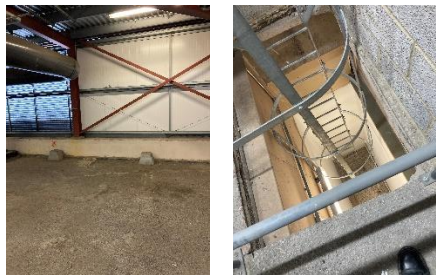
35	M	<p>AMP Electrical LTD lightning protection test record 29/05/2024, states a fail. Confirm remedial works are complete, and retest system once roof works are complete.</p>	<p>Lightning protection defects reported, confirm remedial works complete, and retest system once roof works are complete.</p>	Leighton Rawlinson			
36	T	<p>West Block roof plant area observed to have dead end spaces, accessed by vertical ladders and alternative ladder access fire exit routes, in addition to insufficient fire exit direction signs.</p>

<p>Provide additional fire exit direction signs to the West block fire exit routes. The route to the vertical ladder should be easily followed.</p> <p>The upper plant area, accessed by vertical ladder should be considered to be an area where permit to access and no lone working is applied. A ladder lock-off plate should limit access to those with authorised/permit access.</p>	SFM

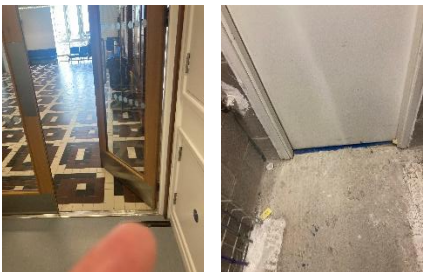
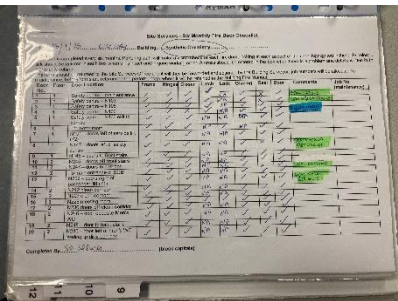
42	M	<p>Routine 6 monthly check of fire doors by Estates Assistants and repairs scheduled as necessary.</p> <p>Reported that there are a number of outstanding door defects to be actioned.</p> <p>Remedial actions on numerous Fire Doors in Chemistry, identified in Jan 2023 by Estates. Repairs remain outstanding and have been chased by FM.</p> <p>Defects observed during the visit.</p>

<p>Defects observed to doors, not closing and large bottom gaps.</p>

<p>Confirm completion of the previously notified fire door defects.</p> <p>Continue to inspect and maintain all fire doors.</p>	SEA			
----	---	--	---	-----	--	--	--

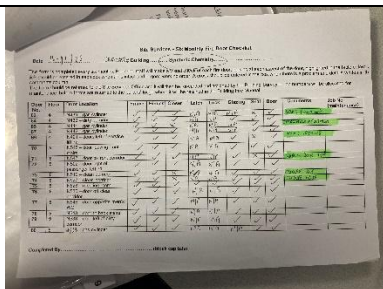
Sample of records of Estate Assistant door checks.

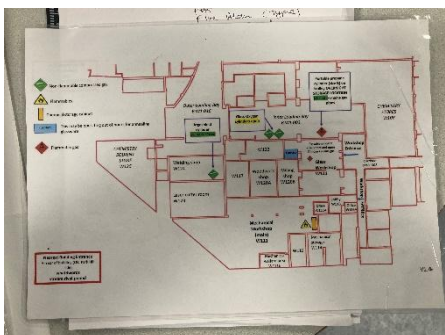
be proved to be in place and effective.					
45	M	<p>The solvent store is clearly a high-risk area, and a separate action is raised to reduce the risk here. However, the significance of a fire in the solvent store appears to be given too low a priority.</p>

<p>The document shown does not mention the solvent store.</p> <p>The consequences of a fire here will have a significant impact on the adjacent areas.</p>

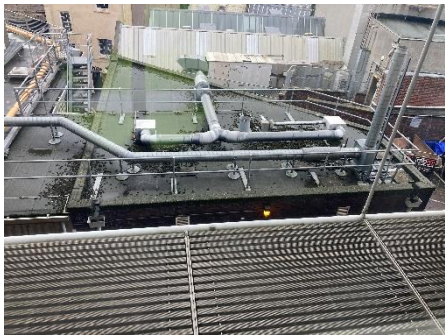
<p>Note the gas pipes and vents.</p>	<p>An appropriate emergency plan should be written for the Solvent store area. Consider the calorific value of the typically stored contents and then consider the consequences of this fuel load on the building. The fire is likely to be rapid and quickly escape the room, via the ventilation provision. This will probably impact the adjacent properties.</p> <p>The situation as it is may be unacceptable, and risk reduction may be required in the form of fire suppression systems, reduction in quantities stored, or storage elsewhere.</p> <p>Guidance available. <i>Storage of flammable liquids in containers HSG51.</i></p>	Sally Hobson

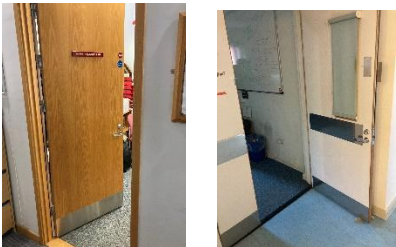
Some additional emergency planning is advised.					
46	M	<p>Fire doors observed to be wedged open throughout the property.</p>

<p>The recommended fire strategy will inform occupants as to the location of protected fire exit routes. The requirement to keep the fire exit doors closed on these routes to be enforced by the university.</p> <p>Estate Assistance to undertake daily tours to confirm all fire doors are closed.</p>	SFM
