Another Failure 20 with measurements and some test mode?

My new MK-312BT is also suffering from "Failure 20".

My PCB is **1.3B**.

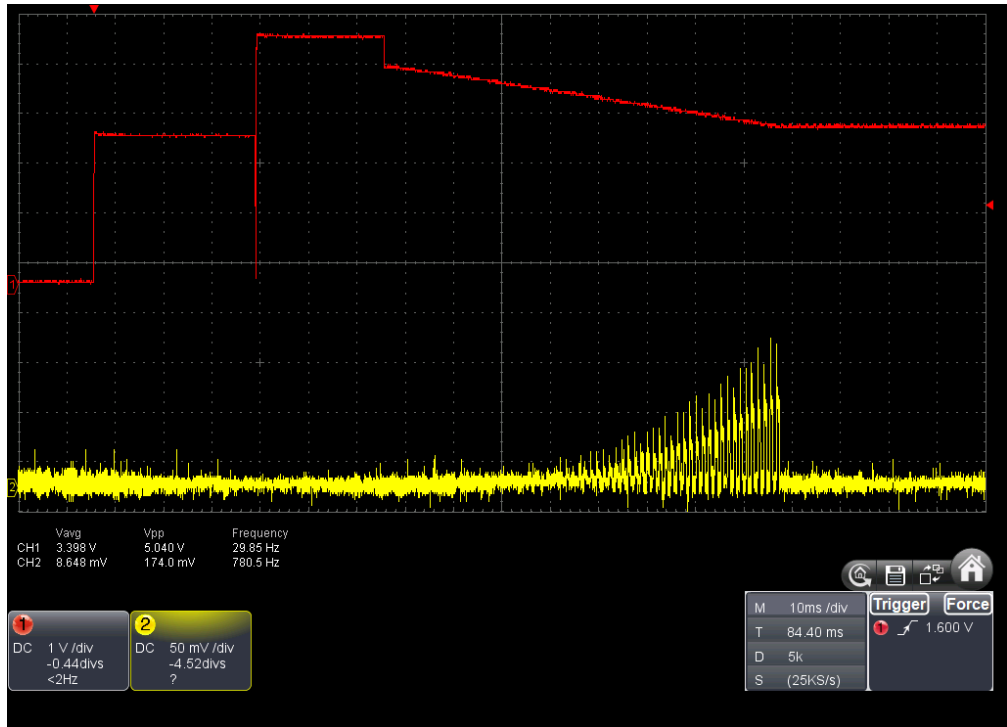
Red = OUT A, Yellow = R30 current sensing resistor:

- Is the voltage at R30 suppose to be so low - peaks are only 100mV?
- Is the output coming from the DAC correct?
- Is the output from U10A correct?

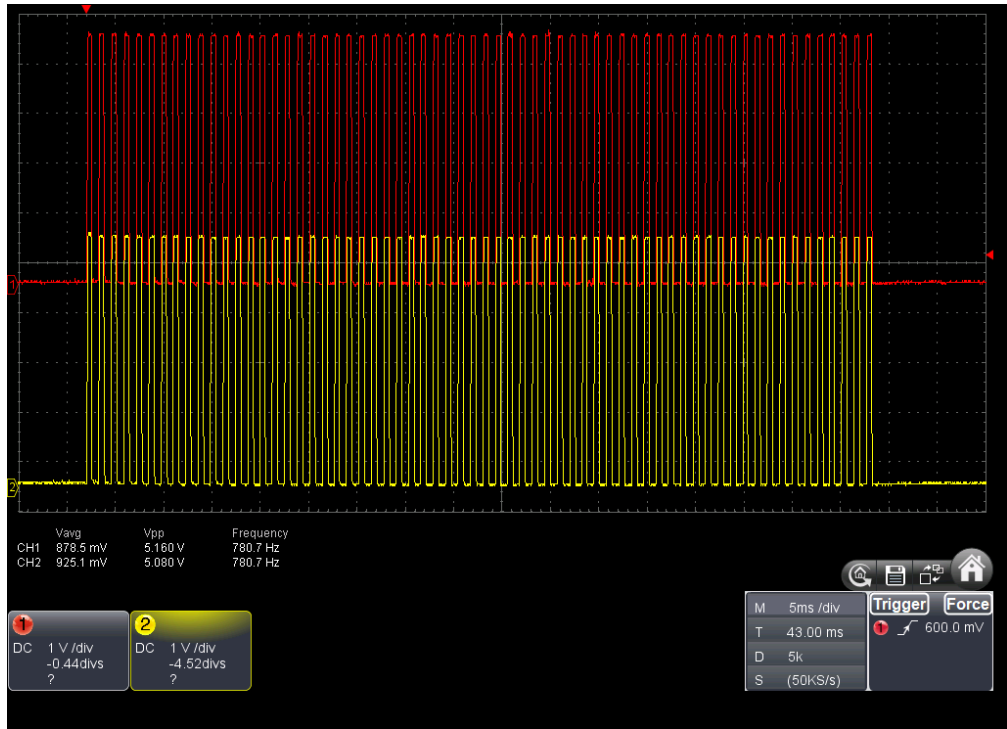
Red = Q1 gate, Yellow = Q2 gate (against ground):

I have not built my device by now, as I am missing the firmware, but looking at your oscilloscope captures this one seems a bit weird to me: "**Red = Q1 gate, Yellow = Q2 gate (against ground):**".

This looks like Q1 and Q2 are switched simultaneously, if they are switching simultaneously you generate a current through the transformer in forward and backward direction in parallel, so the magnetic field will result to zero and therefore there will be no current on the output, but on the input.

Not sure why you deleted your post but you are correct! They are suppose to alternate. I will investigate it further. Still it does not explain missing signal at R30.

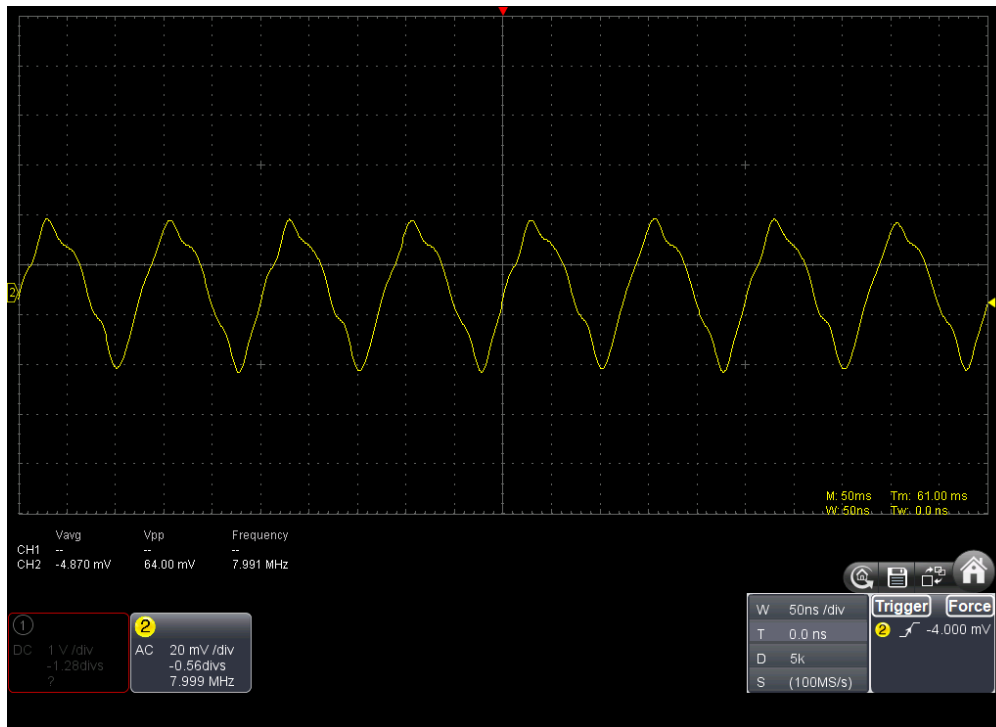
Sometimes the ATMEGA does not startup correctly. The LCD is not correctly initialized (I guess) the top row is full of rectangles, the backlight is ON. The crystal oscillator is ticking correctly at 8MHz. Fuse bytes are correct. I tried to add 100nF cap between RST and GND to slow down the startup time – It made it even worse. The power consumption is 55mA in this case. 5V and 9V rails are OK.

Crystal when the ATMEGA does not startup correctly:

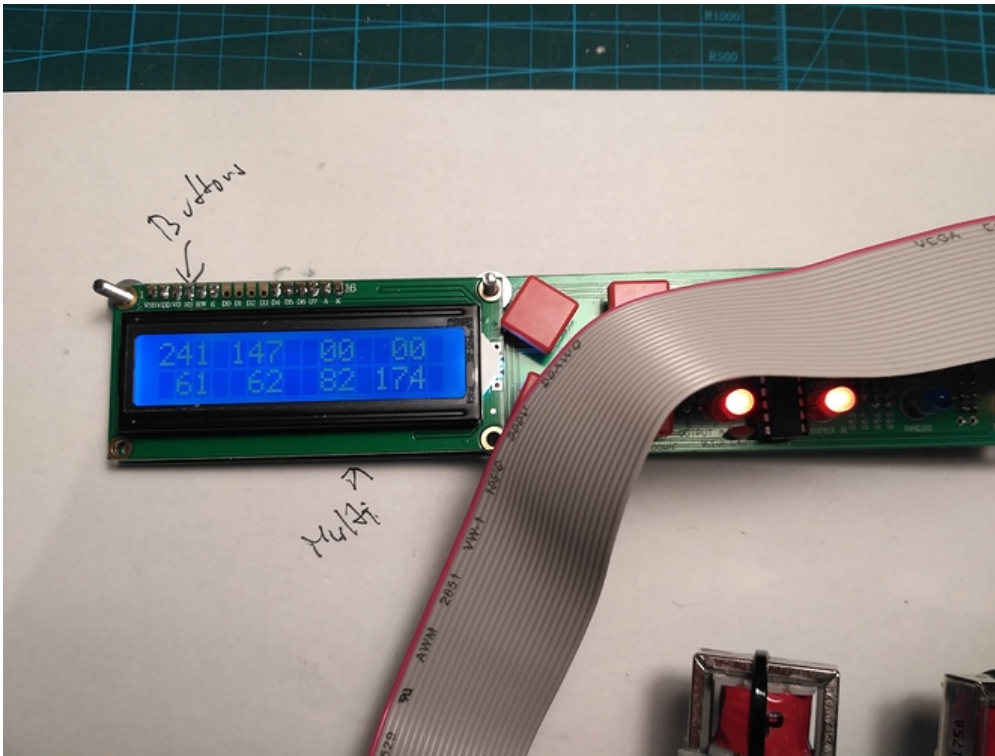
Test mode? When I disconnected one of two 1R in parallel (R30).

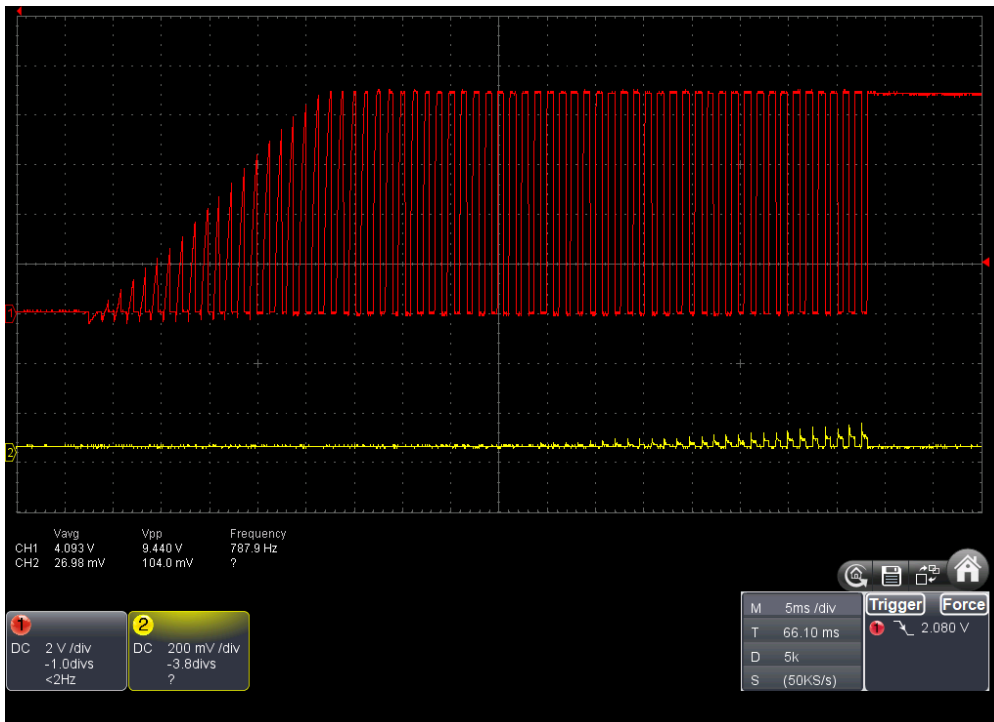
Red is Q1 drain, yellow is R30 current sensing - all against GND.

There is a voltage ramp which means DAC + U10A + Q3 is working.

There is a switching - the voltage is pulled down with each Q1 impulse to its gate - **this means Q1 is working.**

But there is no current flowing through the transformer - am I right? There is no significant voltage drop across R30 (check the yellow voltage scale it is 200mV/div!). I cannot explain why there

The only explanation is the transformer is broken somewhere inside - I measured it twice.
Or the 0.5R resistor (R30) is dead short (thus no voltage drop) which it should not be - there are two 1R in parallel - brown -. black - black - silver - brown... 1R 1%.

There is a difference between IRF9Z24PBF (VISHAY) and IRF9Z24NPBF (INFINEON).

You can not use IRF9Z24PBF!

Apparently because this transistor is used in the linear segment this makes enough difference for the unit to go into the Failure 20 mode.

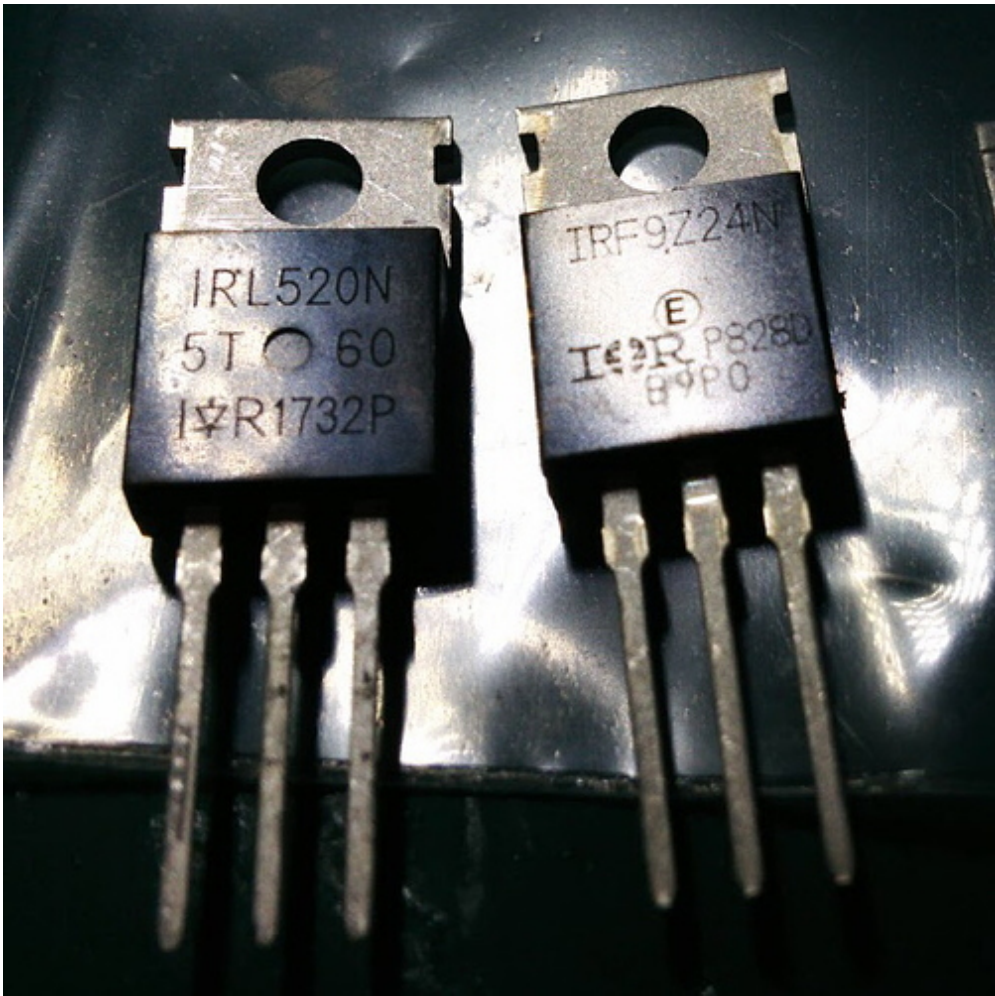
Below two are from China seller.

IRL520N = Apparently they don't have the correct font for IR Logo 🤔

IRF9Z24N = Look legit but the small circle is in the middle. The VT did not match with Yours. 🤔

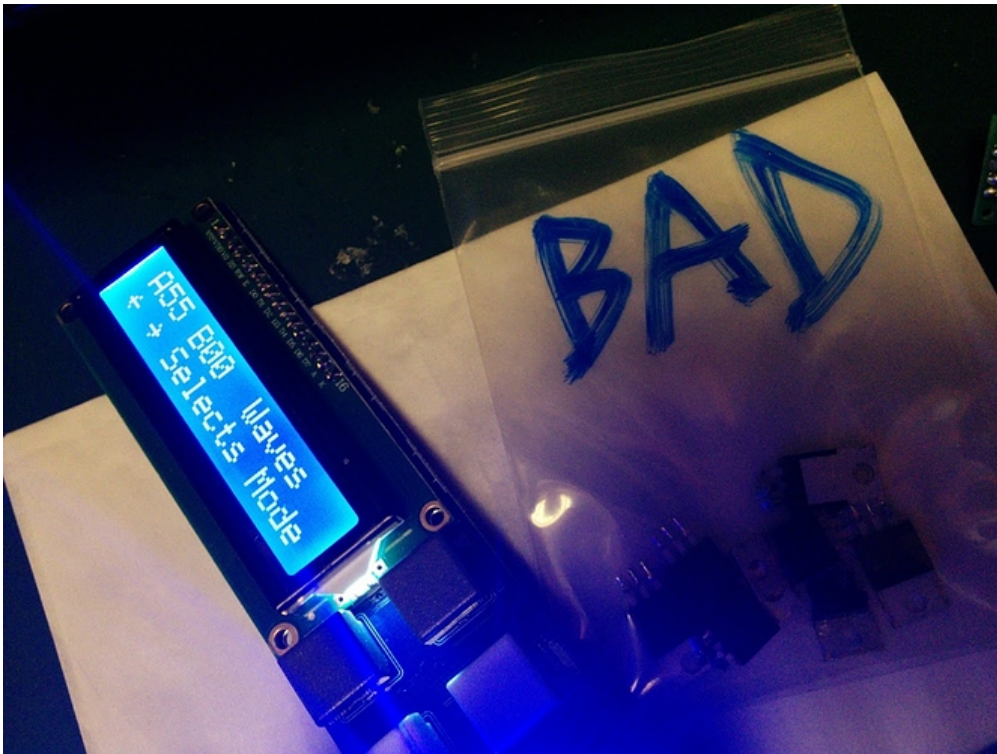
Replaced all of the counterfeit mosfet with genuine one and problem solved. No longer having failure 20.

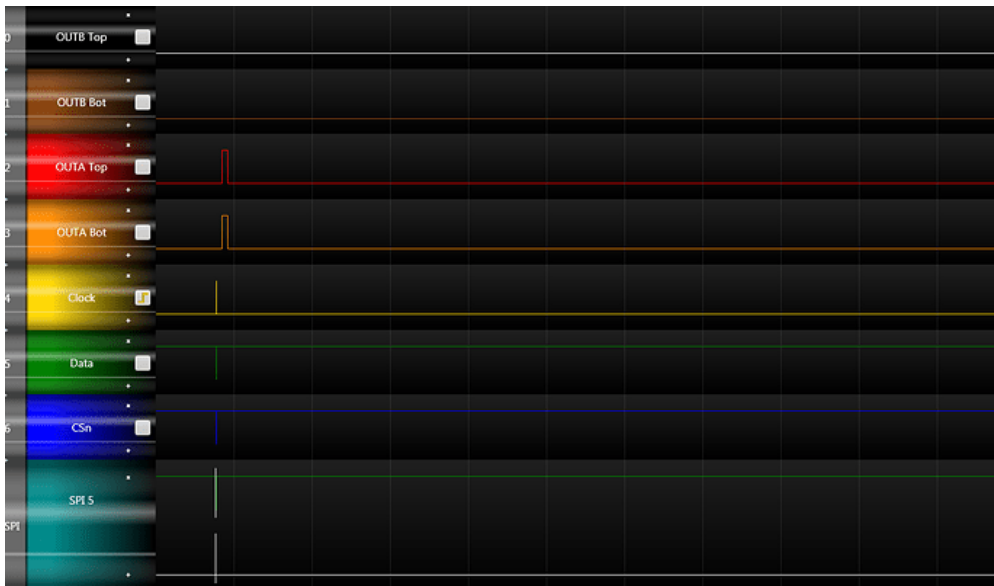
During power up there is a Ramp on R30 (0.50 Ohm) when channel A is ramping up but there is no corresponding Ramp on R30 when Channel Bs DAC ramps up. CH A Ramps first then Channel B but no voltage is seen on R30 is this normal?

Only Channel A is examined by the ADC

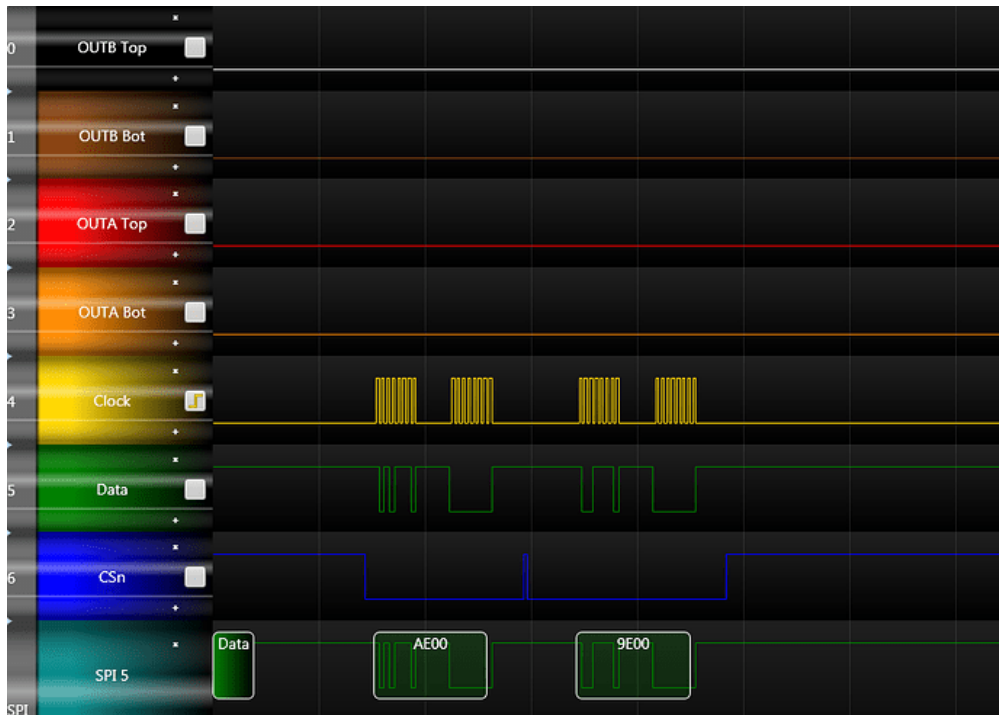
Zoomed in on DAC Data

It looks like PB2 and PB3 assert (OUTA Top and OutA Bot in the logic analyzer) but PB0 and PB1 never assert (OUTB Top and OUTB Bot in the logic analyzer)

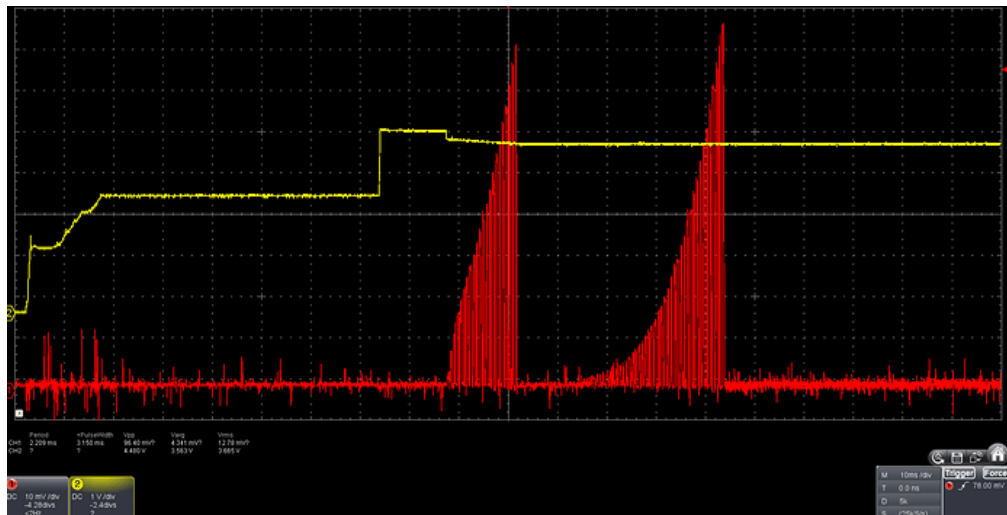
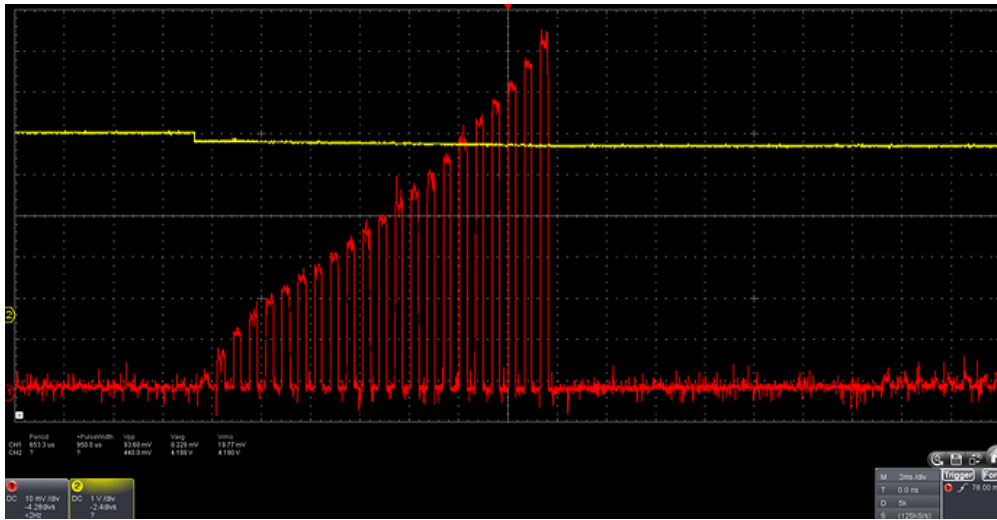
There are the measurements:
R-R30 (current sensing, ADC input), Y-out_A (DAC output)

And yes the R30 signal is this weak - I checked several times 1x/10x probes and setting. The testing is done at low currents.

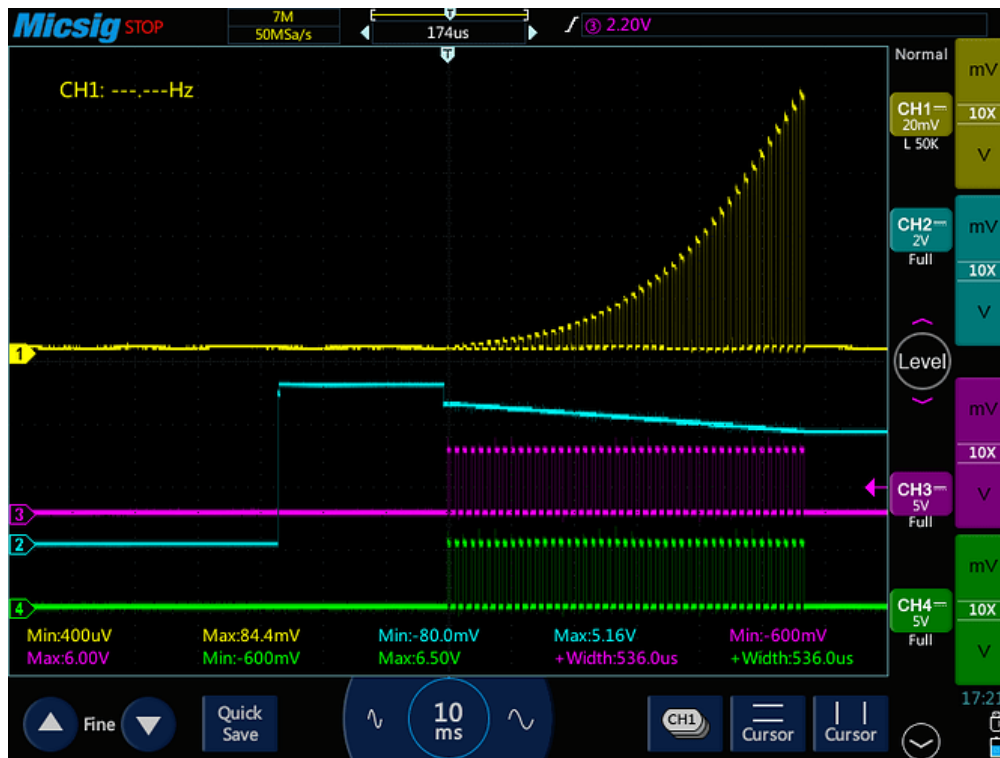
Init sequence for mk312bt

Yellow - R30 (current to transformer). 83mV max

Cyan - DAC channel A. 4.52V ... 3.6V

It looks really good. It matches with that, what I can see in the source code. The 83mV on the current measuring resistor are reached after 42 steps at 3.6V on the DAC. If they are not reached even after 64 steps, failure 20 occurs.
