# Ibanez FL9 Flanger

# Guitar Pedal Repair

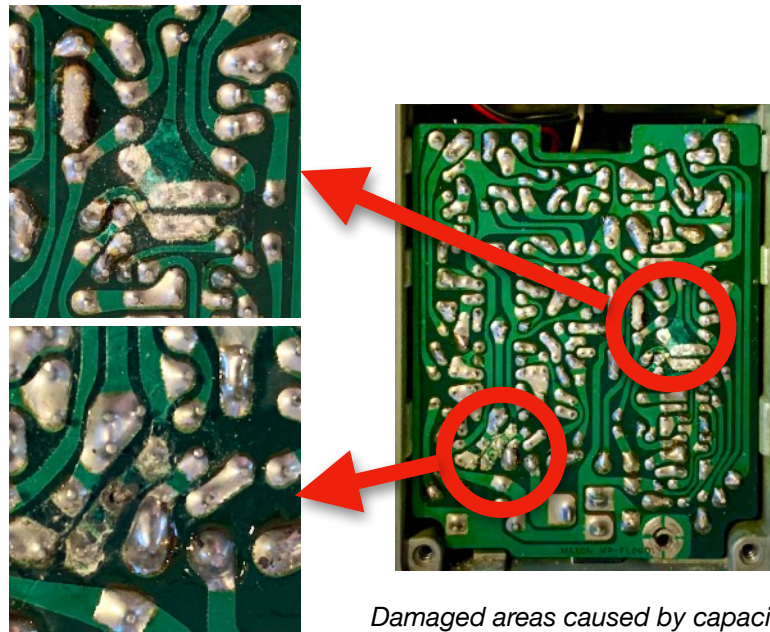
Here's what was found. Patches of the underside of the PCB were corroded. Apparently after decades of use, a few of the aluminum electrolytic capacitors leaked some of their semi-liquid dielectric fluid which quickly attacked the solder joints and copper traces. In one case, the fluid ate away all of the solder for one component, disconnecting from the circuitry.

*Damaged areas caused by capacitor leakage.*

Examination of the board revealed that capacitors C130, C131, C132, C133, and C135 had caused the damage so they were removed first to permit cleaning and examination of the circuit traces. In this case the primary solder removal tool was a professional solder sucker for component leads. A flux-impregnated copper braid was very helpful for removing excess solder from larger areas.

It's expected that after decades of use, some electronic components would begin to age. The first to go are usually aluminum electrolytic capacitors. And to be safe, *all* of the aluminum electrolytic capacitors will be replaced — not just the damaged ones — to prevent future capacitor leakage. Hopefully for at least another 30 years.

The first step in repairing the PCB is to remove the damaged capacitors and as much of the corrosion as possible. After cleaning, the surrounding PCB traces will be tested for continuity

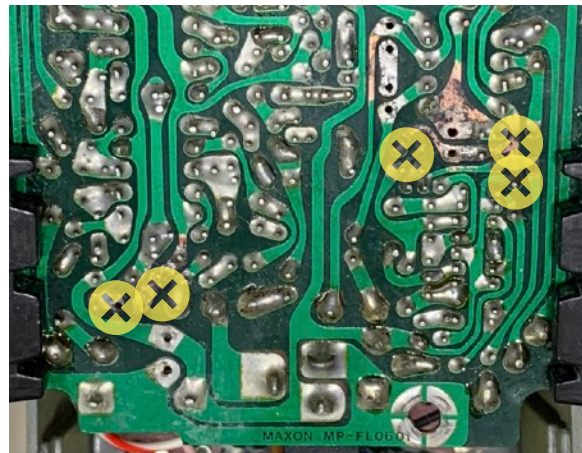
The continuity test revealed five broken copper traces within the damaged areas. We'll fix those as we replace the surrounding capacitors.

For areas with damaged traces that should have been connected to a new capacitor, bent component leads were shaped to follow the damaged track and solder was applied along the length of the wire. This technique is an acceptable way to bridge trace damage and restore continuity. For other damaged tracks, a short leftover component wire was soldered over the break.

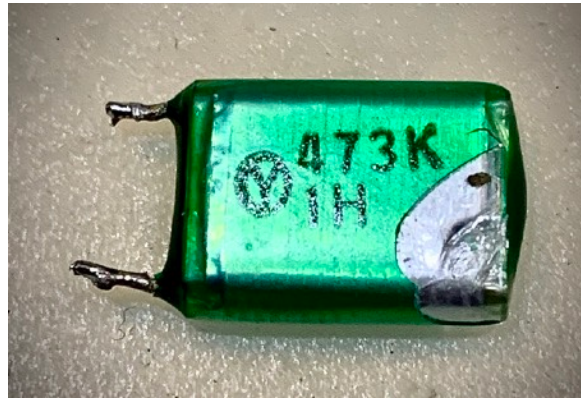
*Handling damage to the surprisingly fragile coating of C121.*

An order was placed with DigiKey for the replacements including a film capacitor upgrade for C116 and a new film capacitor to replace C121 that was damaged during the removal process. While waiting for the order to be received, a new reverse-engineered schematic and PCB component layout was prepared to help locate the capacitors that needed to be replaced. See the section, **Reverse Engineer the PCB** for more details.

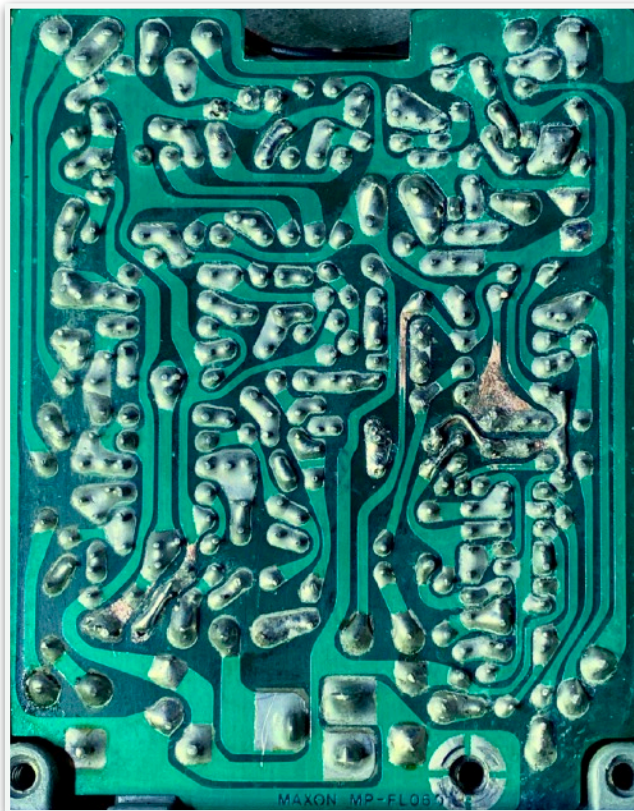
*Finished capacitor replacement and PCB repair before conformal coating application.*

Don't be tempted to apply solder to areas where copper was exposed due to corrosion. It will make repairs more difficult in the future. Instead, we protected the exposed copper traces from oxidation with a conformal coating after the pedal was completely repaired and tested.
