Golden Gate Bridge Inspection Program

Bridge Engineering 101

GGB – Biennial Inspection Schedule

Inspection Form and Report

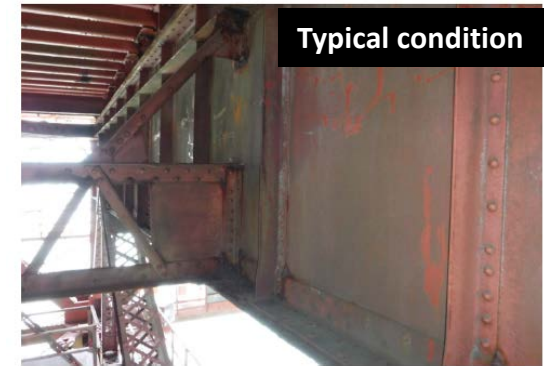
Typical condition

Typical Floorbeam Condition (S Face)

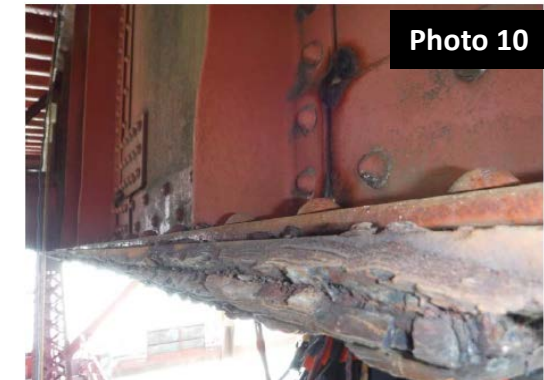
Photo 10

1/8-1/4" pack rust typical on bottom cover plate edges (CS3)(see Photo 10).

1. Clean and paint corroded areas and replace fasteners as needed.
2. Remove dirt/debris from stiffener pockets at sway bracing to connection and install drain holes in the stiffeners to help reduce up/corrosion.

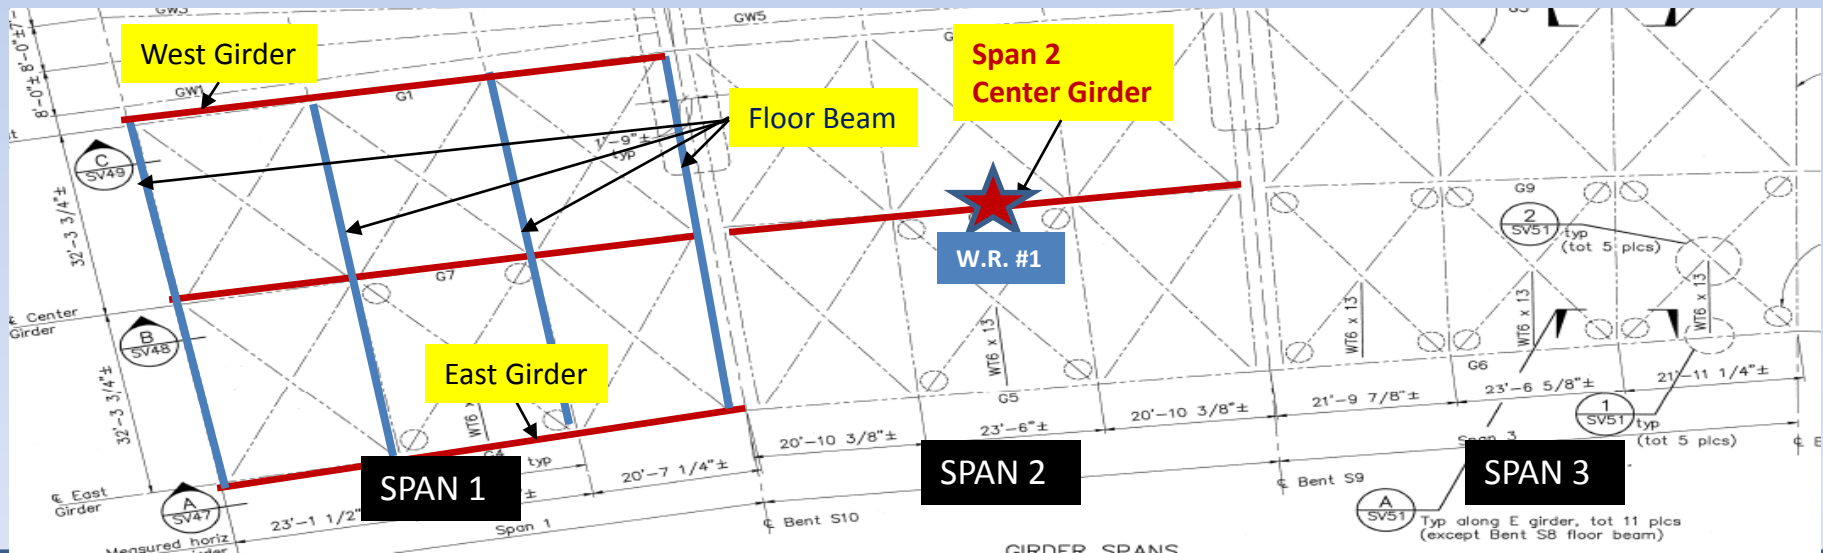
SAV-Girder Spans

Live Load	Rating Factor	Location
Legal Vehicle – Type 3S2	1.06	Span 2 – Center Girder

- The Span 2 center girder is the controlling member for the entire GGB. So, any additional weight which makes the R.F. less than 1.0 could lead to post weight limits on the bridge
