UNIT 1 Girder Spans: Special Inspections for Steel Girders

Unit 1 Girder Spans

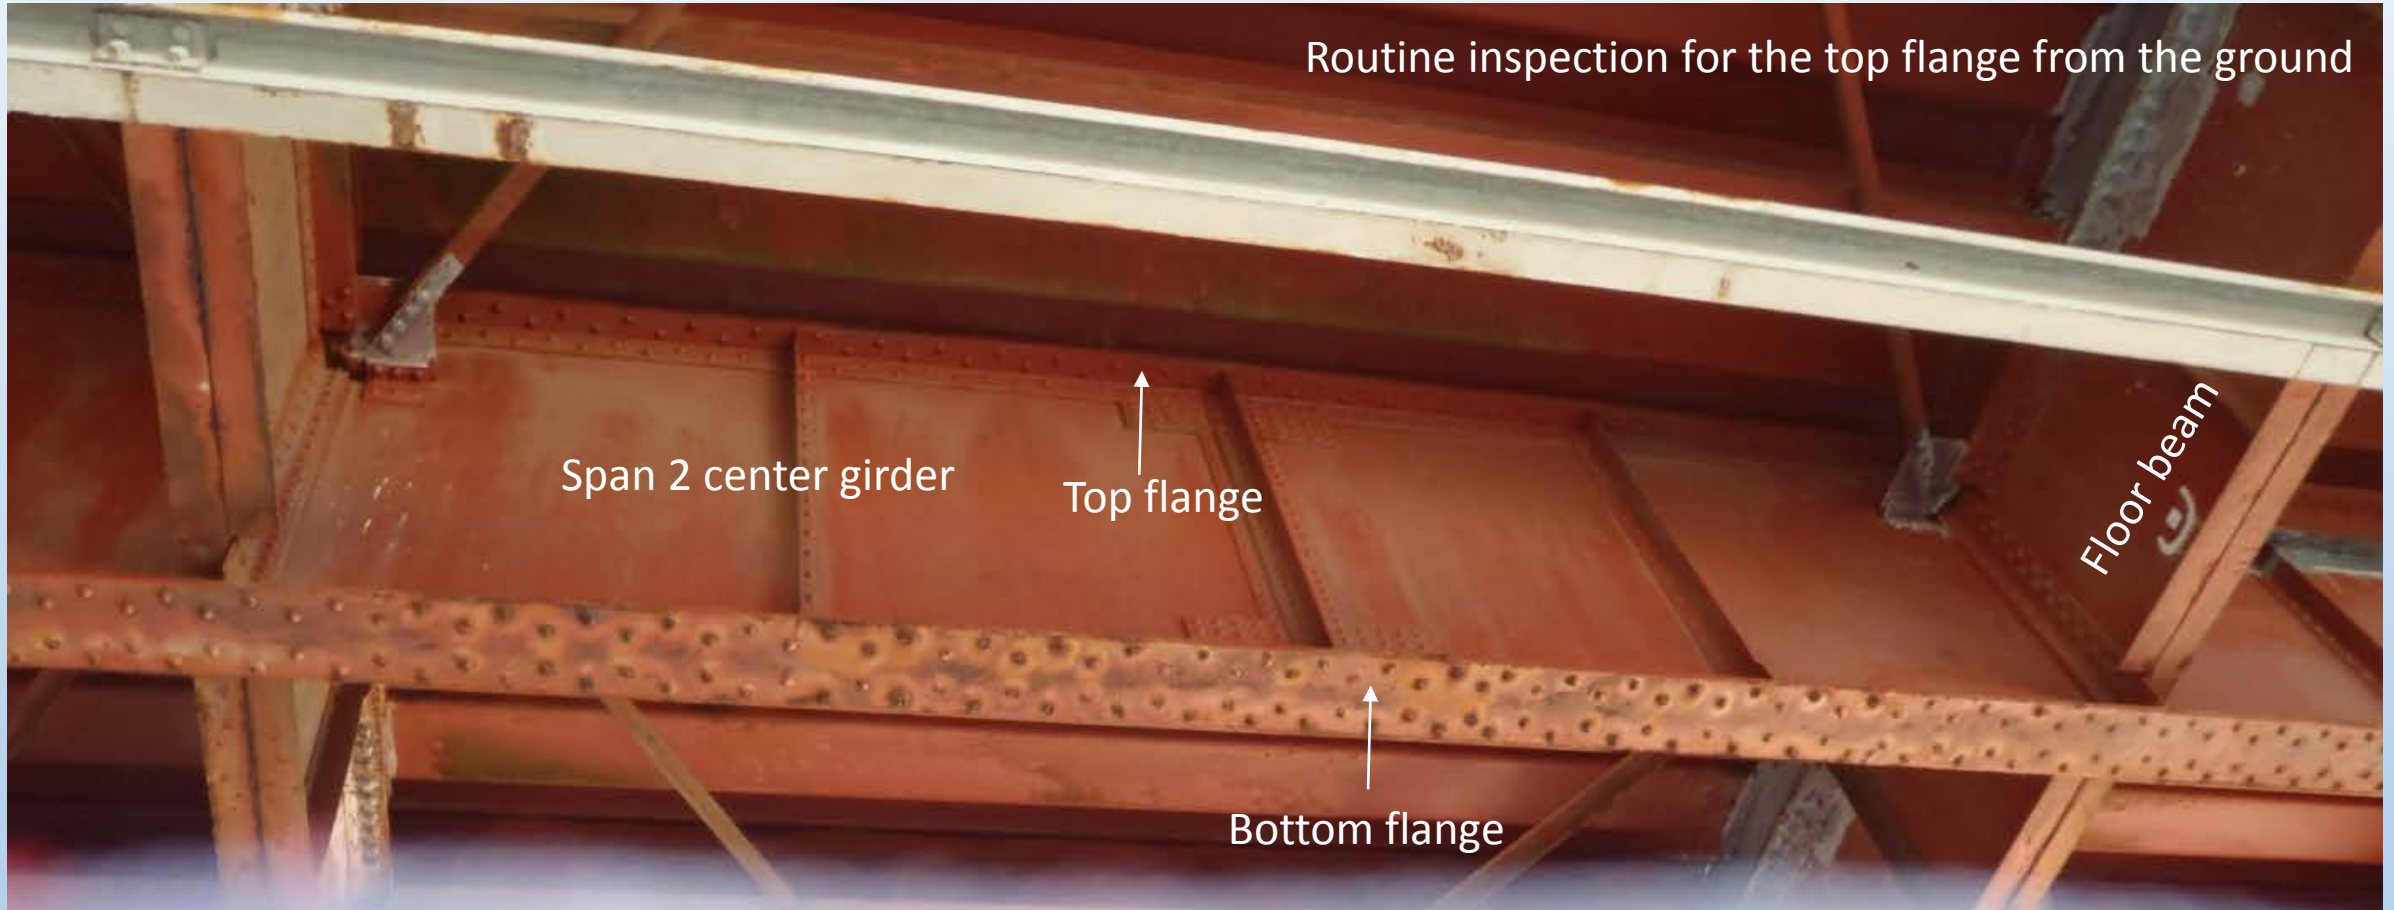
Span 2 Center Girder

(1) Center Girder shows moderate to heavy corrosion on rivet heads and steel pitting on top flange

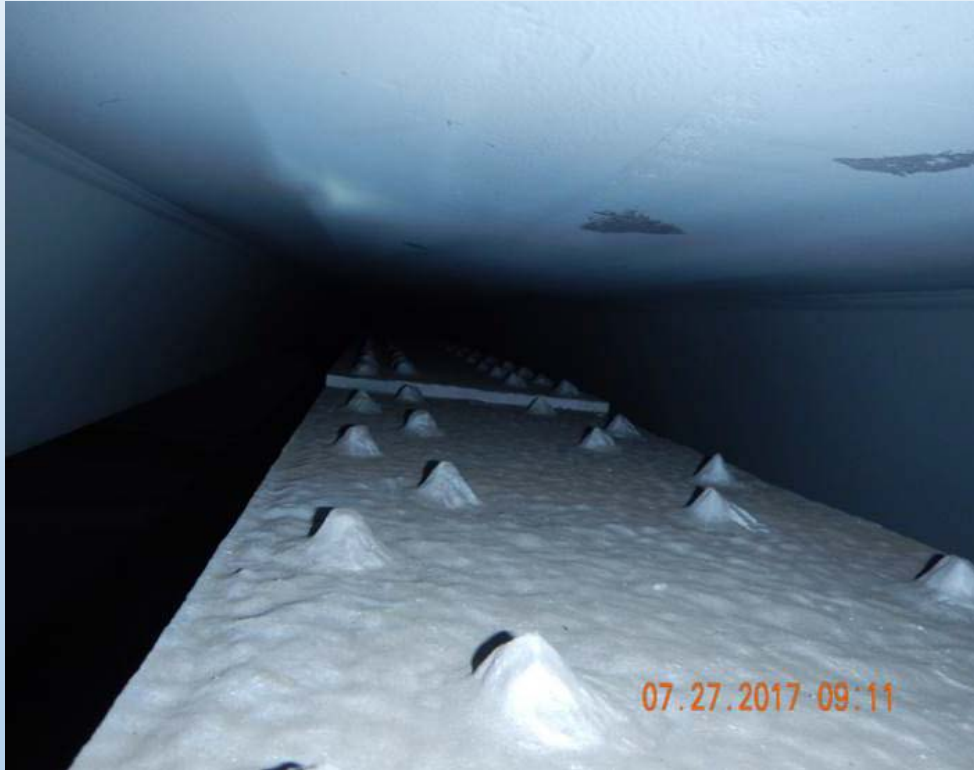
■ Span 2 Center Girder (Rivets)

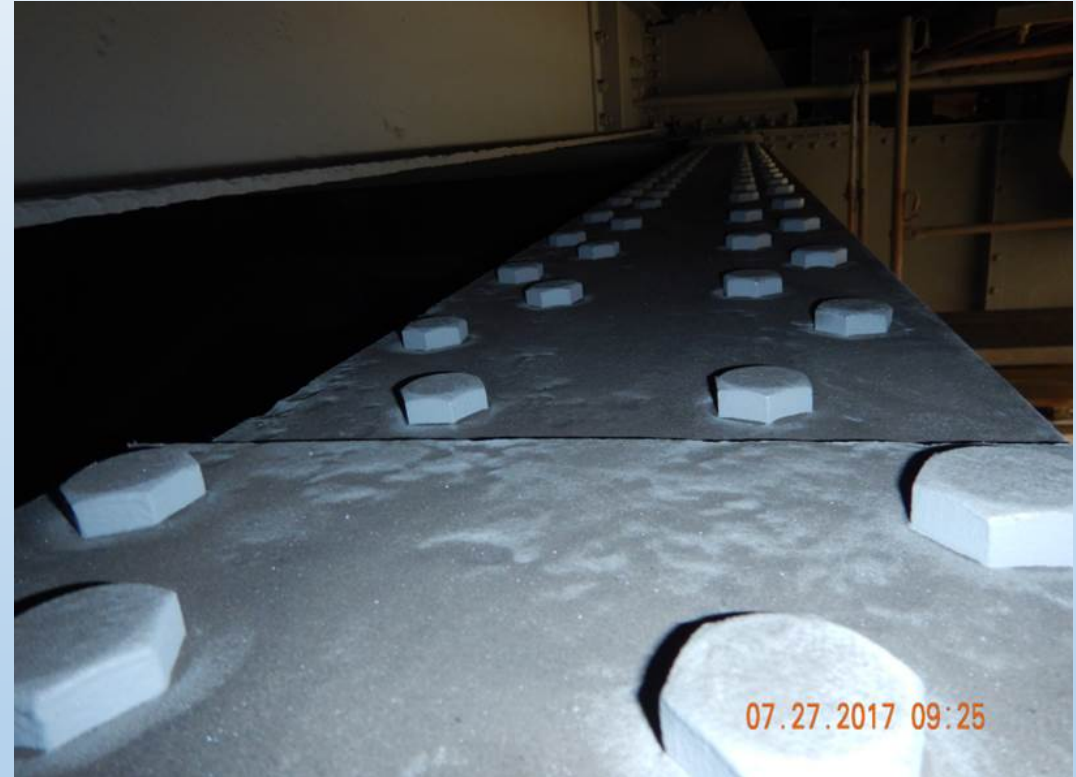
■ Span 2 East & West Girders (Bolts)

No information on when rivets on the W. and E. Girders were replaced with bolts is available.
