INSPECTION REPORT

For the Property at:
210 VICTORIA STREET, 2408
TORONTO, ON M5B 2R3

Prepared for: SHIRLEY YEE FONG
Inspection Date: Monday, July 12, 2021
Prepared by: Carl Chen, RHI#:380

RE: Report No. 3537
210 Victoria Street, 2408
Toronto, ON
M5B 2R3

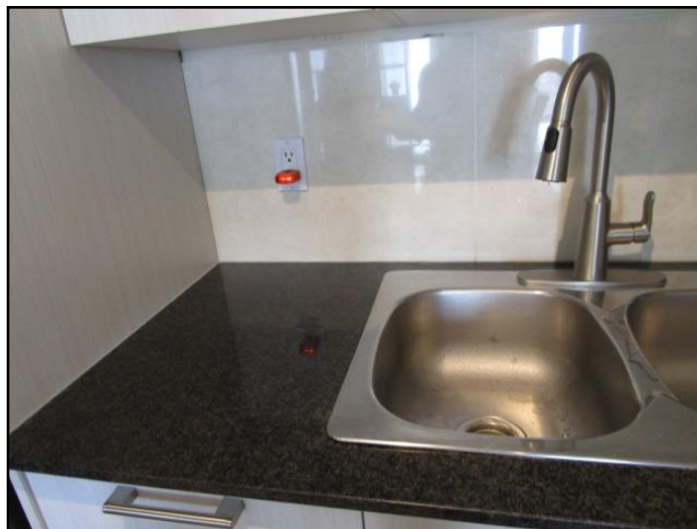
2. Condition: • [No GFCI/GFI \(Ground Fault Circuit Interrupter\)](#)

Implication(s): Electric shock

Location: First Floor Kitchen

1. No GFCI/GFI (Ground Fault Circuit...

Task: Upgrade

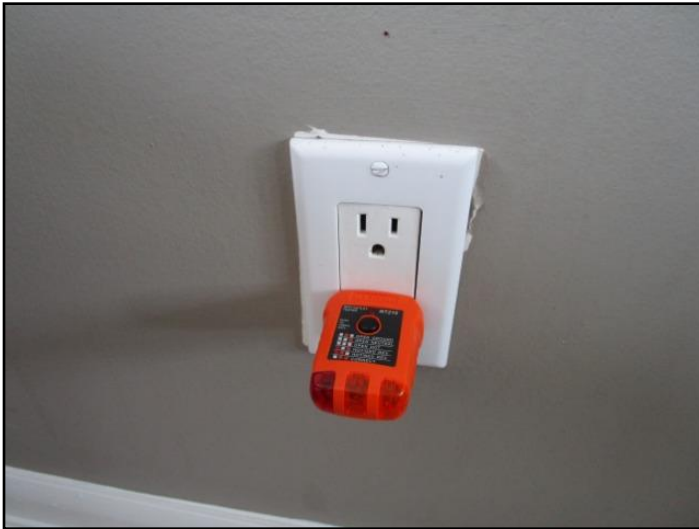
switch in bedroom not working, plugs no power, further check and fixing needed

Implication(s): Inadequate lighting

Location: First Floor Bedroom

2. Inoperative

Task: Further evaluation Fix

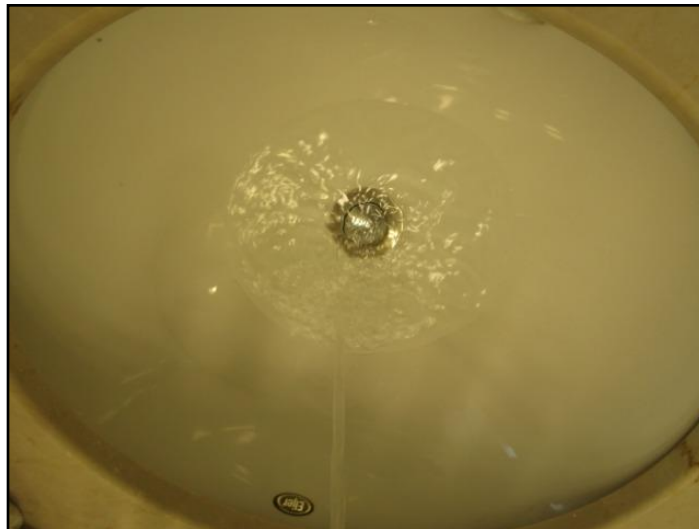
5. Condition: • Drain stop ineffective

Implication(s): Nuisance | Reduced operability

Location: First Floor Bathroom

4. *Drain stop ineffective*

Task: Repair

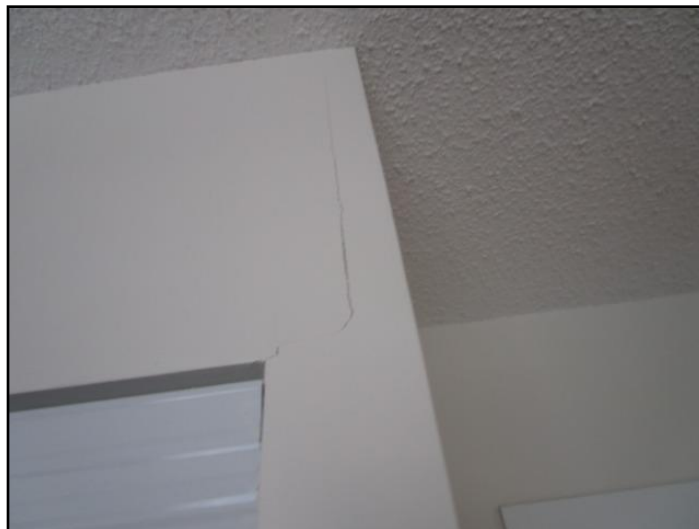
6. Condition: • Typical minor flaws

some minor cracks

Location: Various

5. Typical minor flaws

Task: Fix

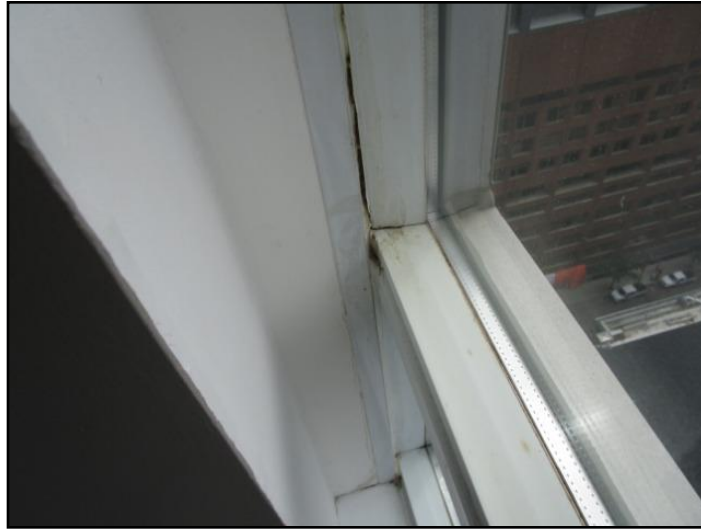
7. Condition: • Water stains

water stains on windows, further check and fixing needed

Implication(s): Chance of water damage to structure, finishes and contents

Location: First Floor Bedroom

6. Water stains

Task: Further evaluation Fix

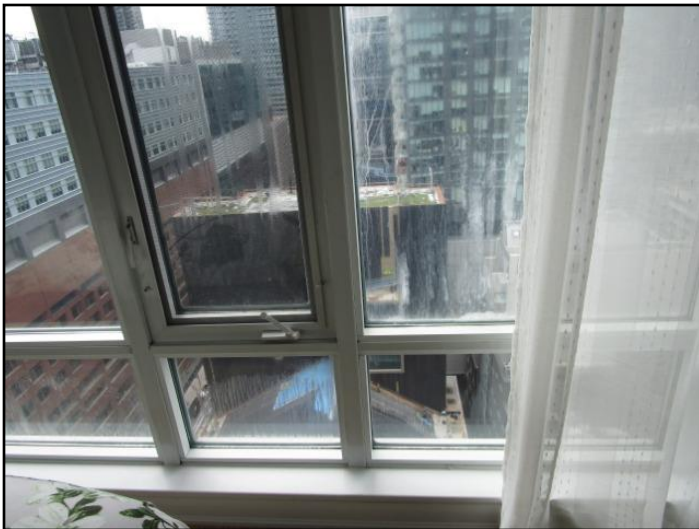
8. Condition: • [Lost seal on double or triple glazing](#)

Implication(s): Shortened life expectancy of material

Location: Various

7. Lost seal on double or triple glazing

Task: Replace

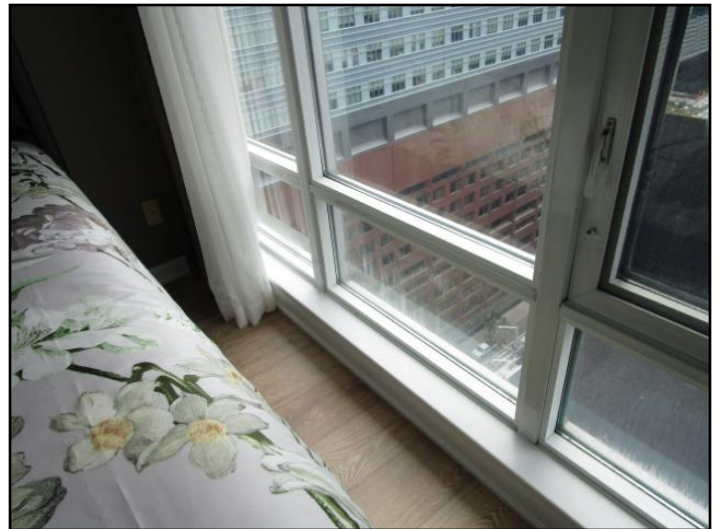
8. Lost seal on double or triple glazing

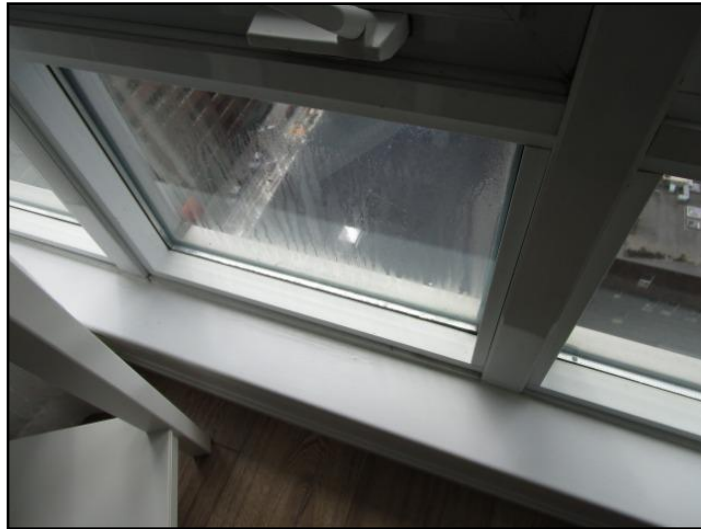
9. Lost seal on double or triple glazing

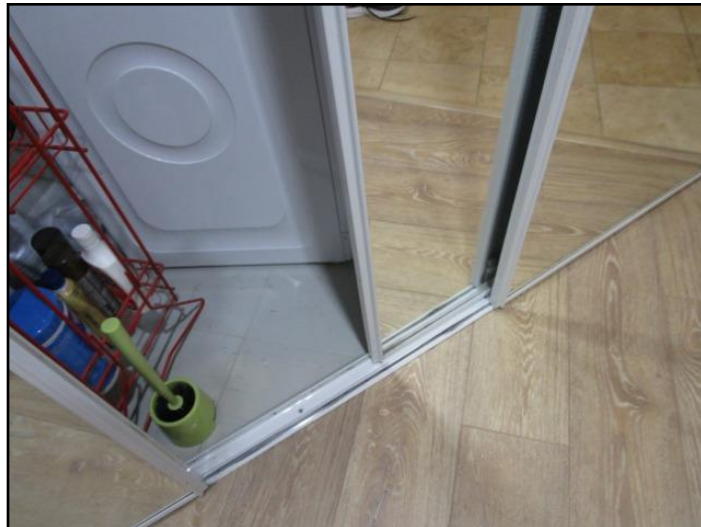
9. Condition: • [Stiff](#)

Implication(s): Reduced operability

Location: First Floor

10. Stiff

Task: Fix

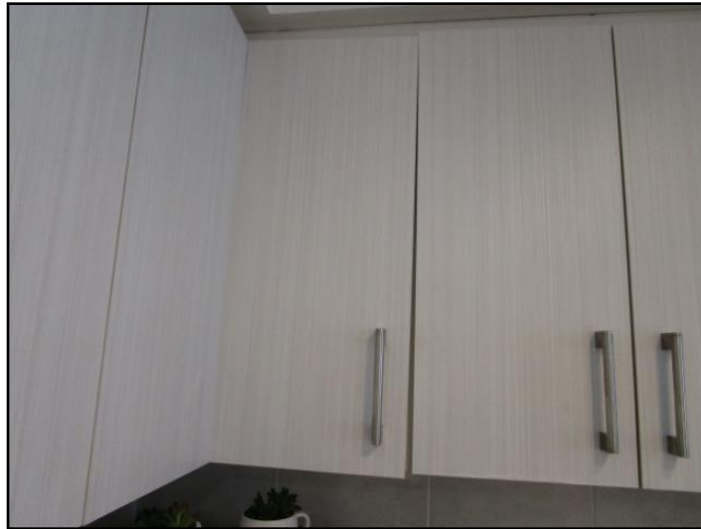
10. Condition: • [Doors or drawers missing or loose](#)

Implication(s): Nuisance | Damage or physical injury due to falling materials

Location: First Floor Kitchen

11. Doors or drawers missing or loose

Task: Fix

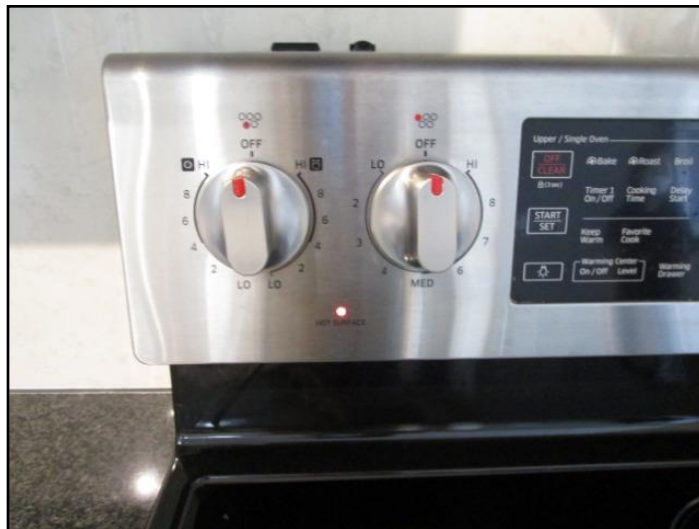
12.

11. **Condition:** • hot surface light always on

Location: First Floor Kitchen

Task: Further evaluation Fix

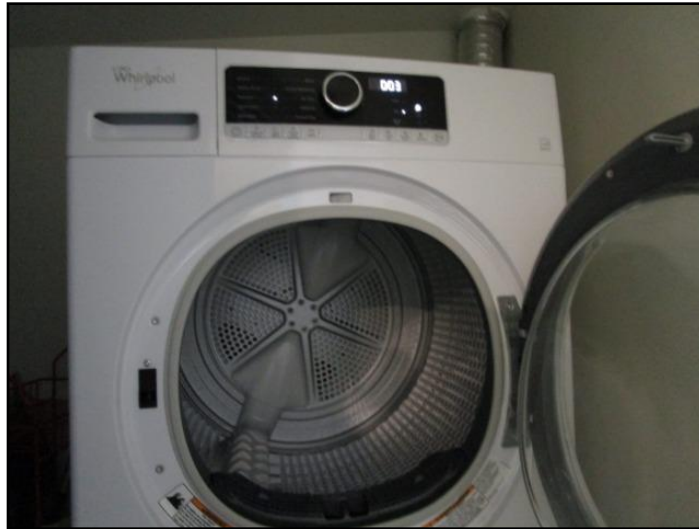
12. **Condition:** • No heat

Implication(s): Equipment ineffective

Location: First Floor

13. No heat

Task: Repair or replace Further evaluation

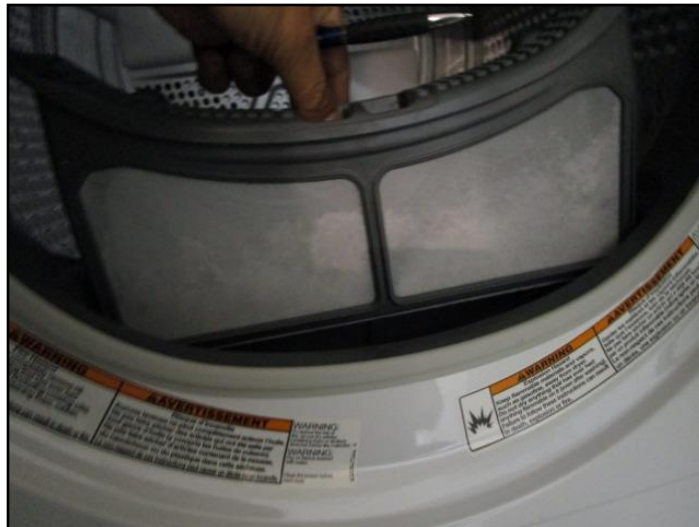
13. Condition: • Lint trap dirty

Location: First Floor Laundry Area

14. Lint trap dirty

Task: Clean
