INSPECTION REPORT

426 UNIVERSITY AVENUE, 1010
TORONTO, ON M5G 1S9

Inspection Date: Sunday, April 27, 2025

RE: Report No. 3928
426 University Avenue, 1010
Toronto, ON
M5G 1S9

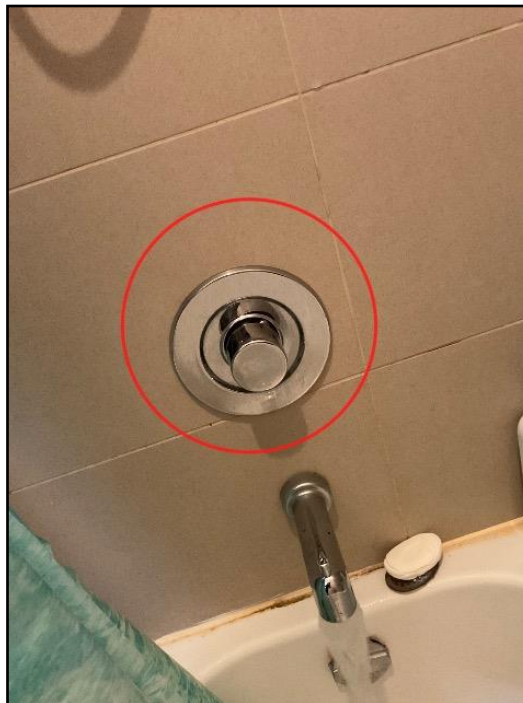
FIXTURES AND FAUCETS \ Faucet

1. Condition: • Handle missing

Location: Bathroom

Task: Repair or replace

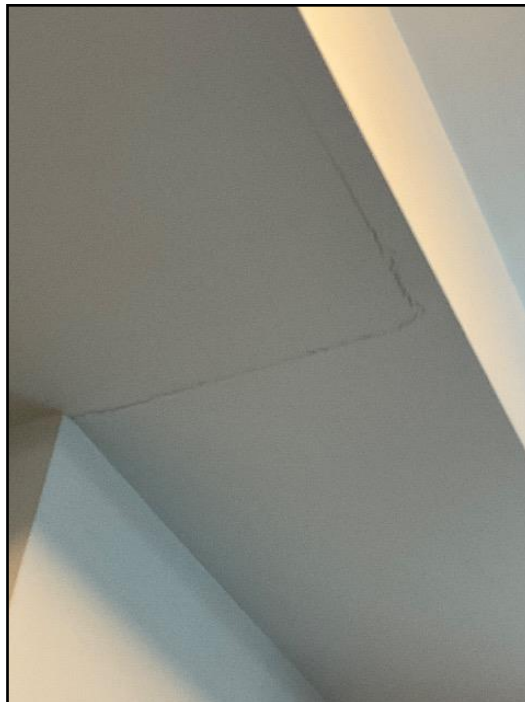
2. Condition: • [Cracks](#)

Location: Various

2. Cracks

Task: Repair Monitor

Time: When remodelling

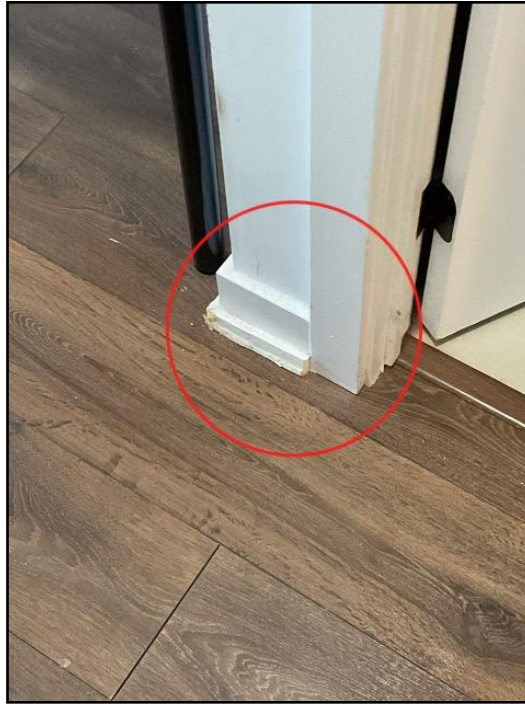
3. Condition: • Baseboard damaged

Location: First Floor

Task: Repair or replace

Time: When remodelling

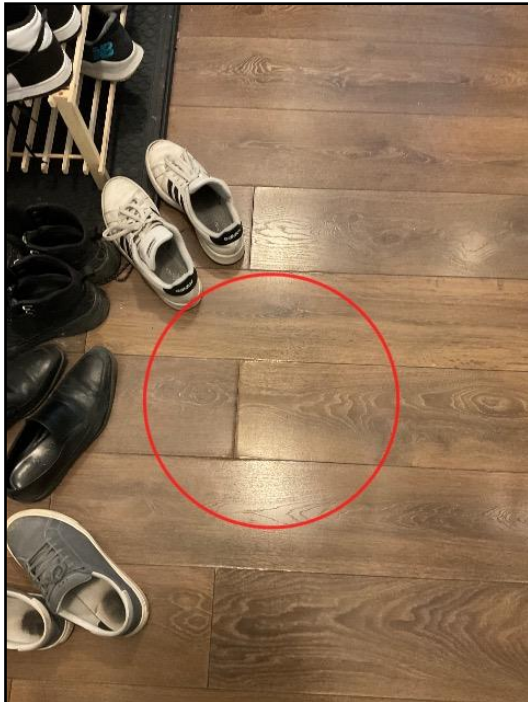
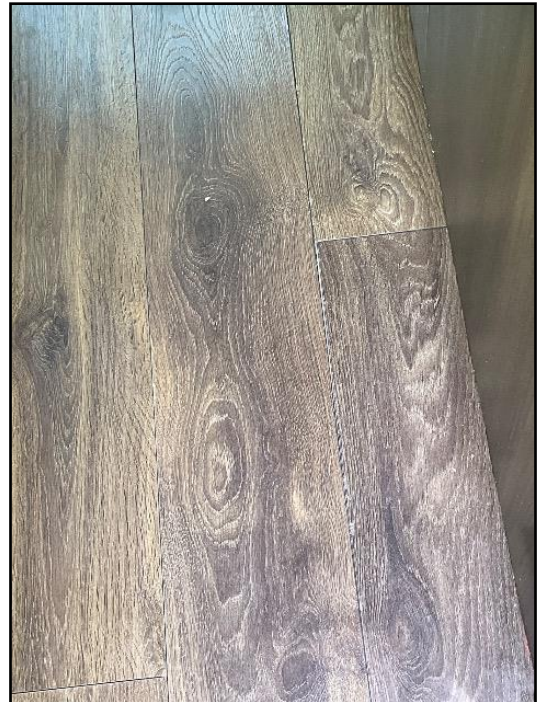
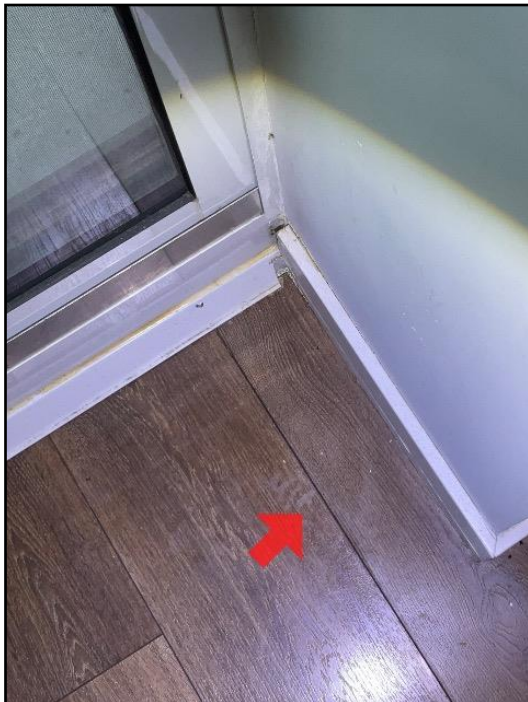
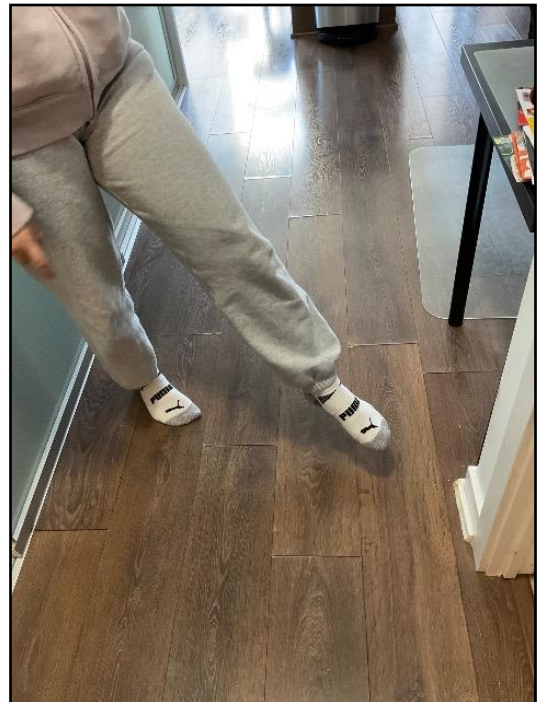
4. **Condition:** • [Warped](#)

Location: Various

4. Warped

5. Warped

6. Warped

7. Warped

Task: Repair or replace

Time: If necessary When remodelling

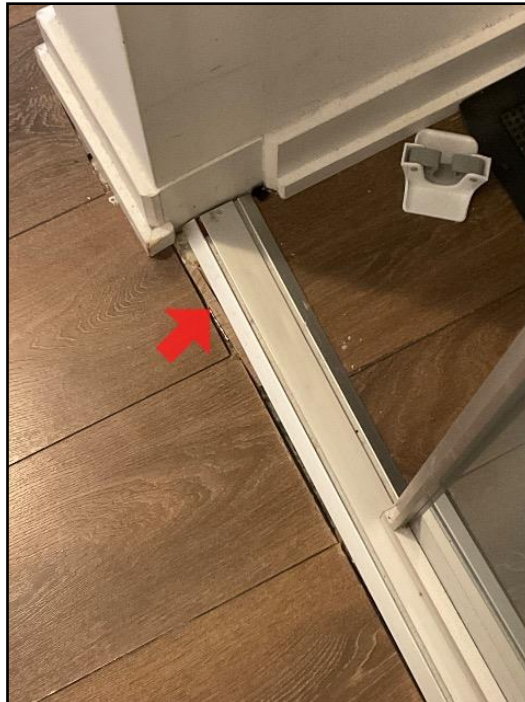
5. Condition: • [Exposed tongues](#)

Location: Various

8. Exposed tongues

Task: Repair

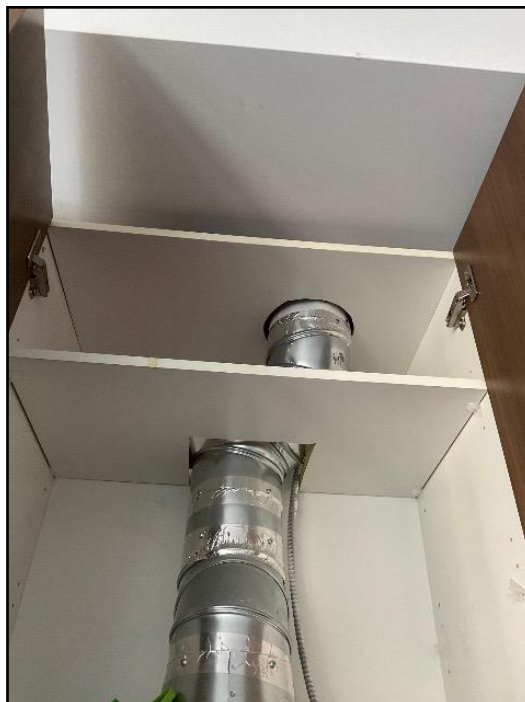
6. Condition: • Venting arrangement poor

Noise heard when bathroom fan is on

Location: Kitchen

9. Venting arrangement poor

Task: Further evaluation Fix

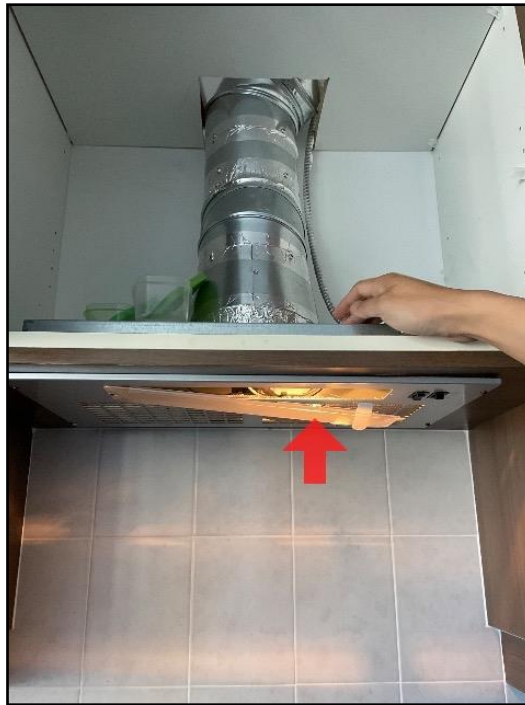
10.

7. Condition: • Parts damaged

Location: First Floor Kitchen

Task: Repair or replace

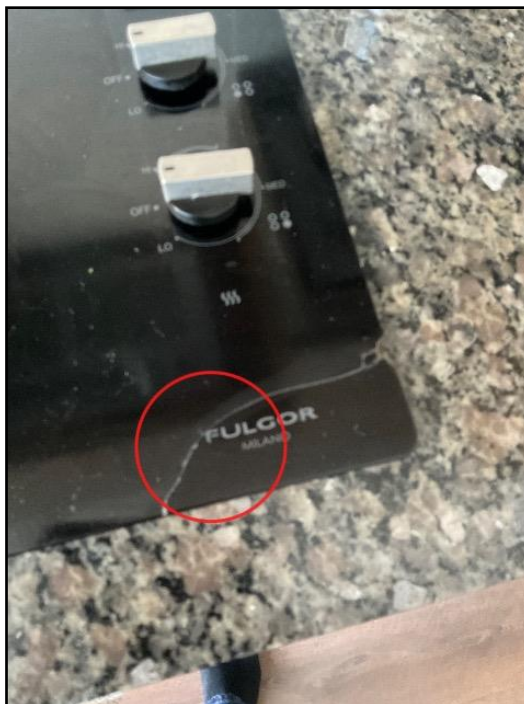
11.

8. Condition: • Cracked panel

Location: First Floor Kitchen

Task: Replace

Time: If necessary
