INSPECTION REPORT

For the Property at:
2466 CLAYMORE CRESCENT
MISSISSAUGA, ON L5C 3A3

Prepared for: JACK CHANG
Inspection Date: Saturday, January 2, 2021
Prepared by: Carl Chen

RE: Report No. 3472
2466 Claymore Crescent
Mississauga, ON
L5C 3A3

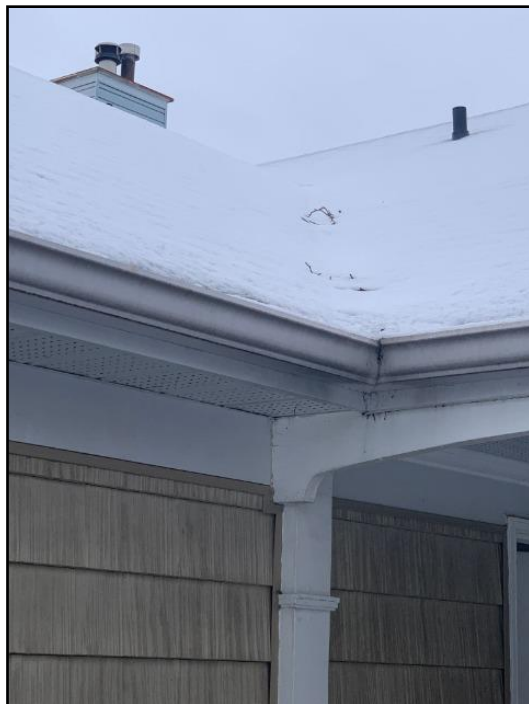
4. Condition: • [Clogged](#)

Implication(s): Chance of water damage to structure, finishes and contents

2. Clogged

Task: Service

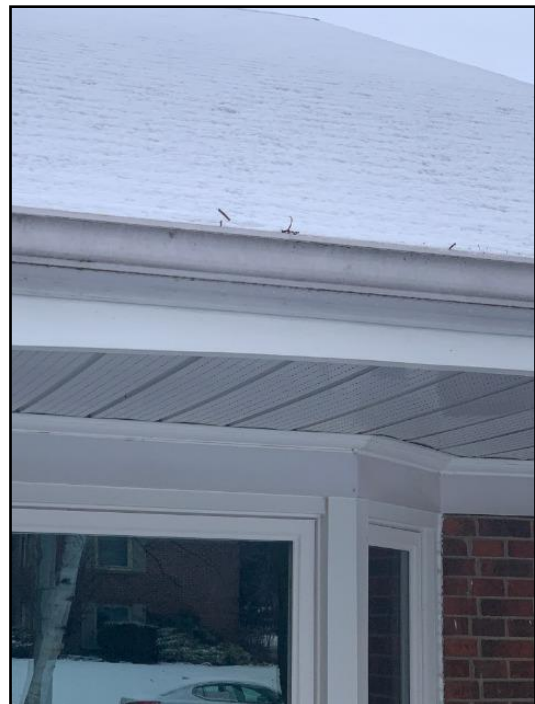
3. Clogged

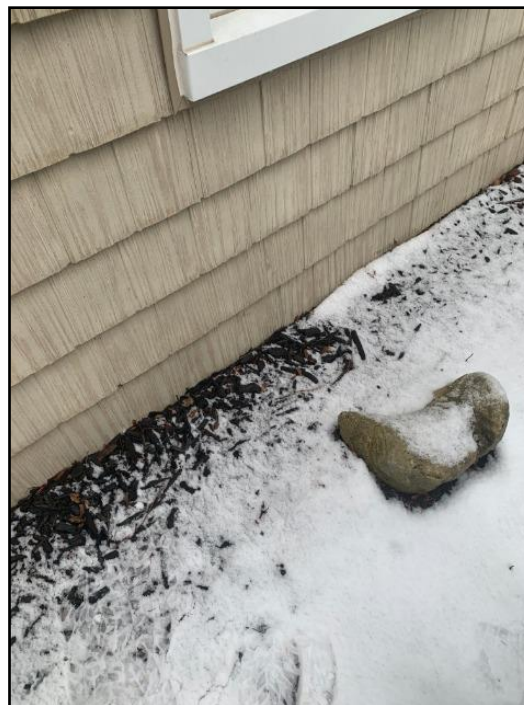
5. Condition: • [Too close to grade](#)

Implication(s): Chance of water damage to structure, finishes and contents | Material deterioration

4. Too close to grade

Task: Correct

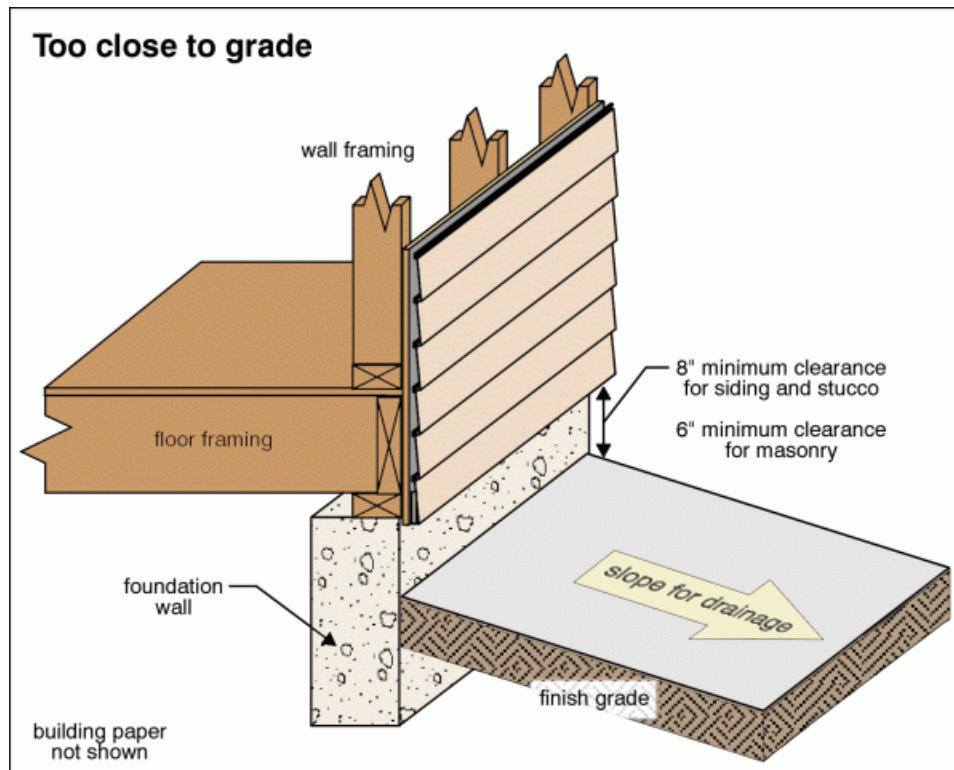
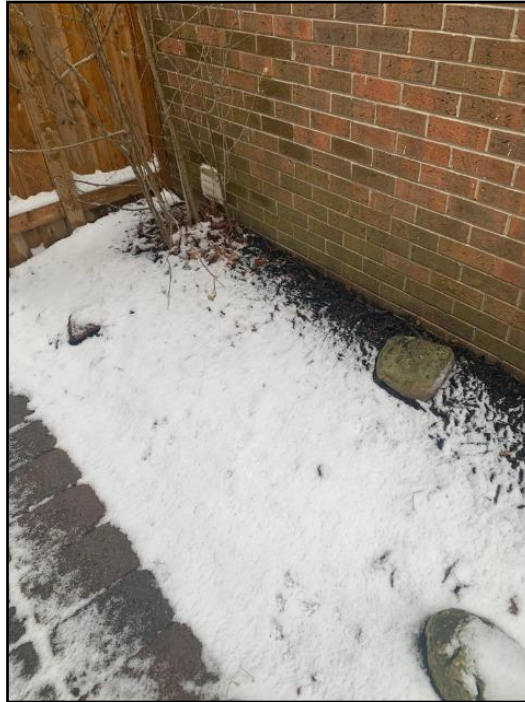
6. Condition: • [Too close to grade](#)

Implication(s): Chance of water entering building | Weakened structure | Rot

5. Too close to grade

Task: Correct

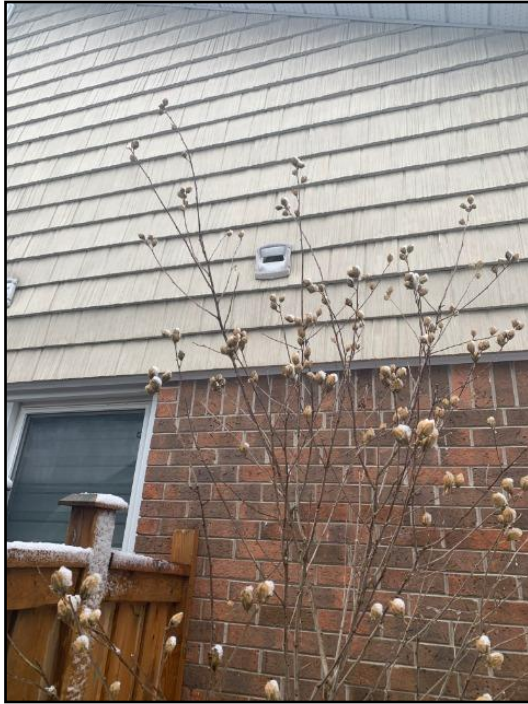
7. Condition: • Cover damaged

Implication(s): Increased operating costs

6. Cover damaged

Task: Replace

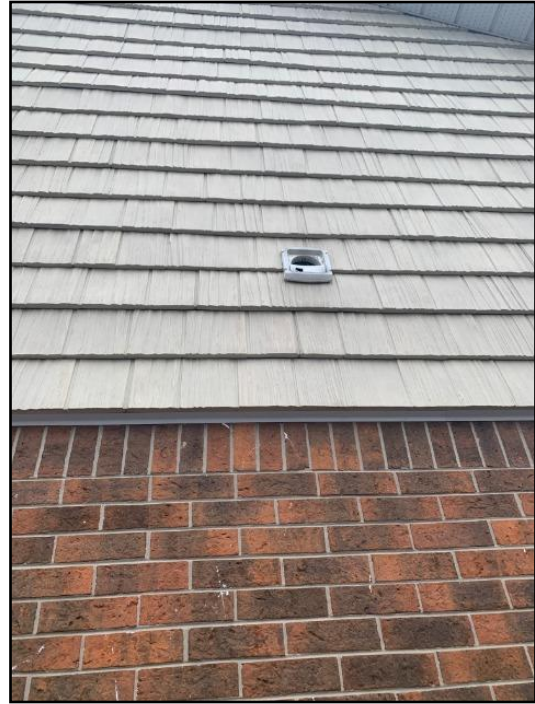
7. Cover damaged

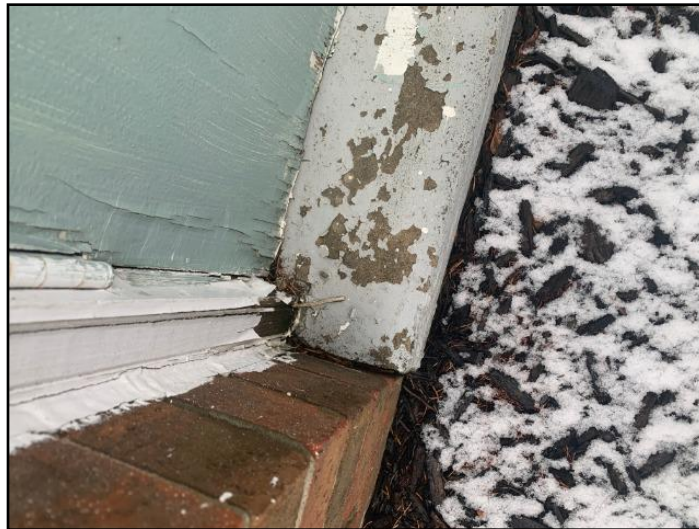
8. Condition: • Paint or stain - deteriorated / missing

Implication(s): Shortened life expectancy of material

8. Paint or stain - deteriorated / missing

Task: Repair or replace

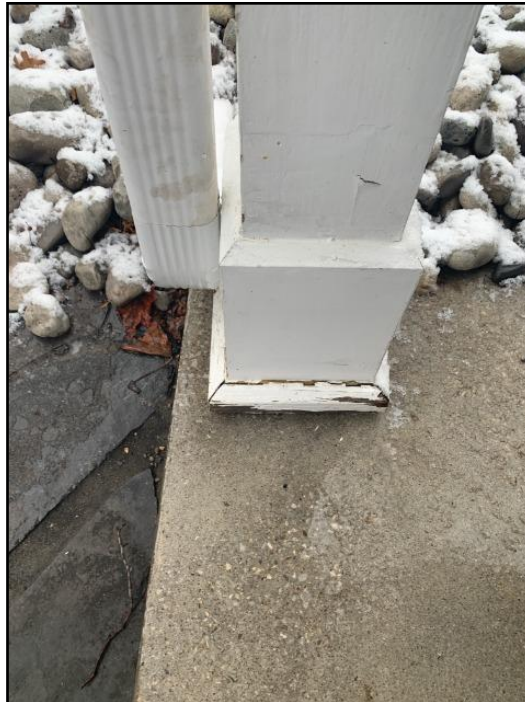
9. Condition: • [Rot](#)

Implication(s): Weakened structure | Chance of movement

9. Rot

Task: Service

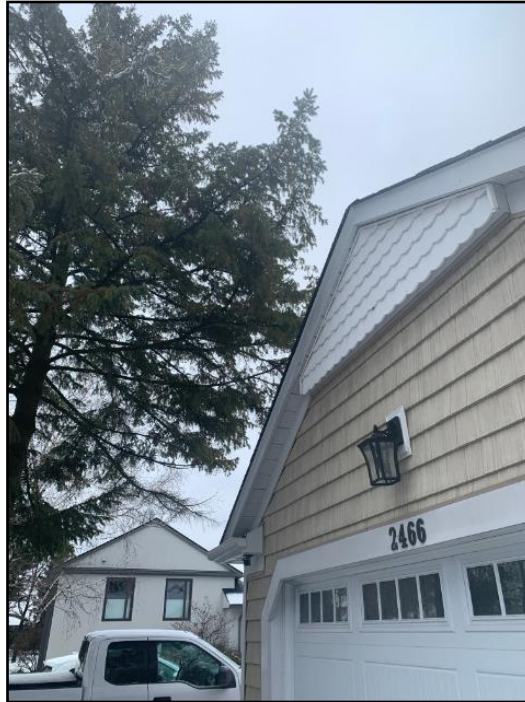
10. Condition: • tree branches or vines above roof

10. tree branches or vines above roof

Task: Monitor Service

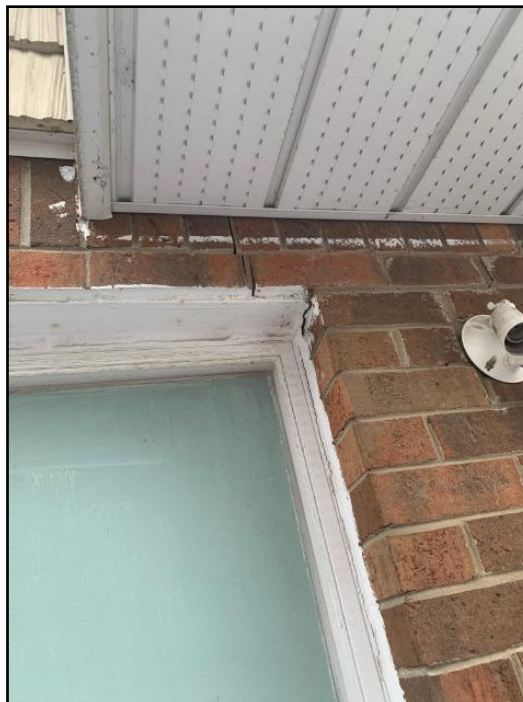
11. Condition: • [Cracked](#)

Implication(s): Weakened structure

11. Cracked

Task: Monitor Fix

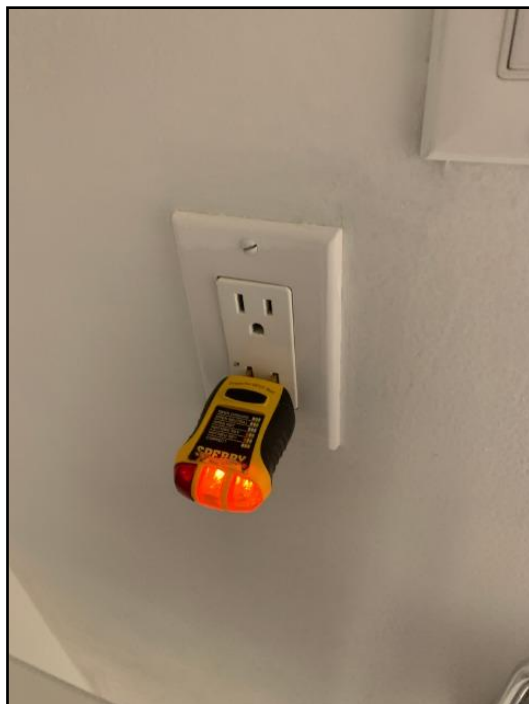
12. Condition: • [No GFCI/GFI \(Ground Fault Circuit Interrupter\)](#)

Implication(s): Electric shock

12. No GFCI/GFI (Ground Fault Circuit...

Task: Upgrade

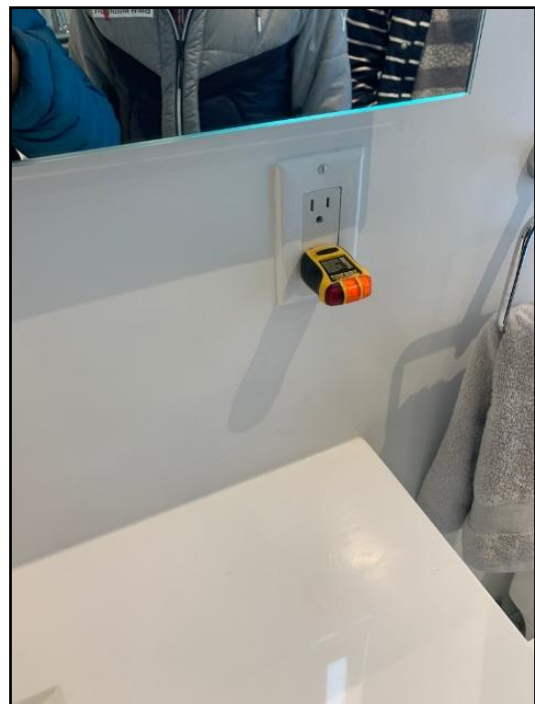
13. No GFCI/GFI (Ground Fault Circuit...

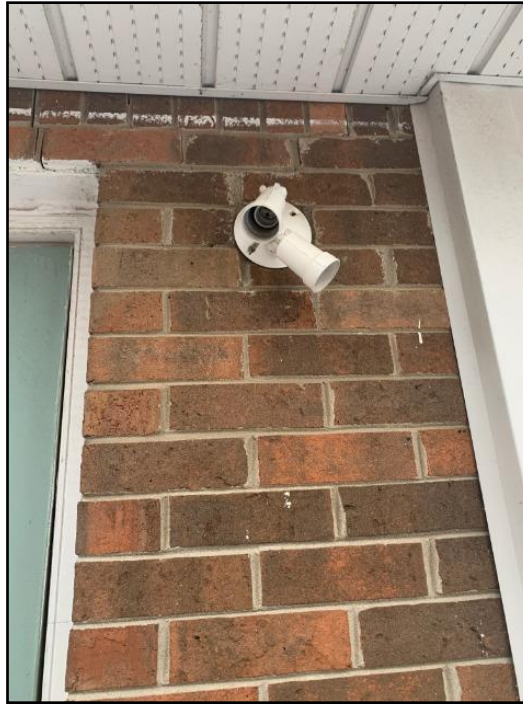
13. Condition: • [Missing](#)

Implication(s): Inadequate lighting

14. Missing

Task: Provide

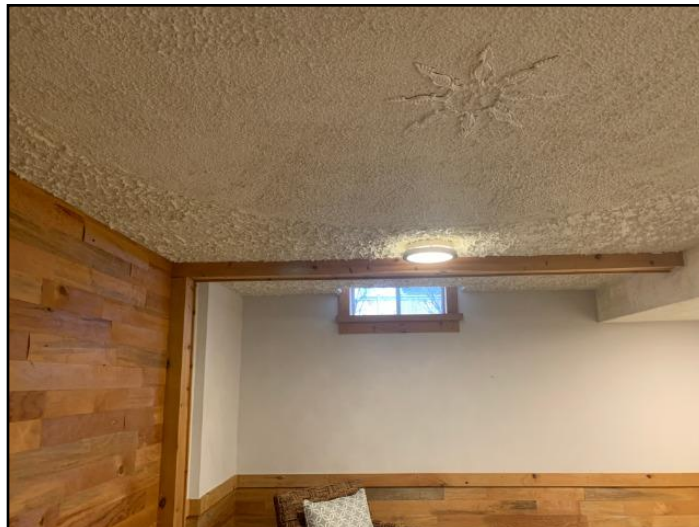
16. Condition: • Missing

Implication(s): Increased heating costs | Reduced comfort

15. Missing

Task: Provide

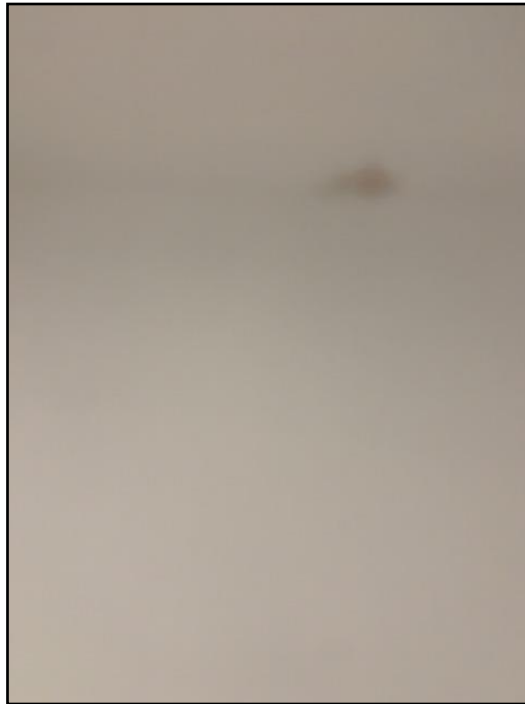
18. Condition: • Water stains

Implication(s): Chance of water damage to structure, finishes and contents

17. Water stains

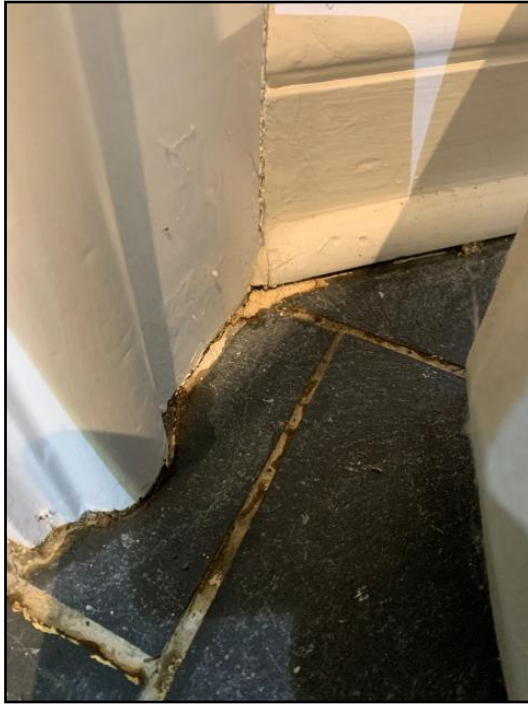
19. Condition: • Water stains

water stains found on floor where close to fireplace, keep monitoring required, fixing might needed, check chimney as needed

Implication(s): Chance of water damage to structure, finishes and contents

18. Water stains

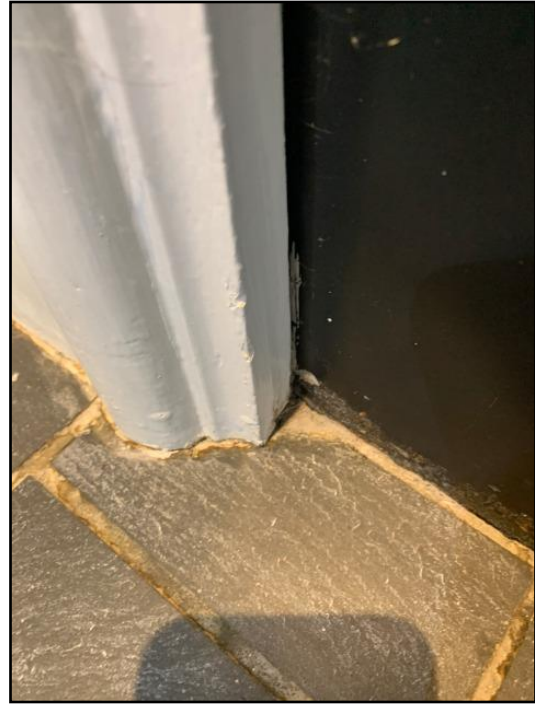
19. Water stains

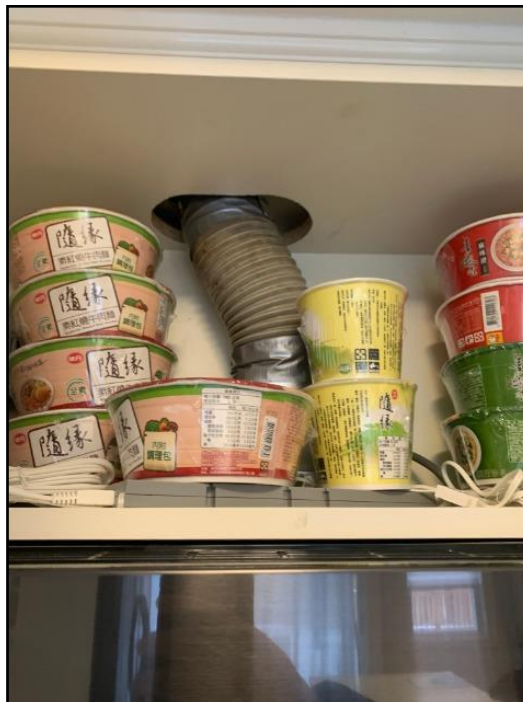
20. Condition: • flexible duct using, replacing with rigid duct with smooth interior needed

20. flexible duct using, replacing with rigid...

Task: Replace
