Home Inspection Report

251 N Bristol Ave, Los Angeles, CA 90049

Inspection Date: 08/13/2025 6:00AM

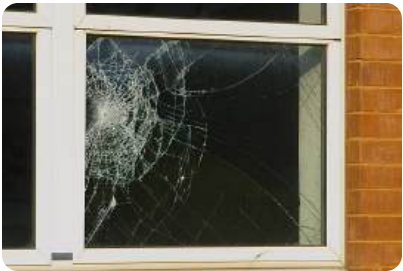
CRACKED WINDOW PANE

The damaged glass pane may expose sharp edges and reduce the thermal barrier against the elements. Further evaluation by a qualified contractor is recommended to repair or replace the damaged window as needed.

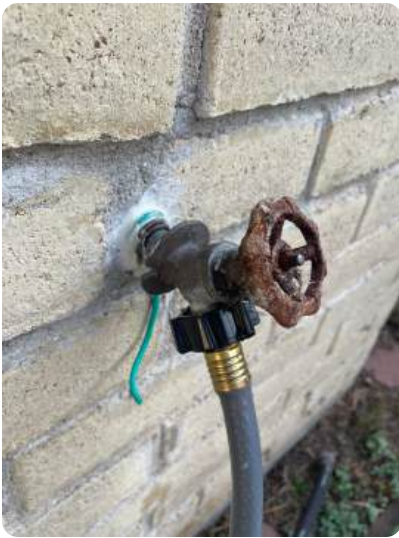
Location: *Front of house*

HOSE BIB REPLACEMENT RECOMMENDED

The exterior hose bib located at the front of the house requires replacement. Replace the damaged/failed exterior faucet to prevent leaks and potential water intrusion. It is recommended that a qualified plumber or licensed contractor replace the unit and verify the isolation valve operation.

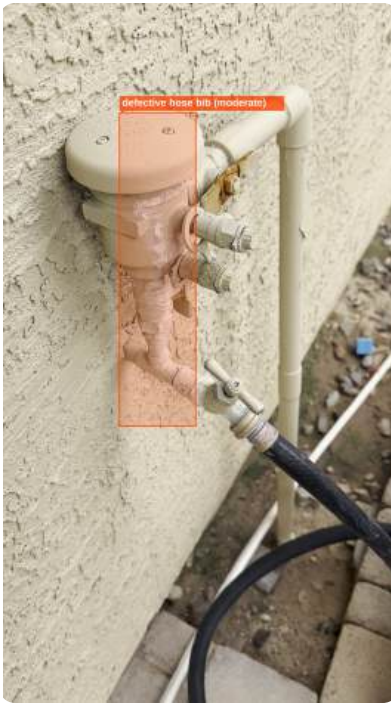
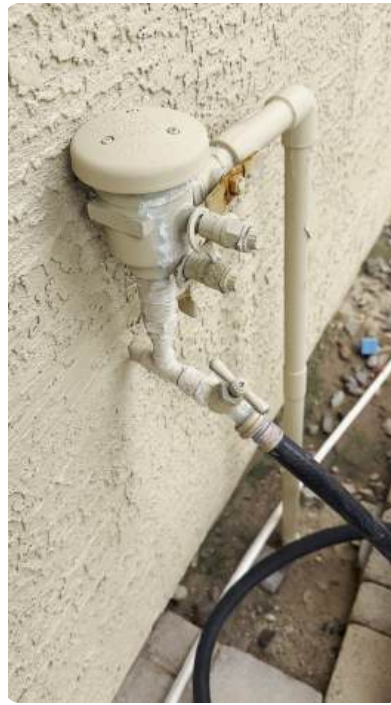
HOSE BIB HANDLE DAMAGED OR MISSING

The handle for the exterior spigot was damaged or missing. Repairs or replacement as needed are recommended to be performed by a qualified individual to ensure proper operation.

Annotated image: defective hose bib at Back Yard
IMAGE/JPEG

Original image: defective hose bib at Back Yard
IMAGE/JPEG

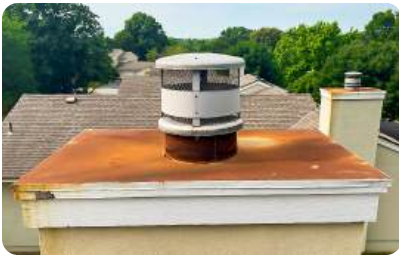
CORRODED CHIMNEY CAP

The chimney cap displayed signs of corrosion. Regular maintenance, such as sealing, is recommended to prevent further damage and extend its longevity.

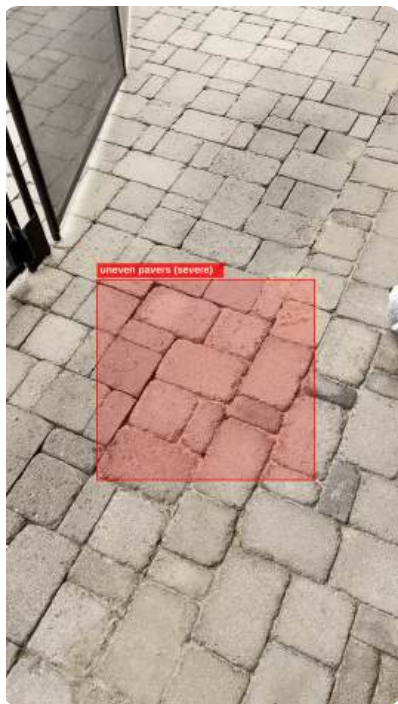
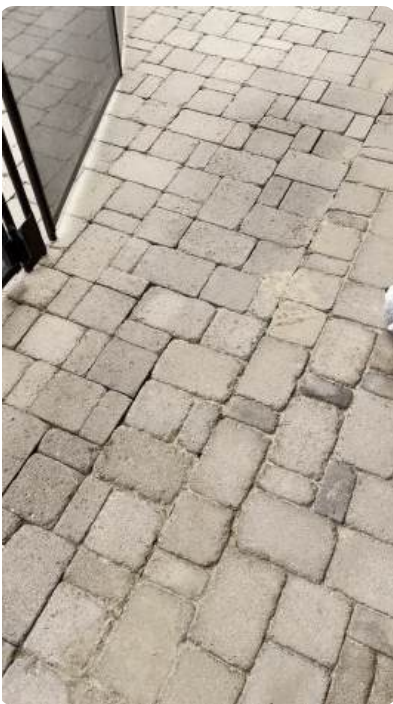
UNEVEN PAVERS — TRIP HAZARD

Uneven paver stones were observed in the backyard, creating a potential trip hazard to occupants and visitors. This condition

presents an immediate safety concern and should be corrected. Recommend evaluation and repair by a qualified hardscape contractor or landscaper to re-level, reset, or replace affected pavers to eliminate the trip hazard.

Annotated image: uneven pavers at Back Yard
IMAGE/JPEG

Original image: uneven pavers at Back Yard
IMAGE/JPEG

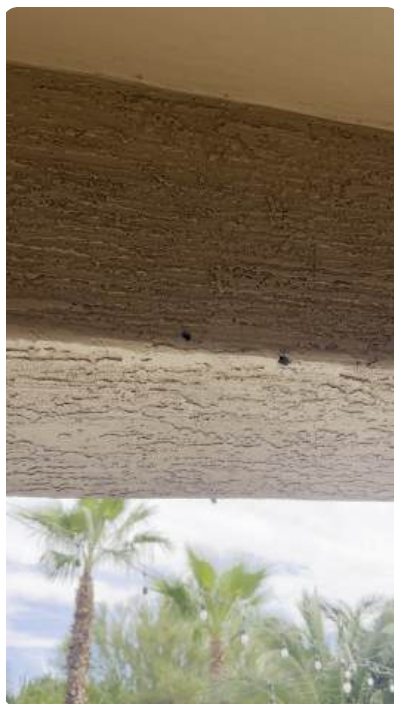
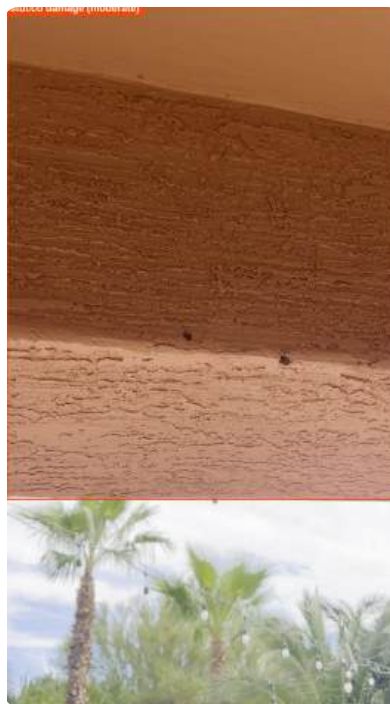
Location: Back Yard

STUCCO CRACKS/DAMAGE

Stucco damage was observed. Gaps or cracks in stucco can allow for moisture intrusion, accelerating deterioration. It is recommended that a qualified contractor evaluate and perform necessary repairs.

Original image: stucco damage at Back Yard
IMAGE/JPEG

Annotated image: stucco damage at Back Yard
IMAGE/JPEG

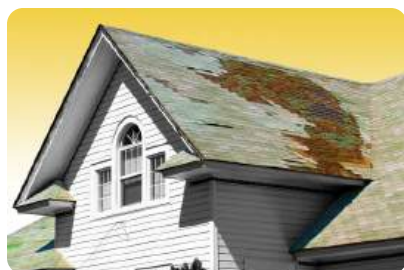
ROOF COVERING BEYOND LIFESPAN - REPLACEMENT RECOMMENDED

Based on the age and type of shingle, the roof has exceeded its expected service life. Even with current repairs, the design of the shingle is beyond its intended lifespan. It is recommended to consult a qualified roofing professional for suggestions and quotes regarding roof replacement.

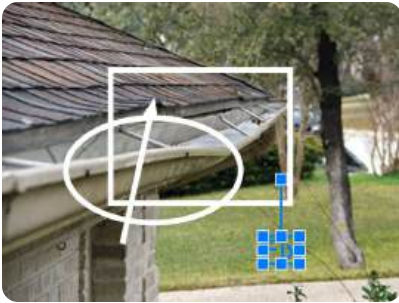
MISSING OR DAMAGED GUTTER HANGER

A gutter hanger was observed to be missing or damaged. It is recommended to properly secure or replace the gutter hangers to ensure the intended stability and proper alignment of the gutter system.

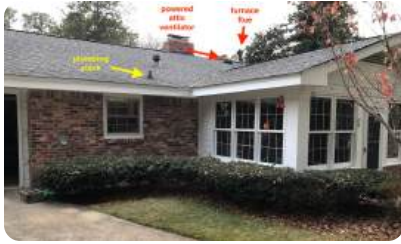
INADEQUATE PLUMBING VENT CLEARANCE NEAR ROOFTOP DECK

The plumbing vent displayed insufficient clearance from a rooftop deck. For proper ventilation and to prevent sewer gases from entering recreational areas, vents should typically extend at least 6 feet above a rooftop deck. It is recommended to consult with a licensed professional to ensure appropriate vent height and mitigate potential health concerns.

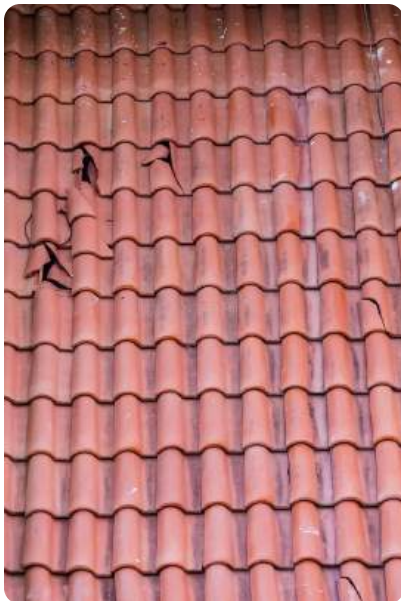
CRACKED ROOF TILES

Cracked tiles were observed in various locations on the roof. It is recommended that a qualified roofing contractor assess and repair these areas as necessary. This type of roofing system typically benefits from annual evaluations and prompt repairs.

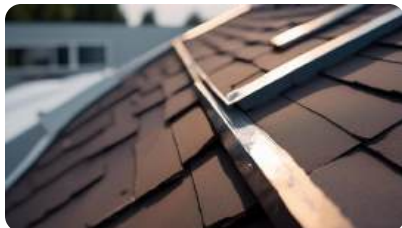
Observations indicate the presence of openings or gaps within the flashing or sealant materials. Such breaches can compromise the water-resistant barrier of the roof, potentially leading to water penetration. It is recommended to engage a certified roofing contractor to address and repair these areas to prevent future moisture intrusion.

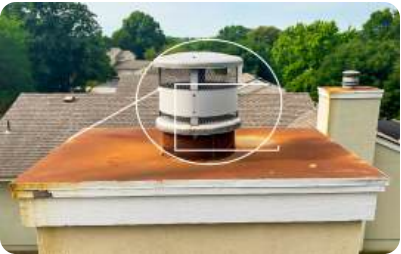
A damaged or missing vent cover could allow debris and small pests to enter. It is recommended to repair or replace the vent cover to ensure proper operation.

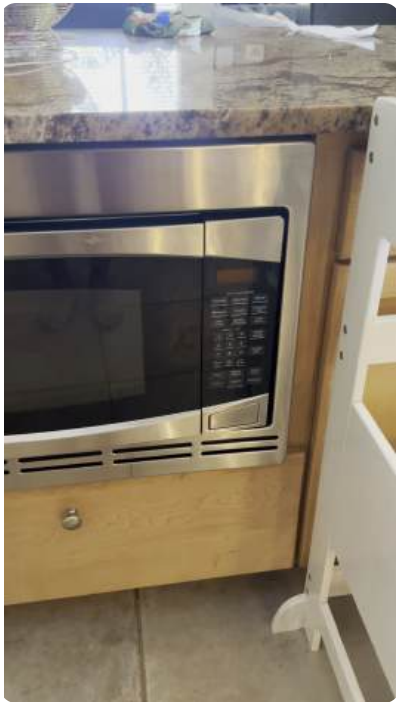
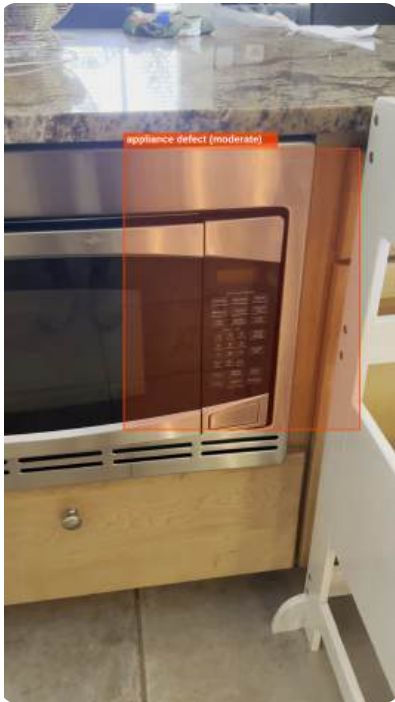
Location: Kitchen

The microwave oven appeared to be non-operational or was malfunctioning. It is advised that a qualified appliance technician evaluate and perform necessary repairs or replacement.

Original image: appliance defect at Kitchen
IMAGE/JPEG

Annotated image: appliance defect at Kitchen
IMAGE/JPEG

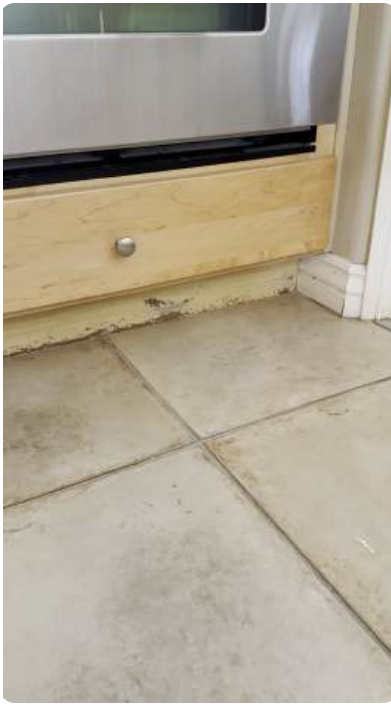
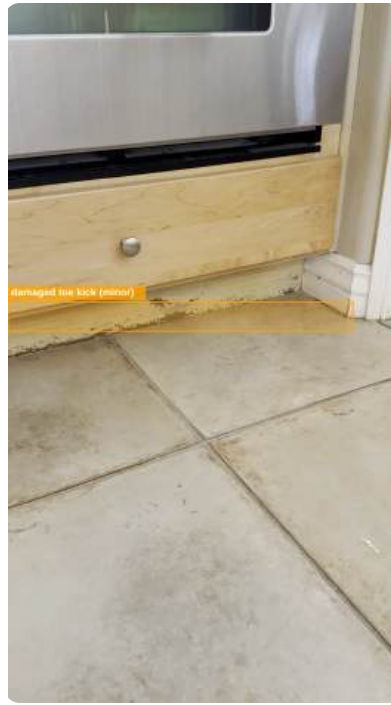
Original image: damaged toe kick at Kitchen
IMAGE/JPEG

Annotated image: damaged toe kick at Kitchen
IMAGE/JPEG

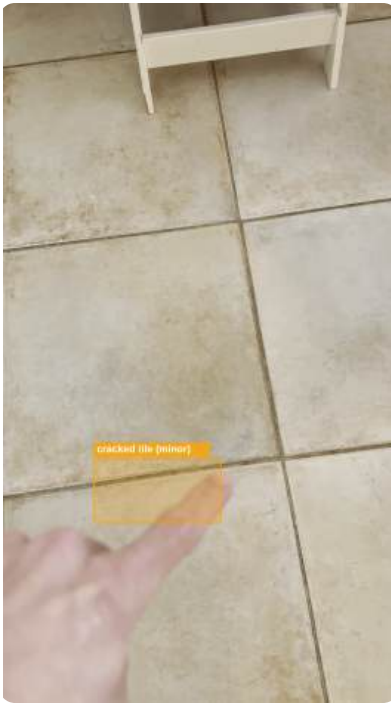
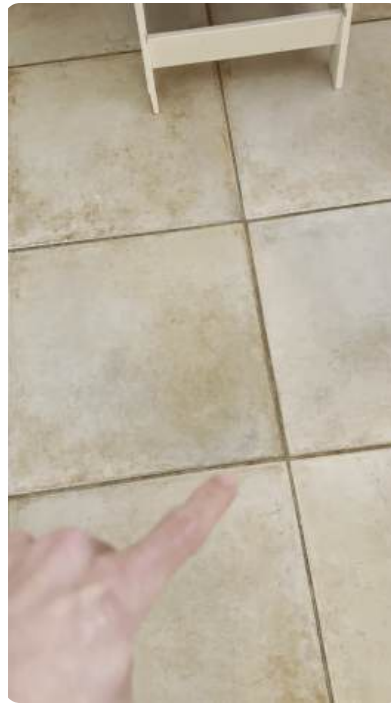
Two small cracks were observed in the kitchen floor tile. Cracked tile can allow moisture to penetrate the substrate and may deteriorate further over time. Recommend repair or replacement of the affected tile(s) by a qualified flooring contractor and verify the integrity of the surrounding substrate and grout. Obtain estimates as needed.

Annotated image: cracked tile at Kitchen
IMAGE/JPEG

Original image: cracked tile at Kitchen
IMAGE/JPEG

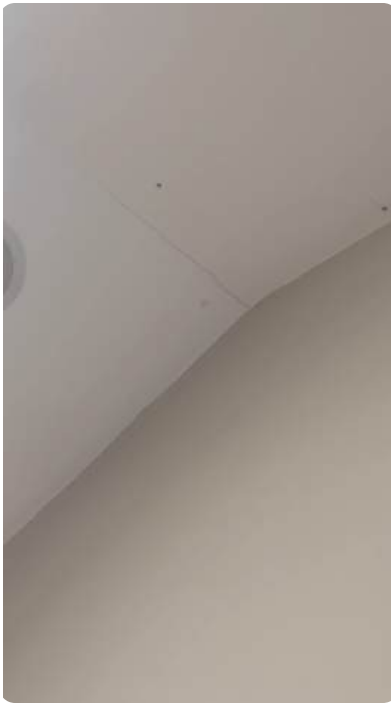
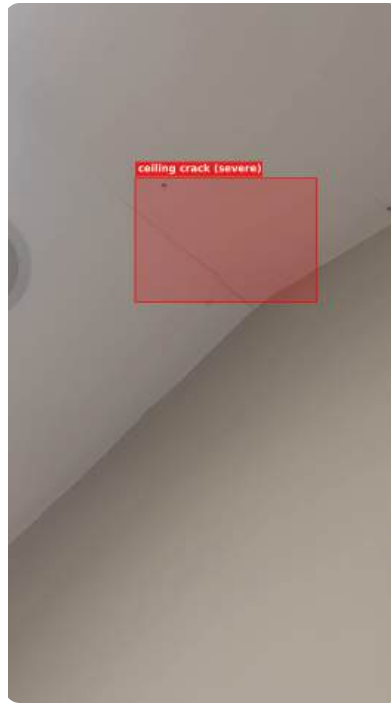
Significant drywall imperfections, including damage, cracking, or inconsistencies, were noted in the referenced area(s). It is advisable to inquire with the current homeowner(s) regarding any past alterations. Repairs should be undertaken by a drywall contractor as desired.

Original image: ceiling crack at Living Room
IMAGE/JPEG

Annotated image: ceiling crack at Living Room
IMAGE/JPEG

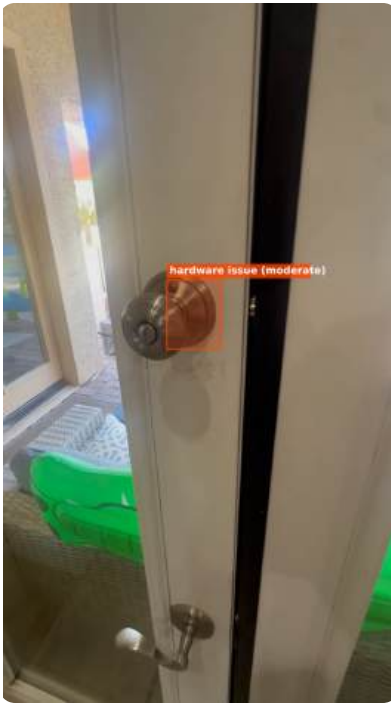
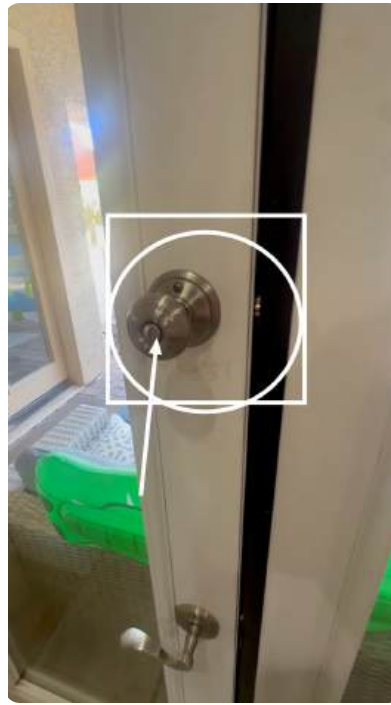
The handle lock on one or more exterior entryways was found to be inoperable or challenging to use. Replacement of the locking doorknob by a qualified professional is recommended.

Annotated image: hardware issue at Living Room
IMAGE/JPEG

Original image: hardware issue at Living Room
IMAGE/JPEG

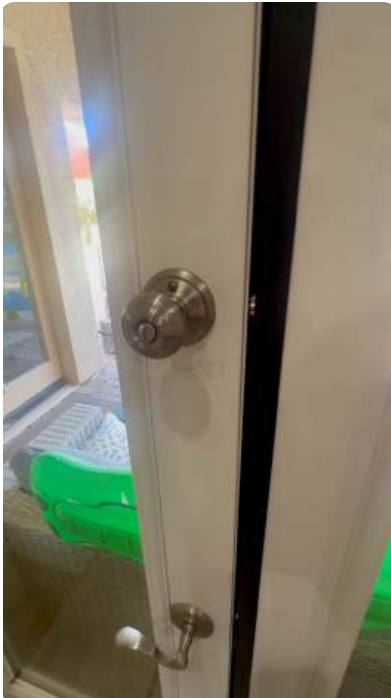
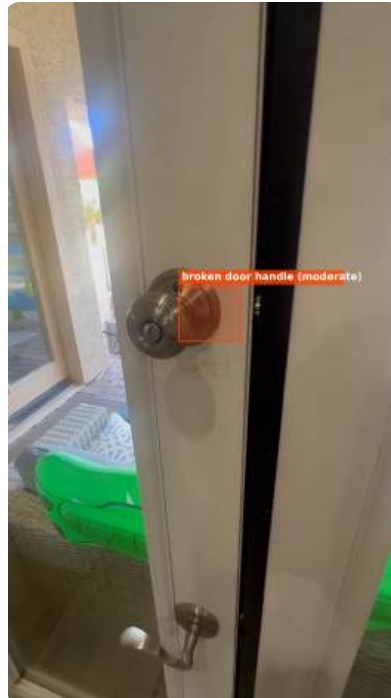
Location: *Living Room*

Various exterior door hardware components, including locksets, hinges, and pulls, were observed to be inoperable, damaged, loose, or absent. It is advised that a qualified contractor perform necessary repairs or replacements.

Original image: broken door handle at Living Room

Annotated image: broken door handle at Living Room

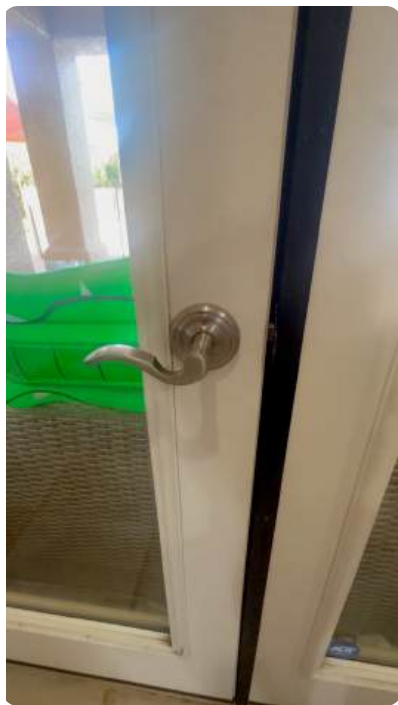
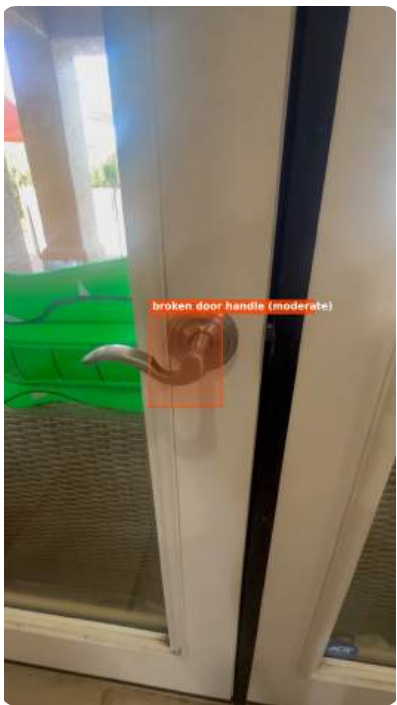
Location: *Living Room*

The door handle is either damaged or missing. It is recommended that a qualified professional evaluate and repair or replace it as necessary.

Original image: broken door handle at Living Room
IMAGE/JPEG

Annotated image: broken door handle at Living Room
IMAGE/JPEG

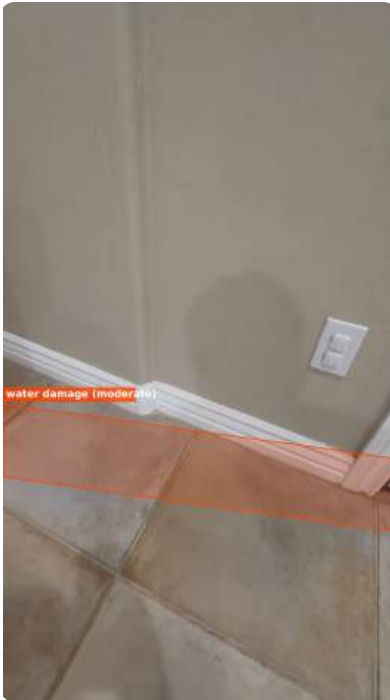
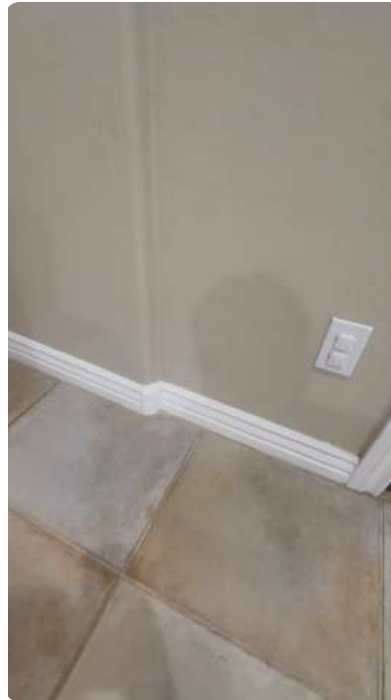
Water damage was observed on the subflooring during the assessment. This damage may signify a historical or ongoing leak. It is advised to consult with the seller regarding the nature of the damage and any prior repairs. Alternatively, monitor the affected area for any subsequent deterioration.

Annotated image: water damage at Living Room
IMAGE/JPEG

Original image: water damage at Living Room
IMAGE/JPEG

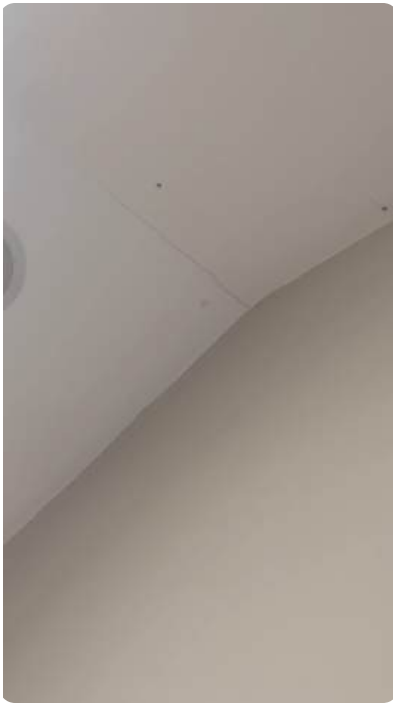
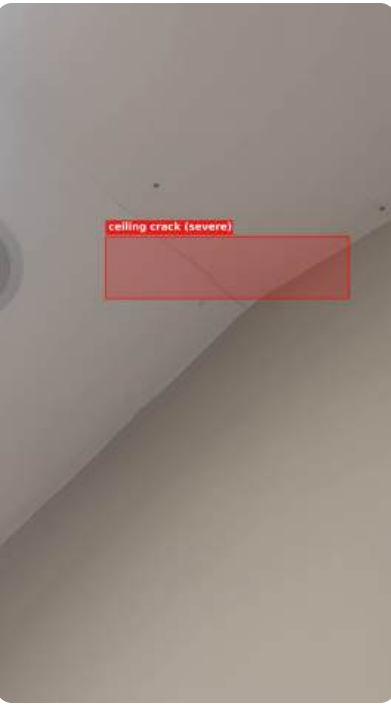
Location: Living Room

Significant cracking was observed in the ceiling in the Living Room that may indicate underlying structural movement or damage. A licensed contractor or structural engineer should be engaged to evaluate the extent and cause of the cracking and to recommend necessary repairs. This condition may represent a safety risk and should be addressed promptly.

Original image: ceiling crack at Living Room
IMAGE/JPEG

Annotated image: ceiling crack at Living Room
IMAGE/JPEG

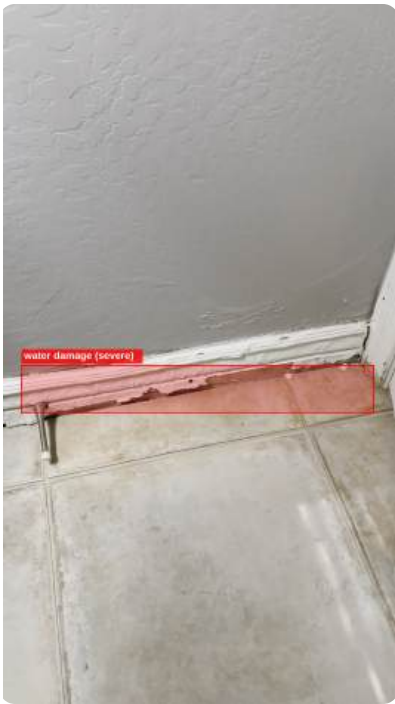
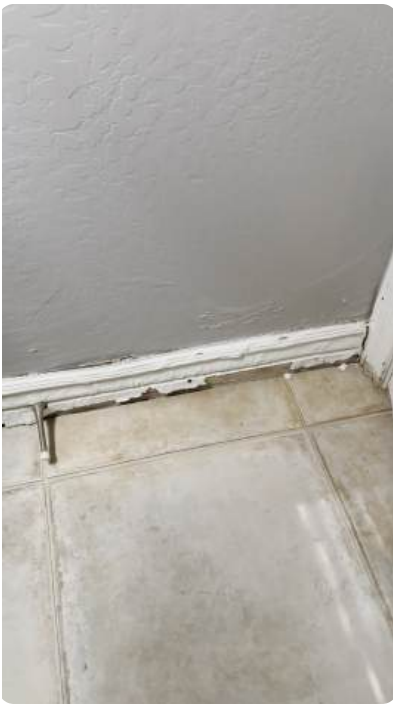
The observed leakage could cause additional damage to the framing member and floor decking. Water staining and dampness were noted in one or more areas, as confirmed by a moisture meter. This condition increases the risk of insect infestation, mildew, and decay. It is recommended to consult a licensed contractor to identify and rectify the source of the dampness, which may involve improving exterior drainage, installing a waterproofing system, or sealing foundation cracks.

Annotated image: water damage at Master Bathroom
IMAGE/JPEG

Original image: water damage at Master Bathroom
IMAGE/JPEG

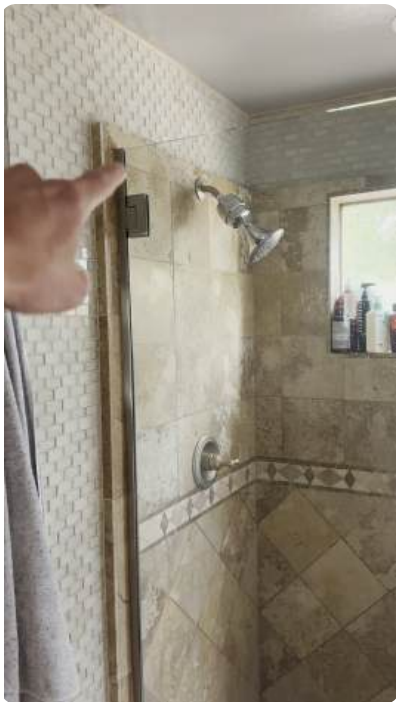
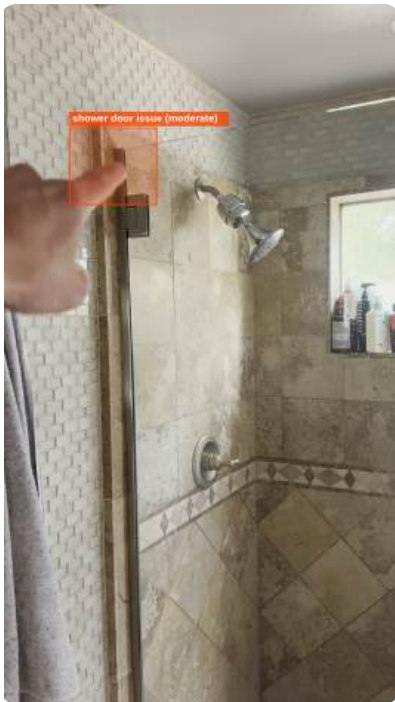
Location: Master Bathroom

The shower door was observed to be striking the adjoining glass and is misaligned. This condition can cause damage to the glass or hardware and may lead to failure if not corrected. It is recommended that a qualified glass/frameless-shower contractor or

handyman evaluate the door alignment, adjust hinges or track, and install additional support or reinforcement as necessary to prevent further damage.

Original image: shower door issue at Master Bathroom
IMAGE/JPEG

Annotated image: shower door issue at Master Bathroom
IMAGE/JPEG

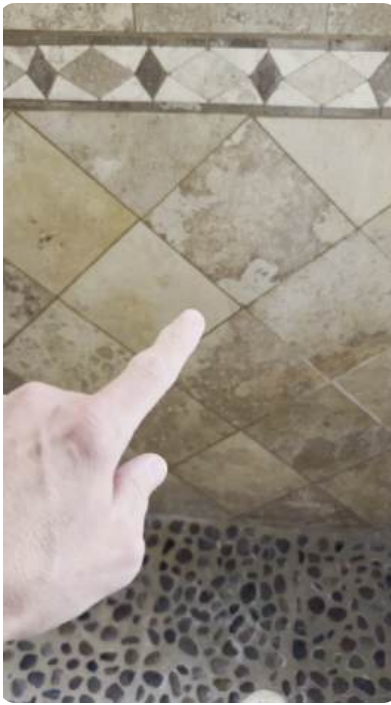
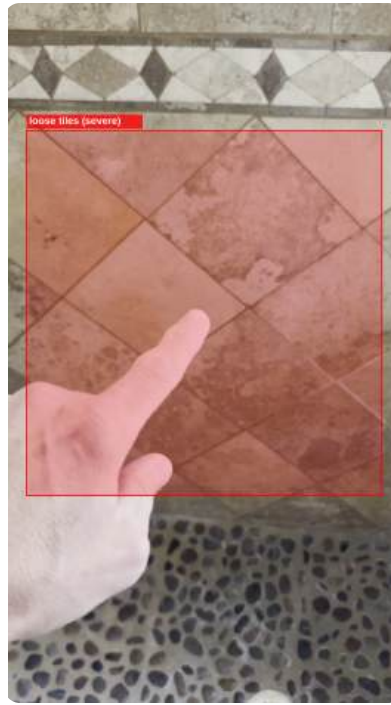
Location: Master Bathroom Shower

Loose tiles were observed in the master bathroom shower and were reported as a potential safety hazard. Loose or detached tiles can fall or create sharp edges and often indicate compromised substrate or prior water intrusion. It is recommended to discontinue use of the shower until a qualified tile contractor or licensed plumber assesses the condition, secures or replaces loose tiles, and evaluates the underlying substrate for moisture damage or continued leaks. Prompt repair is advised to prevent injury and further deterioration.

Original image: loose tiles at Master Bathroom Shower
IMAGE/JPEG

Annotated image: loose tiles at Master Bathroom Shower
IMAGE/JPEG
