PROPERTY INSPECTION REPORT FORM

| <i>251 N Bristol Ave, Los Angeles, CA 90049</i> | |

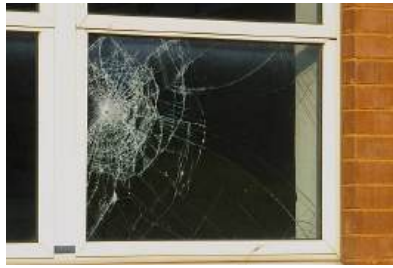
Cracked Window Pane:

recommendation / defect

The damaged glass pane may expose sharp edges and reduce the thermal barrier against the elements. Further evaluation by a qualified contractor is recommended to repair or replace the damaged window as needed.

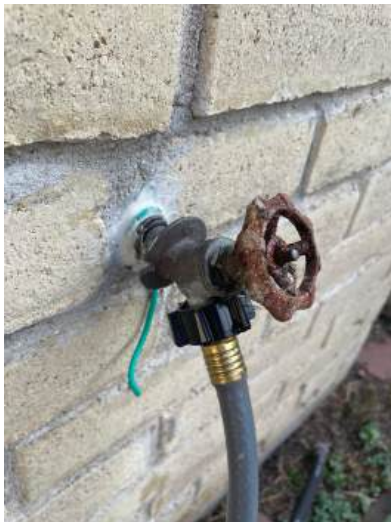
Hose Bib Repair / Replacement Recommended:

Inspector recommends repairing or replacing the exterior hose bib to make it fully operational. Confirm functionality after repair and check for leaks. Obtain quotes from a licensed plumber or qualified contractor as needed.

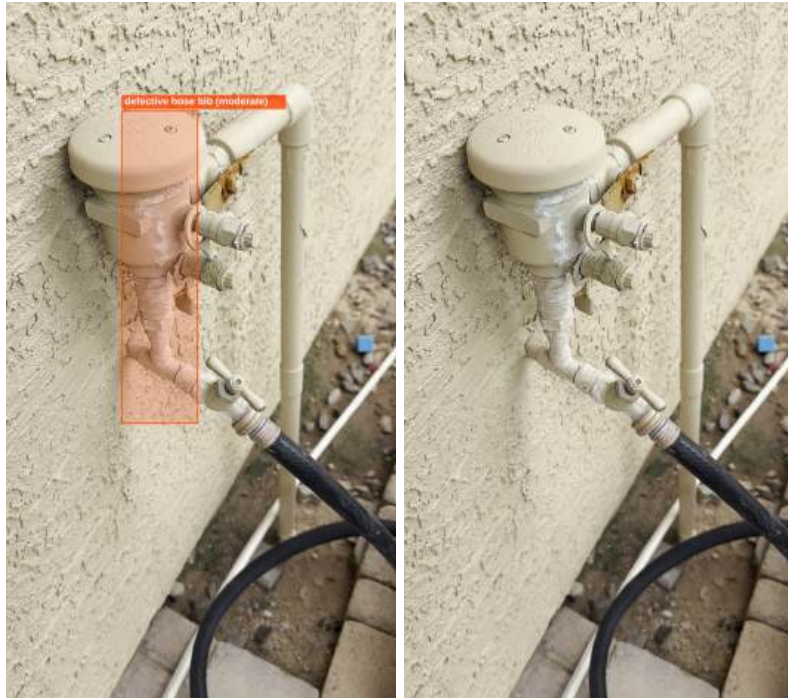
Annotated image: defective hose bib at Back Yard

Hose Bib Handle Damaged or Missing:

The handle for the exterior spigot was damaged or missing. Repairs or replacement as needed are recommended to be performed by a qualified individual to ensure proper operation.

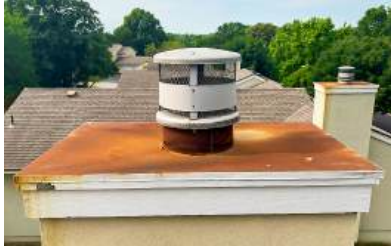
Corroded Chimney Cap:

The chimney cap displayed signs of corrosion. Regular maintenance, such as sealing, is recommended to prevent further damage and extend its longevity.

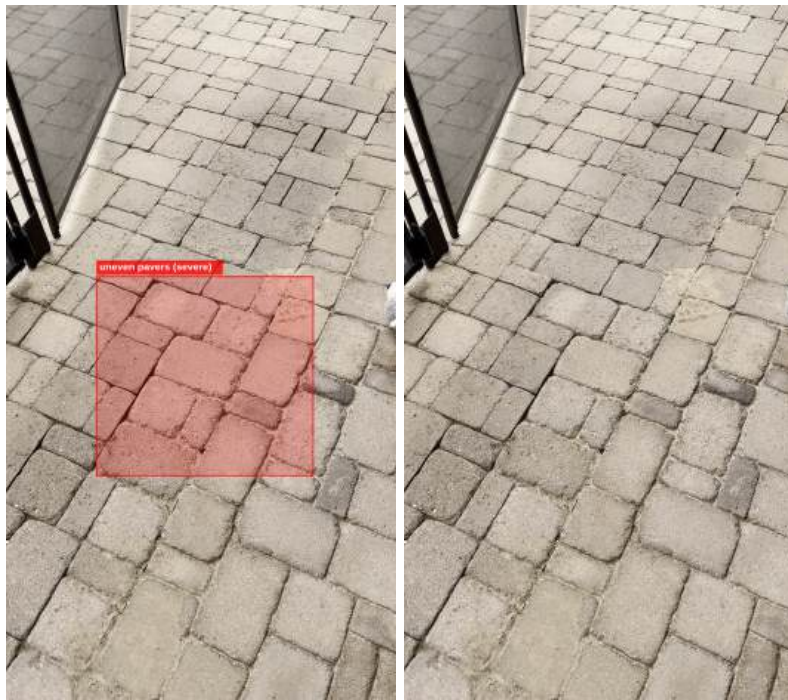
Annotated image: uneven pavers at
Back Yard

Uneven Pavers — Trip Hazard:

Uneven paver stones were observed in the backyard, creating a potential trip hazard to occupants and visitors. This condition presents an immediate safety concern and should be corrected. Recommend evaluation and repair by a qualified hardscape contractor or landscaper to re-level, reset, or replace affected pavers to eliminate the trip hazard.

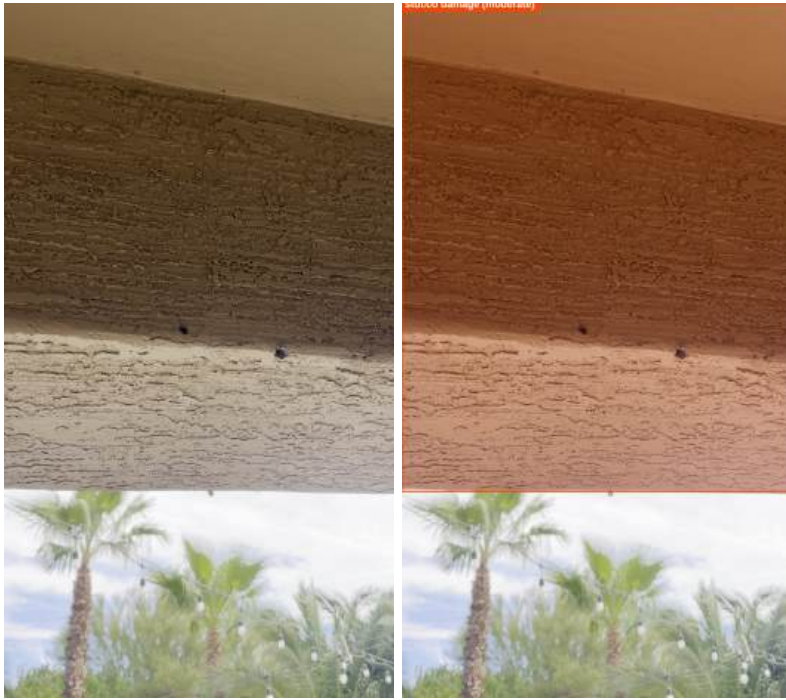
Original image: stucco damage at Back Yard

Stucco Cracks/Damage:

Stucco damage was observed. Gaps or cracks in stucco can allow for moisture intrusion, accelerating deterioration. It is recommended that a qualified contractor evaluate and perform necessary repairs.

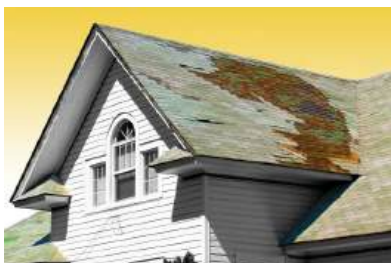
Roof Covering Beyond Lifespan - Replacement Recommended:

Based on the age and type of shingle, the roof has exceeded its expected service life. Even with current repairs, the design of the shingle is beyond its intended lifespan. It is recommended to consult a qualified roofing professional for suggestions and quotes regarding roof replacement.

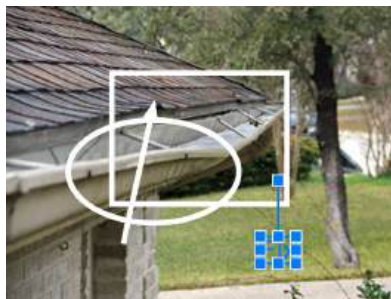
Missing or Damaged Gutter Hanger:

A gutter hanger was observed to be missing or damaged. It is recommended to properly secure or replace the gutter hangers to ensure the intended stability and proper alignment of the gutter system.

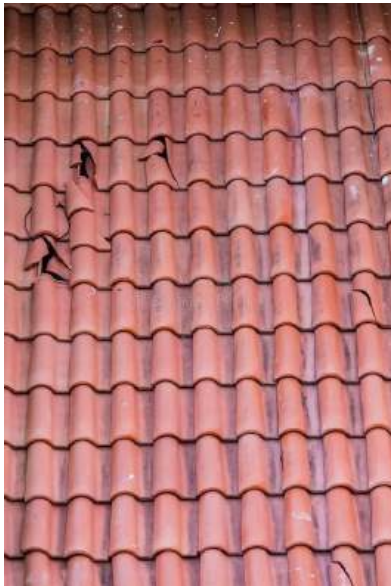
Cracked Roof Tiles:

Cracked tiles were observed in various locations on the roof. It is recommended that a qualified roofing contractor assess and repair these areas as necessary. This type of roofing system typically benefits from annual evaluations and prompt repairs.

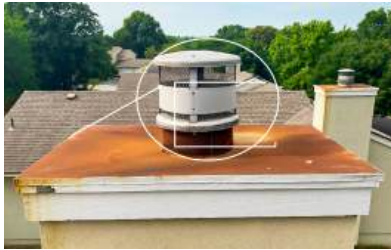
A damaged or missing vent cover could allow debris and small pests to enter. It is recommended to repair or replace the vent cover to ensure proper operation.

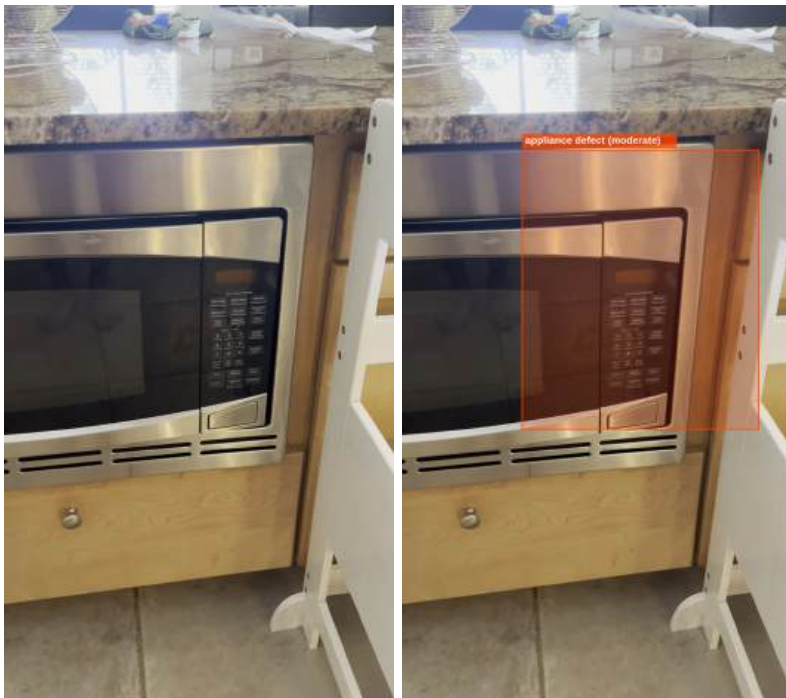
Original image: appliance defect at Kitchen

The microwave oven appeared to be non-operational or was malfunctioning. It is advised that a qualified appliance technician evaluate and perform necessary repairs or replacement.

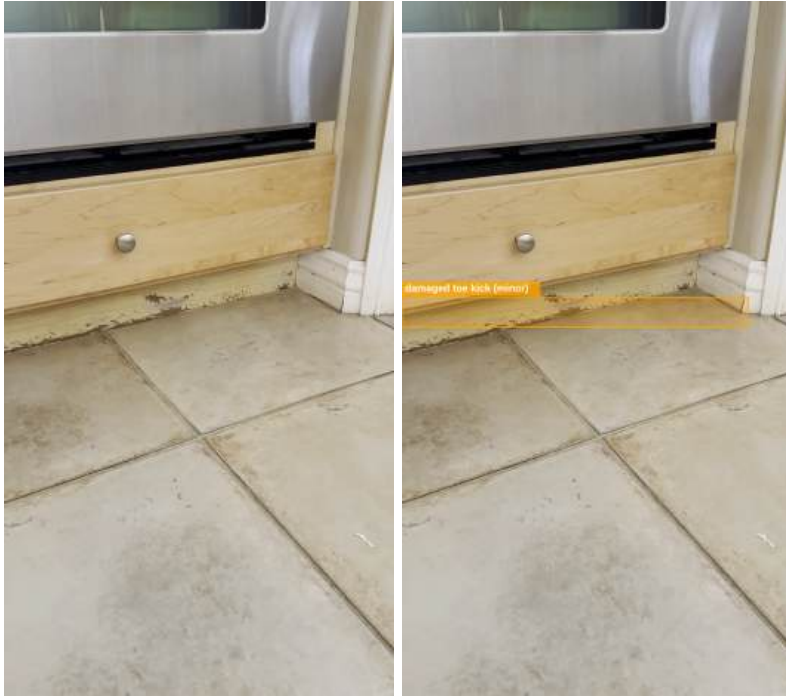
Original image: damaged toe kick at Kitchen

The paint finish exhibited signs of failure or peeling in one or more locations. It is recommended that a qualified contractor perform the necessary repairs.

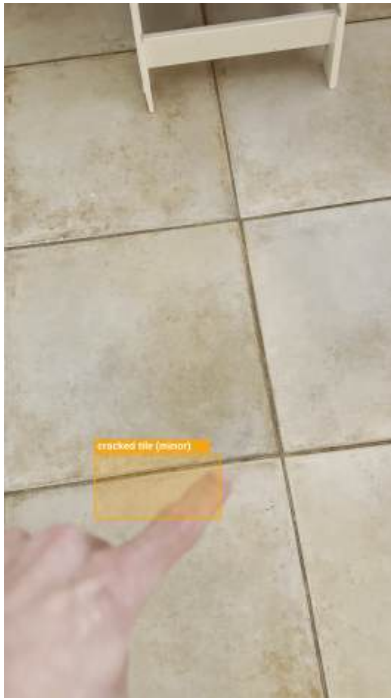
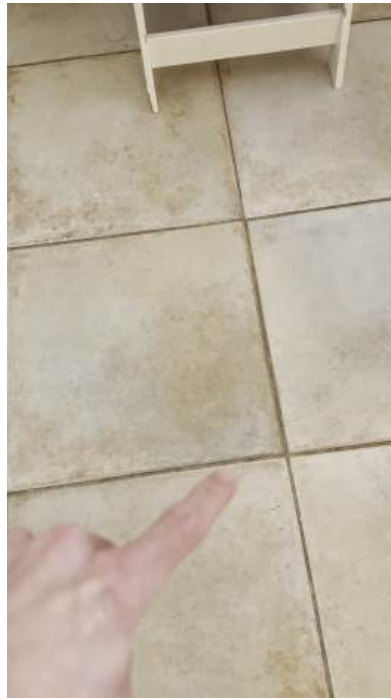
Annotated image: cracked tile at Kitchen

Two small cracks were observed in the kitchen floor tile. Cracked tile can allow moisture to penetrate the substrate and may deteriorate further over time. Recommend repair or replacement of the affected tile(s) by a qualified flooring contractor and verify the integrity of the surrounding substrate and grout. Obtain estimates as needed.

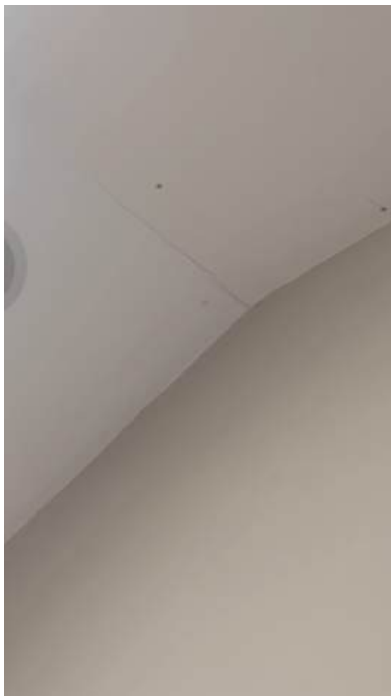
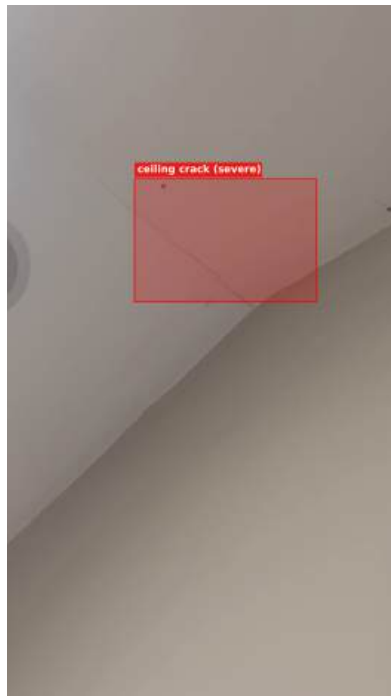
Original image: ceiling crack at Living Room

Significant drywall imperfections, including damage, cracking, or inconsistencies, were noted in the referenced area(s). It is advisable to inquire with the current homeowner(s) regarding any past alterations. Repairs should be undertaken by a drywall contractor as desired.

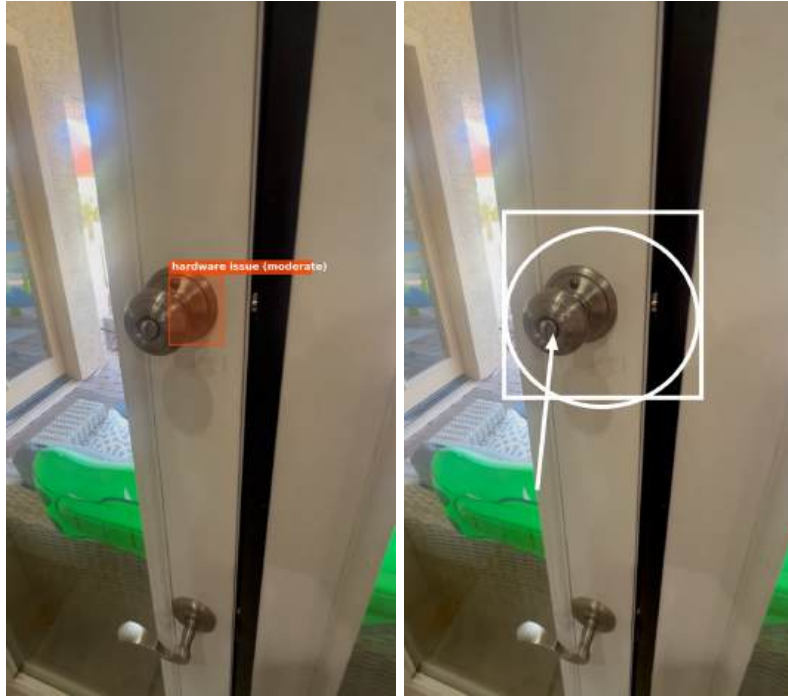
Annotated image: hardware issue at Living Room

The handle lock on one or more exterior entryways was found to be inoperable or challenging to use. Replacement of the locking doorknob by a qualified professional is recommended.

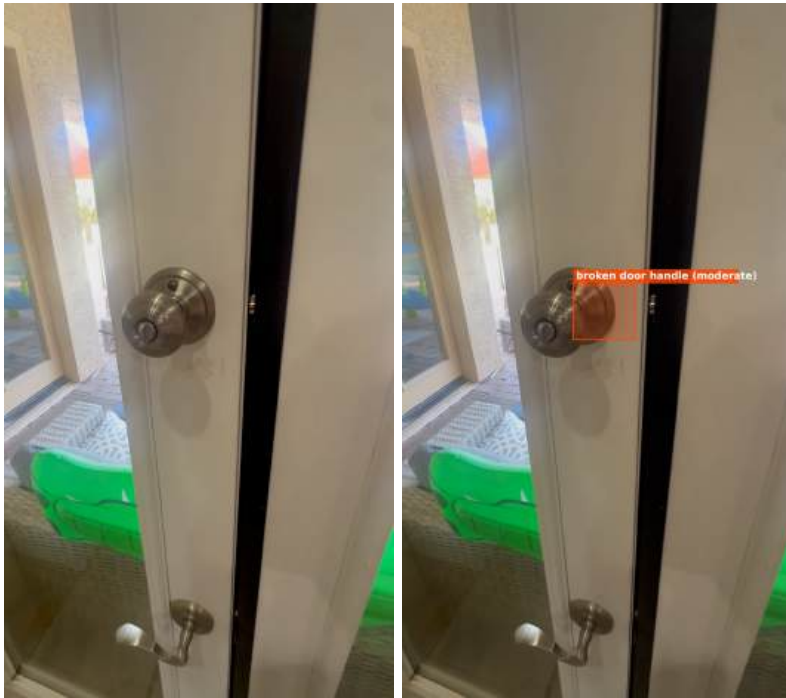
Original image: broken door handle at Living Room *Annotated image: broken door handle at Living Room*

Various exterior door hardware components, including locksets, hinges, and pulls, were observed to be inoperable, damaged, loose, or absent. It is advised that a qualified contractor perform necessary repairs or replacements.

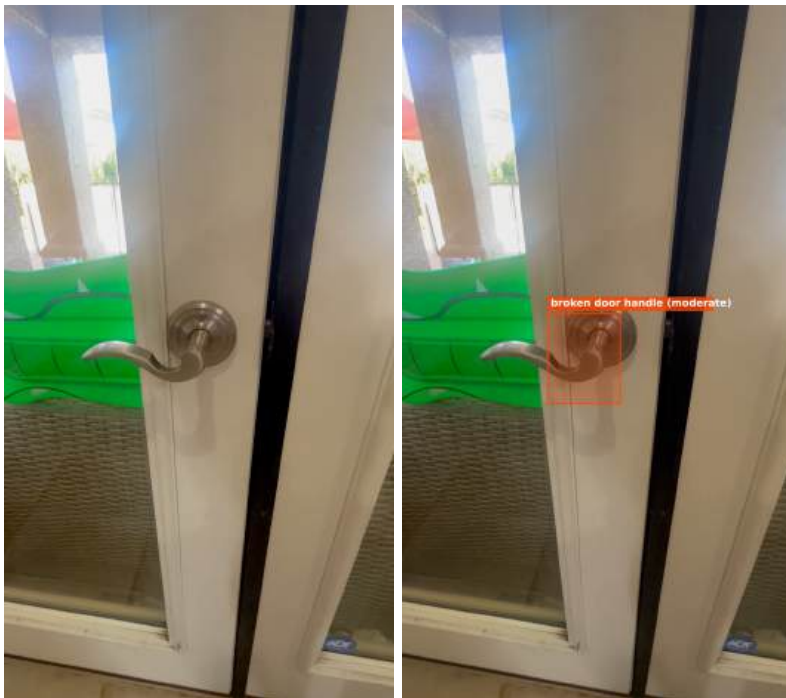
Original image: broken door handle at Living Room *Annotated image: broken door handle at Living Room*

The door handle is either damaged or missing. It is recommended that a qualified professional evaluate and repair or replace it as necessary.

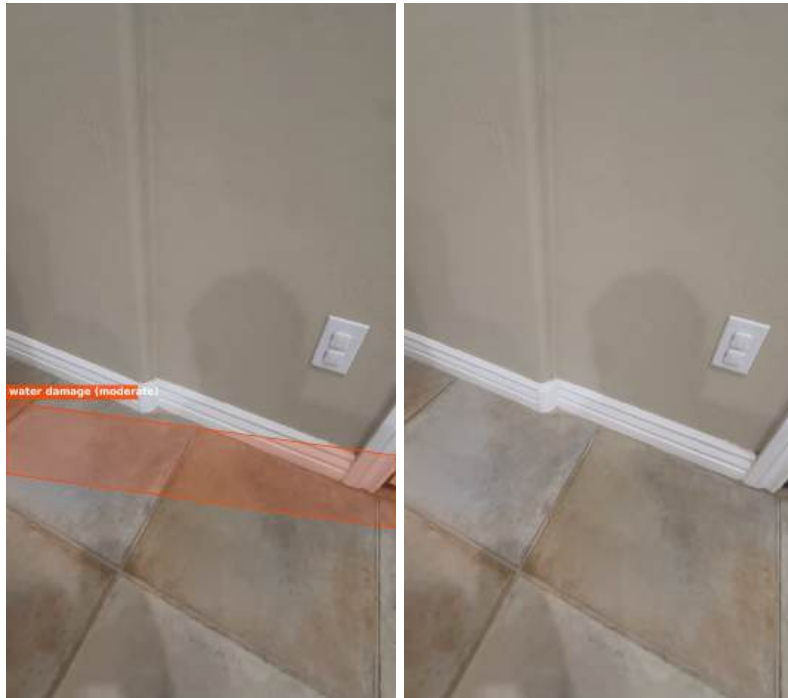
*Annotated image: water damage at
Living Room*

Water damage was observed on the subflooring during the assessment. This damage may signify a historical or ongoing leak. It is advised to consult with the seller regarding the nature of the damage and any prior repairs. Alternatively, monitor the affected area for any subsequent deterioration.

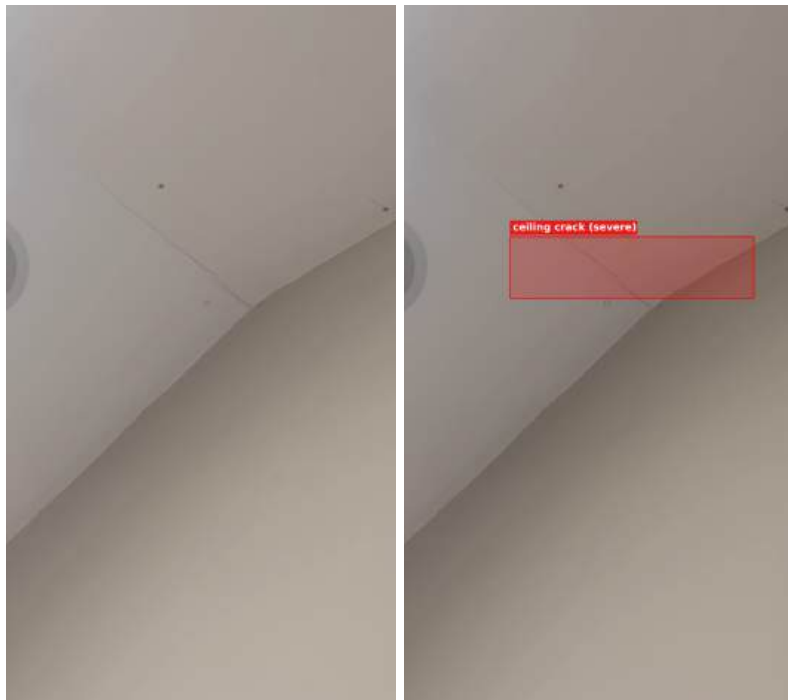
*Original image: ceiling crack at
Living Room*

Significant cracking was observed in the ceiling in the Living Room that may indicate underlying structural movement or damage. A licensed contractor or structural engineer should be engaged to evaluate the extent and cause of the cracking and to recommend necessary repairs. This condition may represent a safety risk and should be addressed promptly.

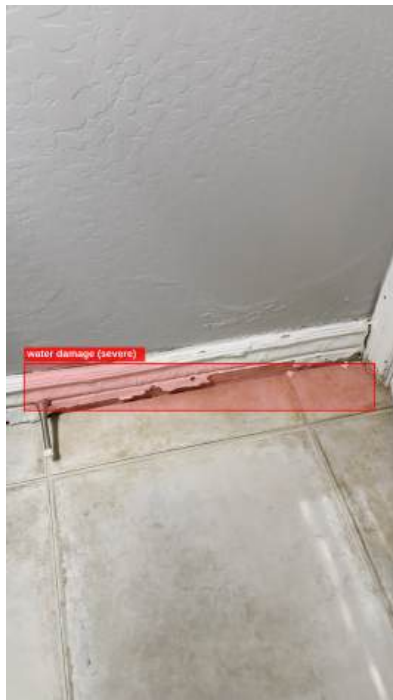
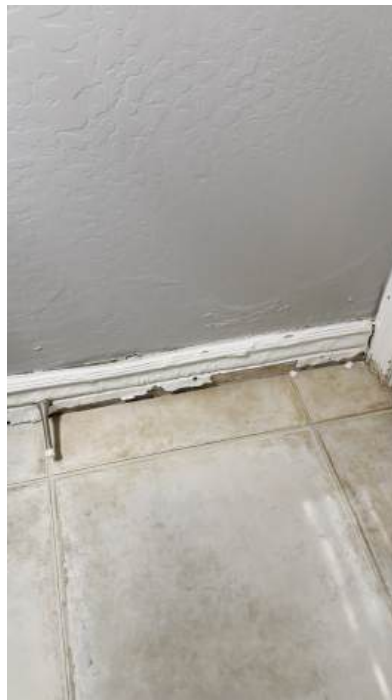
Annotated image: water damage at Master Bathroom

The observed leakage could cause additional damage to the framing member and floor decking. Water staining and dampness were noted in one or more areas, as confirmed by a moisture meter. This condition increases the risk of insect infestation, mildew, and decay. It is recommended to consult a licensed contractor to identify and rectify the source of the dampness, which may involve improving exterior drainage, installing a waterproofing system, or sealing foundation cracks.

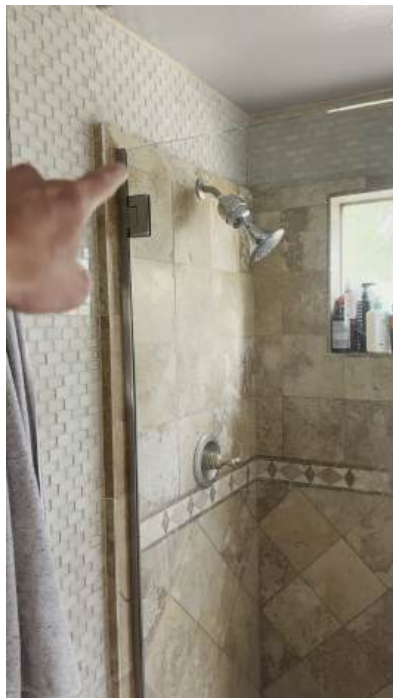
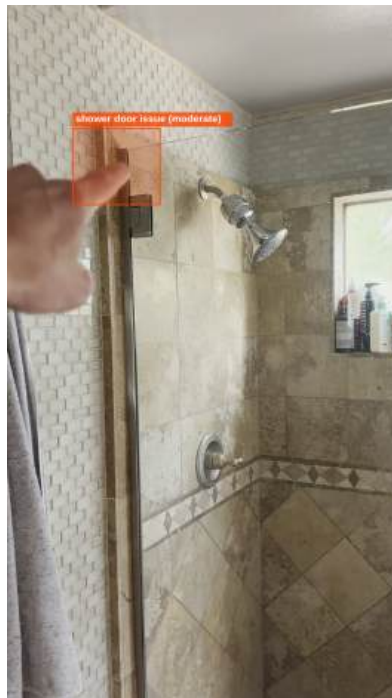
Original image: shower door issue at Master Bathroom

The shower door was observed to be striking the adjoining glass and is misaligned. This condition can cause damage to the glass or hardware and may lead to failure if not corrected. It is recommended that a qualified glass/frameless-shower contractor or handyman evaluate the door alignment, adjust hinges or track, and install additional support or reinforcement as necessary to prevent further damage.

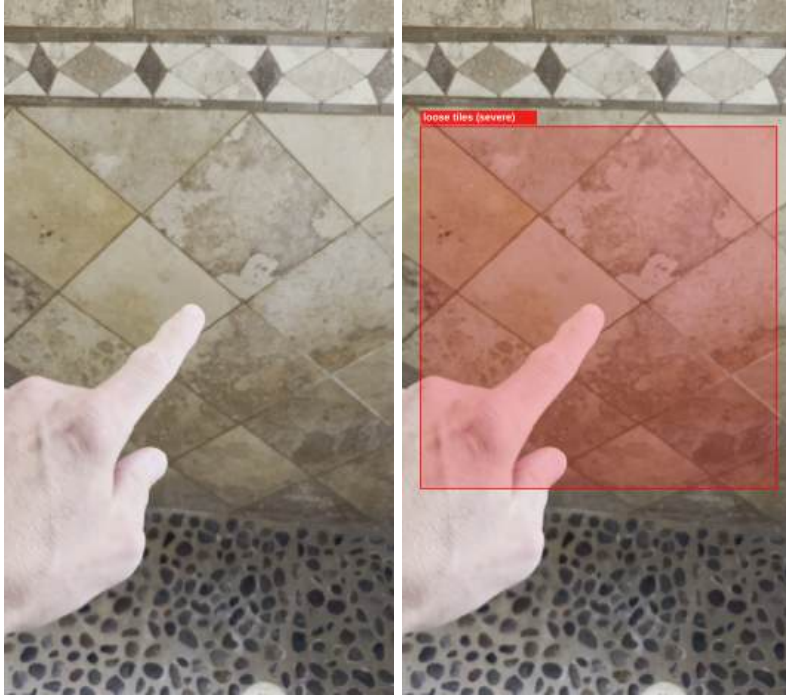
Original image: loose tiles at Master Bathroom Shower Annotated image: loose tiles at Master Bathroom Shower

Loose tiles were observed in the master bathroom shower and were reported as a potential safety hazard. Loose or detached tiles can fall or create sharp edges and often indicate compromised substrate or prior water intrusion. It is recommended to discontinue use of the shower until a qualified tile contractor or licensed plumber assesses the condition, secures or replaces loose tiles, and evaluates the underlying substrate for moisture damage or continued leaks. Prompt repair is advised to prevent injury and further deterioration.
