# Abrasion Resistance Certification Report

이천시 대월면 대대리 576물류센터

Project : 이천 대대리 물류센터

Performance Class : "AR1" – BS 8204 – 2 : 2003 + A2 :2001

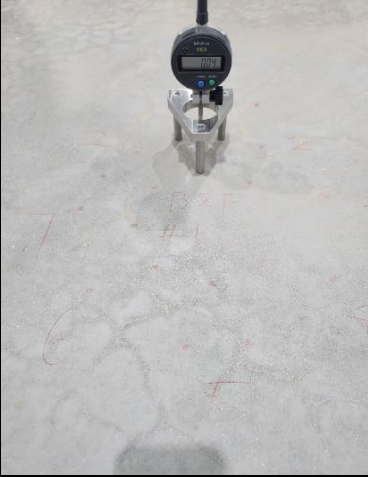
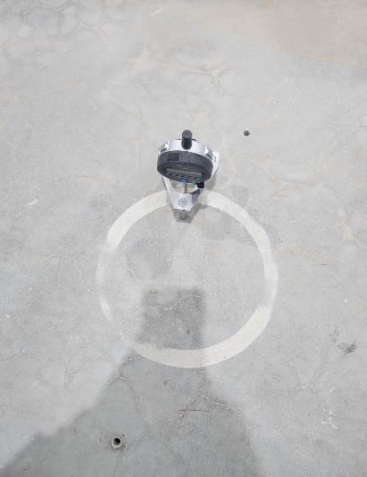
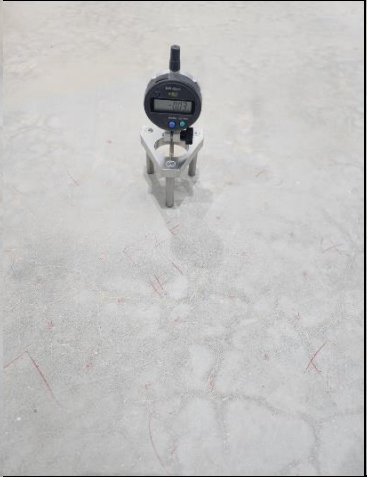
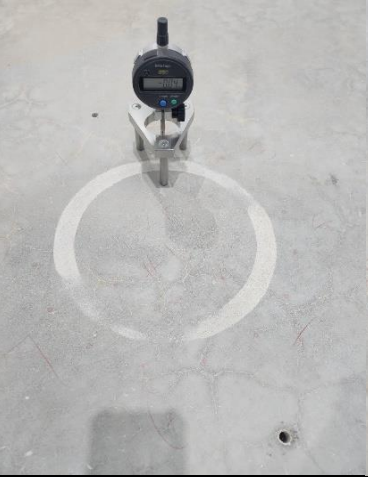
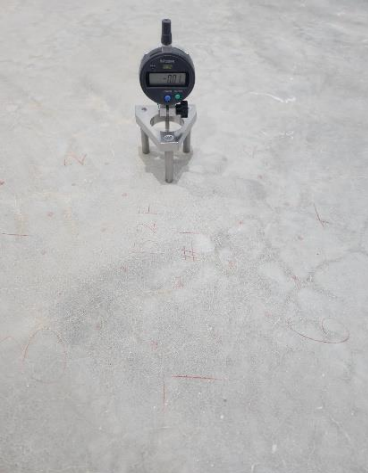
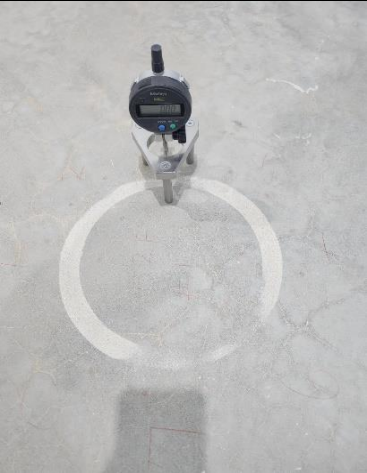
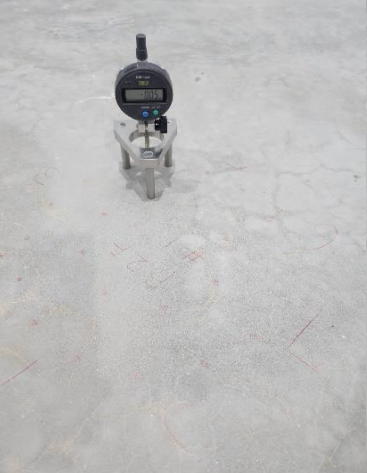
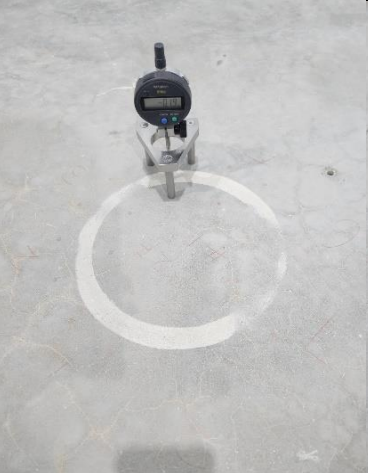
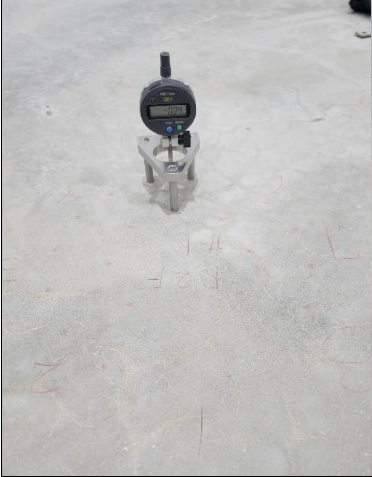
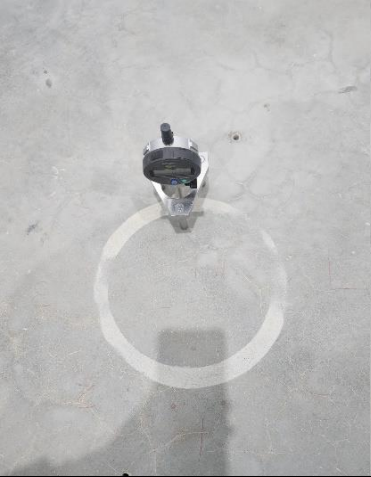
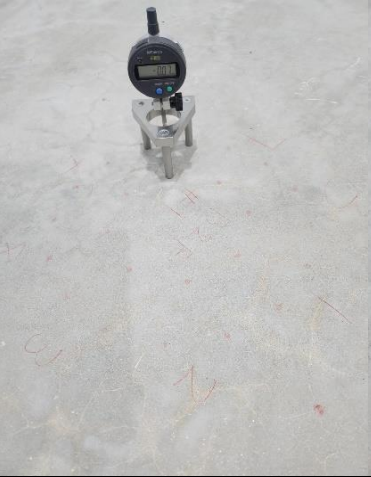
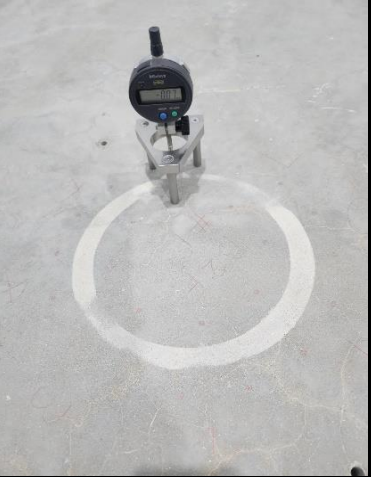
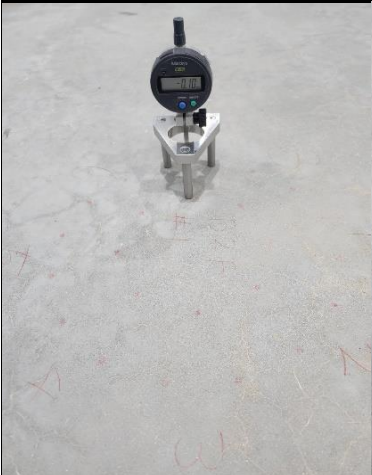
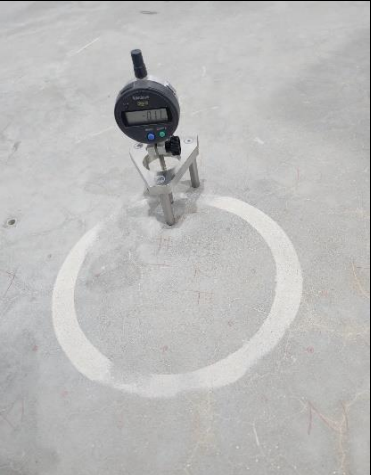
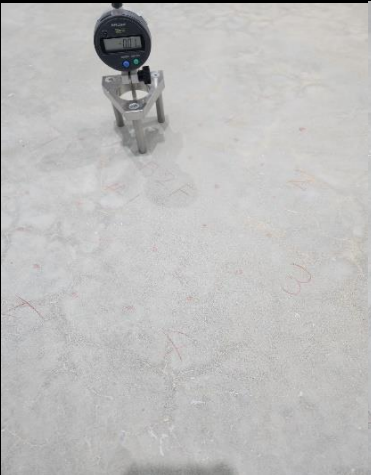
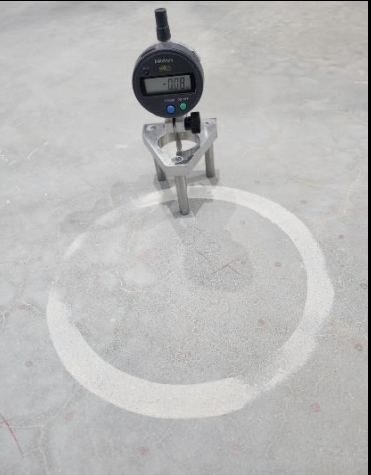
## Abrasion Testing Record Sheet

Point : 1		
		Before : 0.04		
		After : -0.18		
	Point : 8		Point : 2	
	Before : 0.00		Before : -0.03	
	After : 0.00		After : -0.04	
Point : 7				Point : 3
Before : -0.10				Before : -0.01
After : -0.11				After : 0.00
	Point : 6		Point : 4	
	Before : -0.07		Before : -0.05	
	After : -0.07		After : -0.14	
		Point : 5		
		Before : -0.04		
		After : -0.16

Point Number	Difference (mm)	Average Difference (mm)	
1	-0.22	$\frac{-0.44}{8} = \underline{0.055} \quad \text{PASS}$	
2	-0.01		
3	0.01		
4	-0.09		
5	-0.12		
6	0.00		
7	-0.01		
8	0.00

JOB AREA :	B2F #1	Machine Serial Number :	100588
DATE :	2024-03-05	SURVEYOR :	최동현
1 BEFORE	1 AFTER	2 BEFORE	2 AFTER

3 BEFORE	3 AFTER	4 BEFORE	4 AFTER

JOB AREA :	B2F #1	Machine Serial Number :	100588
DATE :	2024-03-05	SURVEYOR :	최동현
5 BEFORE	5 AFTER	6 BEFORE	6 AFTER

7 BEFORE	7 AFTER	8 BEFORE	8 AFTER

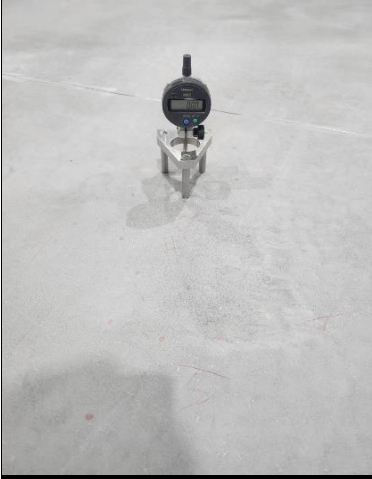
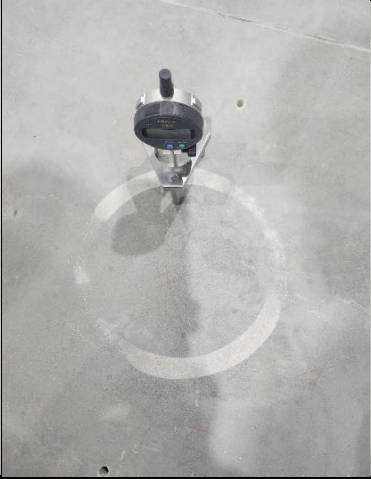
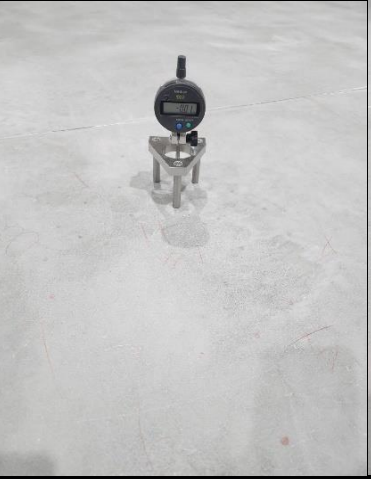
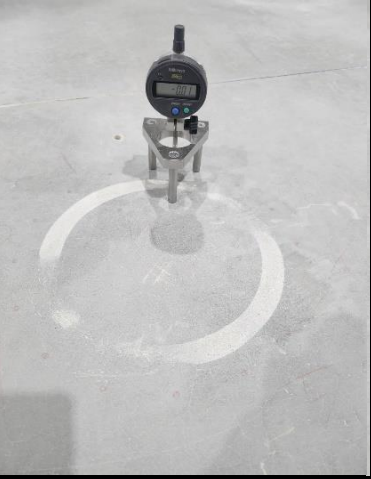
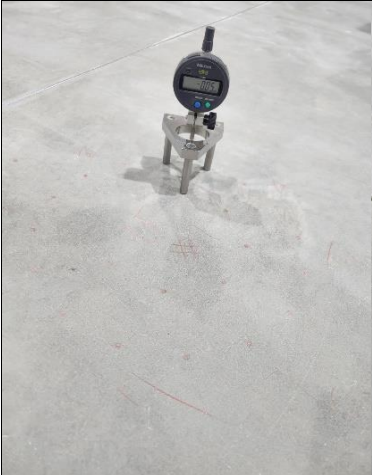
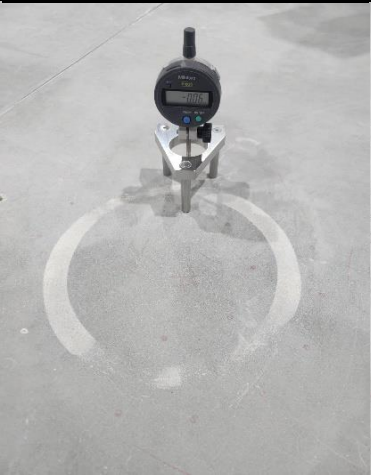
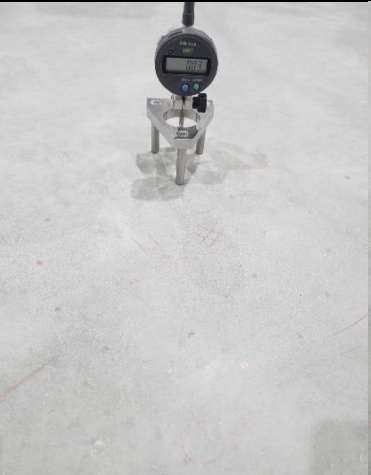
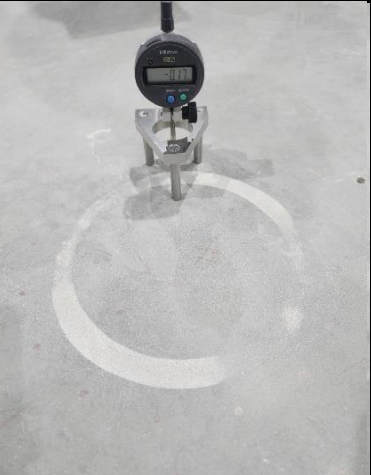
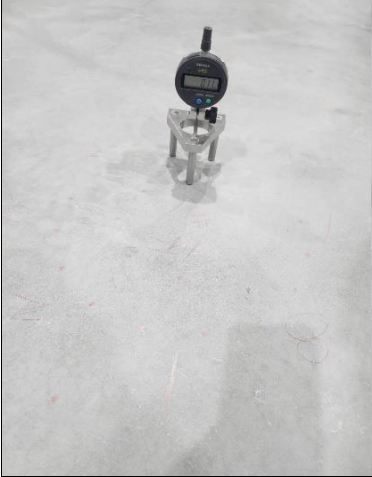
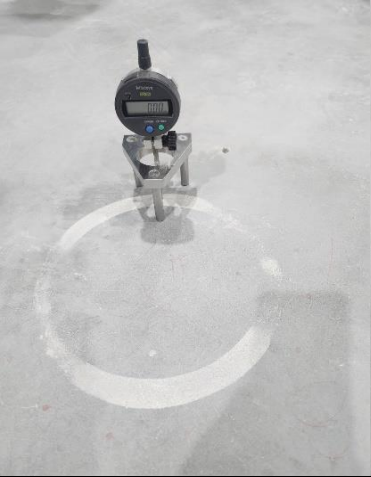
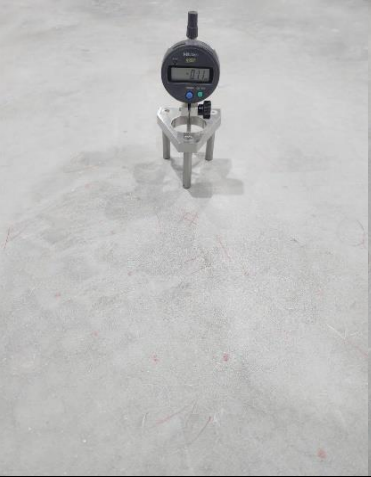
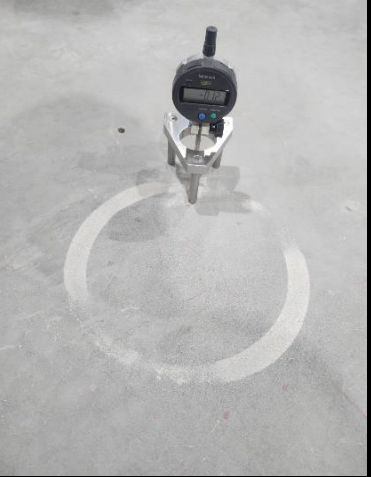
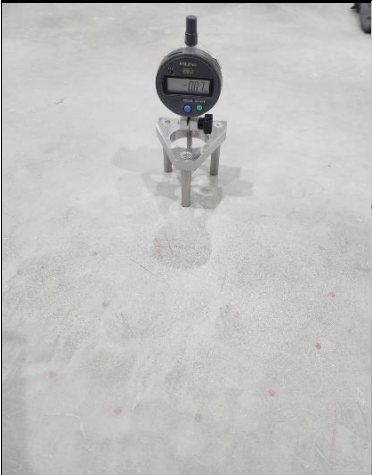
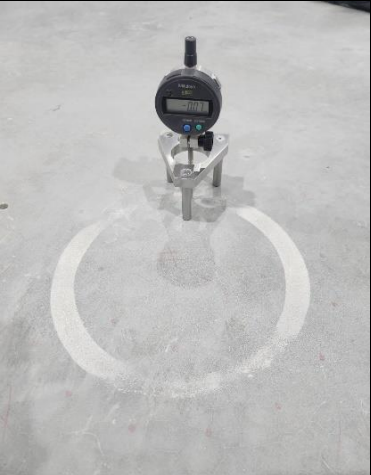
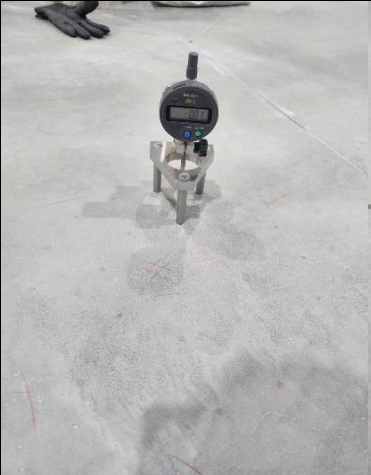
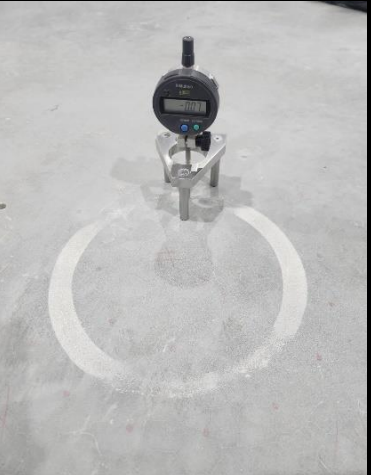
## Abrasion Testing Record Sheet

Point : 1			
		Before : 0.00			
		After : -0.21			
	Point : 8		Point : 2		
	Before : -0.01		Before : -0.01		
	After : -0.22		After : -0.01		
Point : 7				Point : 3	
Before : -0.07				Before : -0.05	
After : -0.07				After : -0.06	
	Point : 6		Point : 4		
	Before : -0.11		Before : 0.03		
	After : -0.12		After : -0.17		
		Point : 5			
		Before : 0.09			
		After : 0.00

Point Number	Difference (mm)	Average Difference (mm)	
1	-0.21	$\frac{-0.73}{8} = \underline{0.091} \quad \text{PASS}$	
2	0.00		
3	-0.01		
4	-0.20		
5	-0.09		
6	-0.01		
7	0.00		
8	-0.21

JOB AREA :	1F #1	Machine Serial Number :	100588
DATE :	2024-03-05	SURVEYOR :	최동현
1 BEFORE	1 AFTER	2 BEFORE	2 AFTER

3 BEFORE	3 AFTER	4 BEFORE	4 AFTER

JOB AREA :	1F #1	Machine Serial Number :	100588
DATE :	2024-03-05	SURVEYOR :	최동현
5 BEFORE	5 AFTER	6 BEFORE	6 AFTER

7 BEFORE	7 AFTER	8 BEFORE	8 AFTER

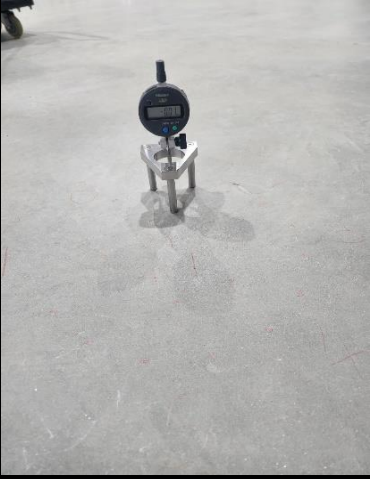
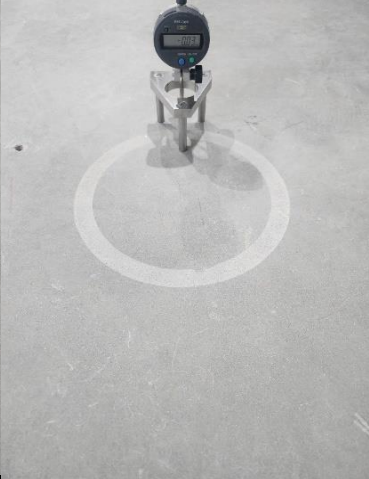
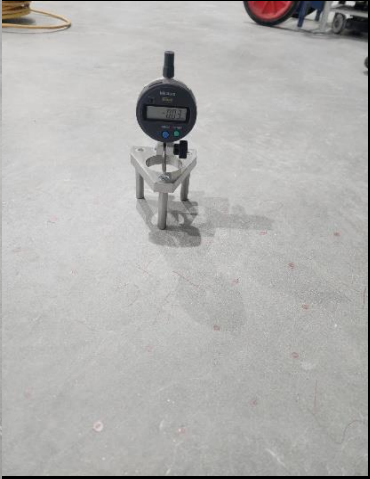
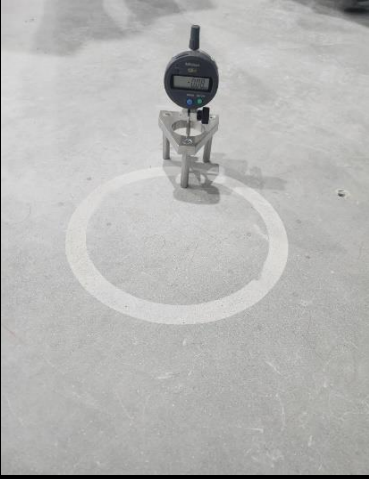
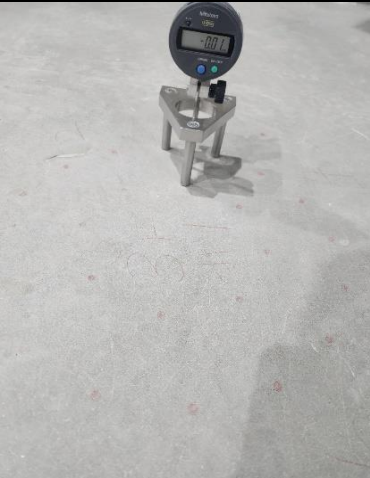
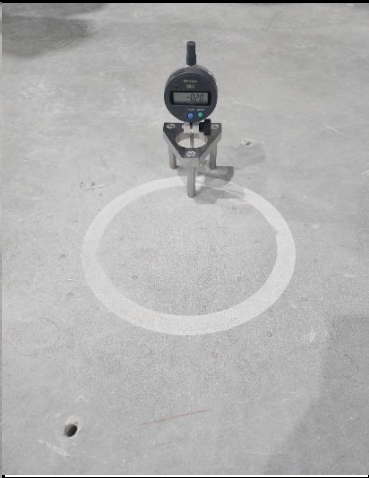
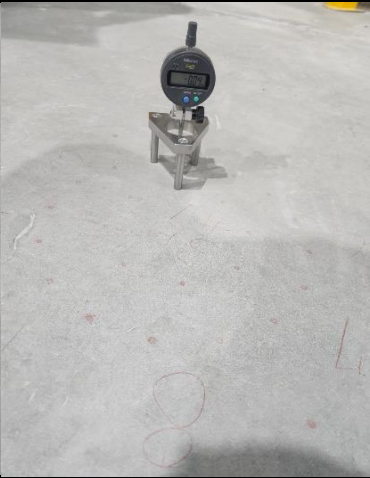
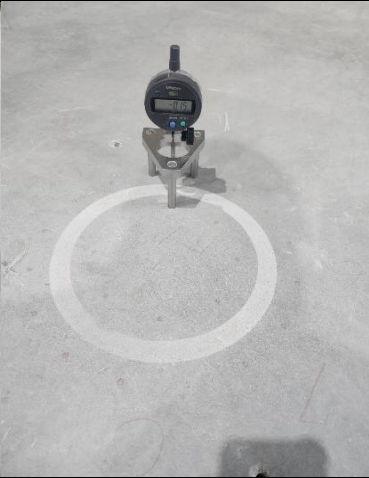
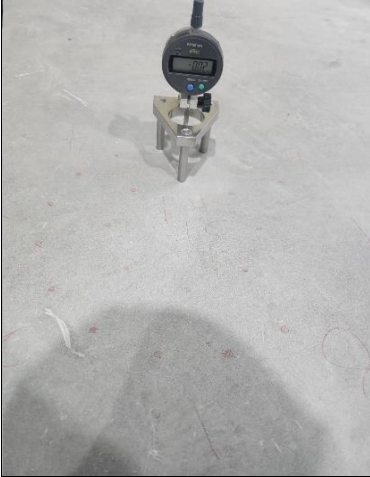
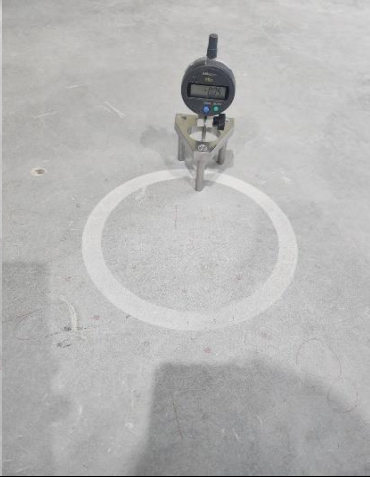
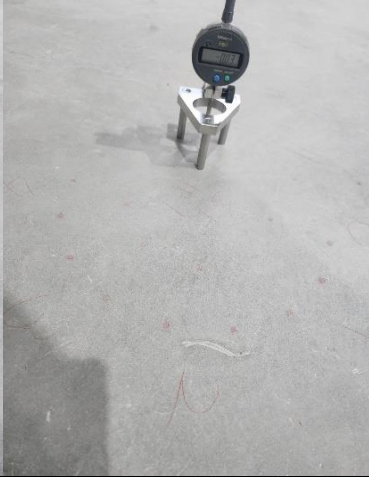
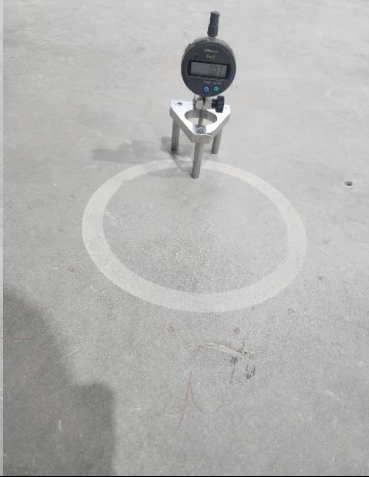
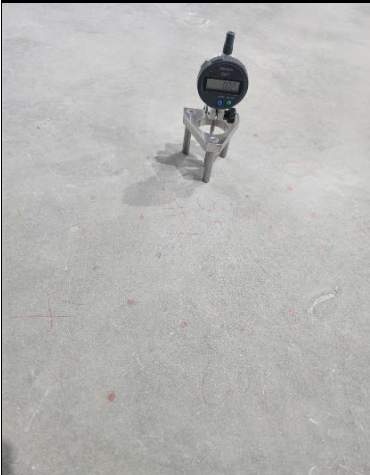
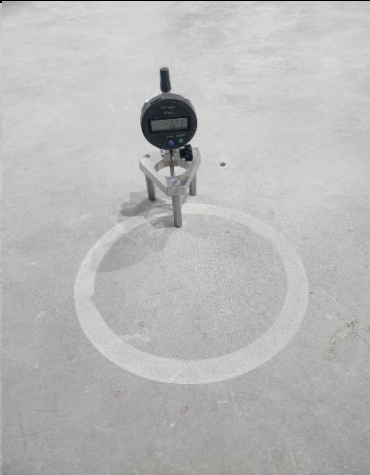
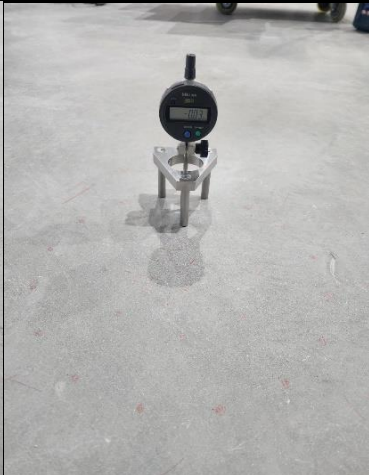
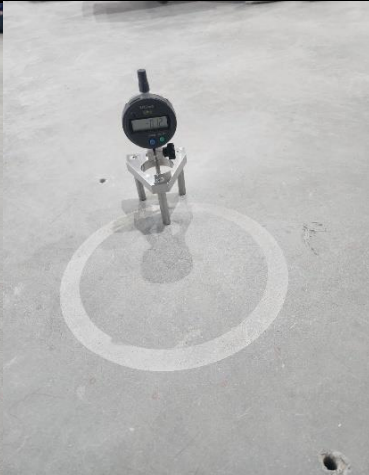
# Abrasion Testing Record Sheet

Point : 1		
		Before : -0.01		
		After : -0.03		
	Point : 8		Point : 2	
	Before : -0.03		Before : -0.03	
	After : -0.90		After : -0.08	
Point : 7				Point : 3
Before : -0.02				Before : -0.01
After : -0.21				After : -0.19
	Point : 6		Point : 4	
	Before : -0.03		Before : -0.04	
	After : -0.07		After : -0.11	
		Point : 5		
		Before : -0.02		
		After : -0.05

Point Number	Difference (mm)	Average Difference (mm)
1	-0.02	$\frac{-1.45}{8} = \underline{0.181} \quad \text{PASS}$
2	-0.05	
3	-0.18	
4	-0.07	
5	-0.03	
6	-0.04	
7	-0.19	
8	-0.87

JOB AREA :	3F #1	Machine Serial Number :	100588
DATE :	2024-03-05	SURVEYOR :	최동현
1 BEFORE	1 AFTER	2 BEFORE	2 AFTER

3 BEFORE	3 AFTER	4 BEFORE	4 AFTER

JOB AREA :	3F #1	Machine Serial Number :	100588
DATE :	2024-03-05	SURVEYOR :	최동현
5 BEFORE	5 AFTER	6 BEFORE	6 AFTER

7 BEFORE	7 AFTER	8 BEFORE	8 AFTER

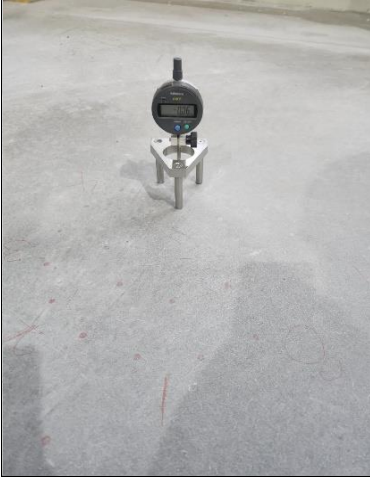
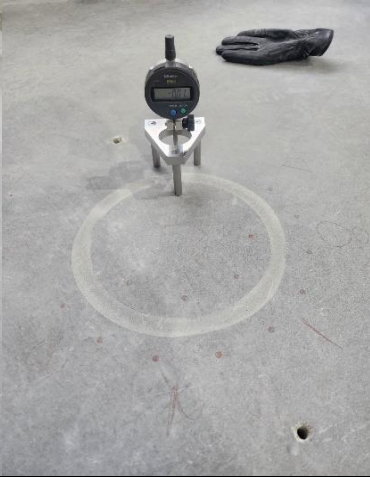
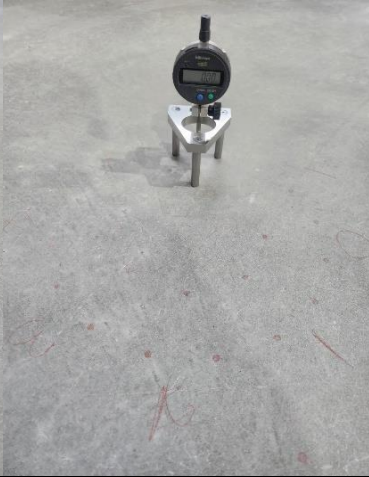
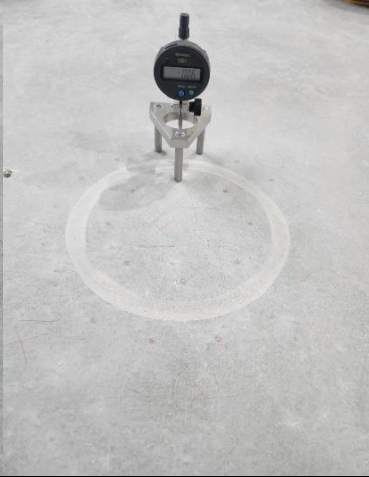
# Abrasion Testing Record Sheet

Point : 1		
		Before : 0.00		
		After : -0.04		
	Point : 8		Point : 2	
	Before : 0.02		Before : -0.01	
	After : 0.00		After : -0.02	
Point : 7				Point : 3
Before : 0.08				Before : 0.00
After : -0.06				After : -0.13
	Point : 6		Point : 4	
	Before : 0.00		Before : 0.02	
	After : -0.01		After : -0.02	
		Point : 5		
		Before : -0.02		
		After : -0.07

Point Number	Difference (mm)	Average Difference (mm)
1	-0.04	$\frac{-0.44}{8} = \underline{0.055} \quad \text{PASS}$
2	-0.01	
3	-0.13	
4	-0.04	
5	-0.05	
6	-0.01	
7	-0.14	
8	-0.02

JOB AREA :	4F #1	Machine Serial Number :	100588
DATE :	2024-03-05	SURVEYOR :	최동현
5 BEFORE	5 AFTER	6 BEFORE	6 AFTER
