<h1>INSPECTION REPORT</h1>	Reference No. : <b>GTS 2025 107806 0008</b>
		Page 1 / 4

<b>Applicant</b>	QINGDAO HENGER SHIPPING SUPPLIES CO.LTD.
<b>Commodity</b>	Donut fender, D2.03*L2.4M
<b>Quantity</b>	18 set
<b>Place of Inspection</b>	Jimo, Qingdao City, Shandong Province, China
<b>Inspection Date</b>	2025/09/24
<b>Inspector</b>	Kevin Tang
<b>Issued By</b>	Bureau Veritas Bivac Asian CRE (Shanghai) Inspection Co., Ltd
<b>Issued Date</b>	2025/09/24
<b>Type of Inspection</b>	<input checked="" type="checkbox"/> Physical Inspection <input type="checkbox"/> Remote Inspection
<b>Sampling Plan</b>	18set
<b>Scope of Inspection</b>	A. Storage Condition B. Visual Quality C. Quantity & Packing D. Dimension
<b>Declared Commercial Document Information by Applicant</b>	N/A

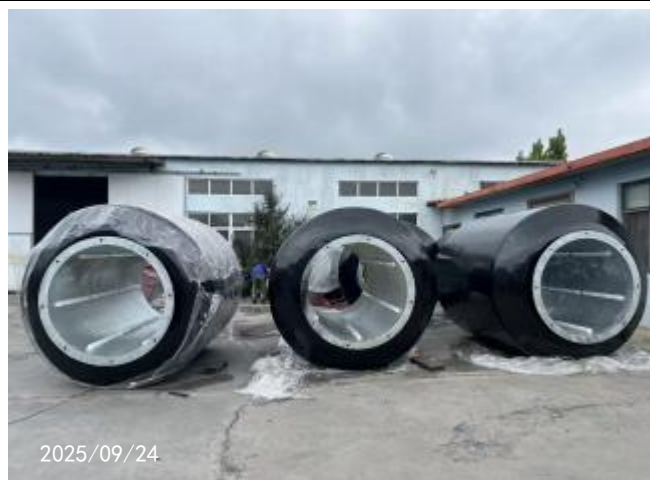
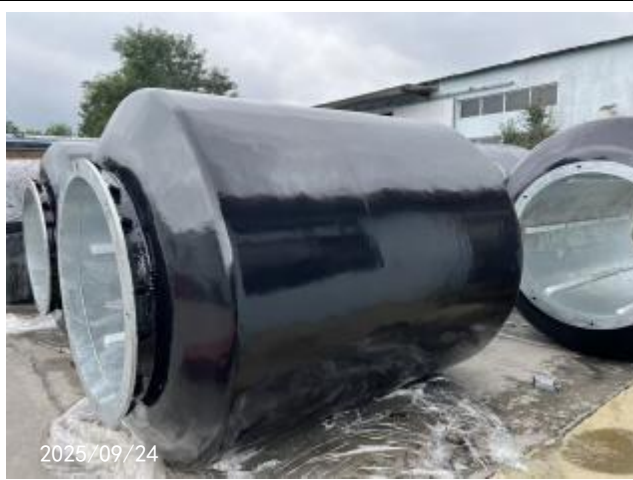
### A. Storage Condition

At time of our attendance, the above mentioned consignments were found to be stored in the open yard of factory.

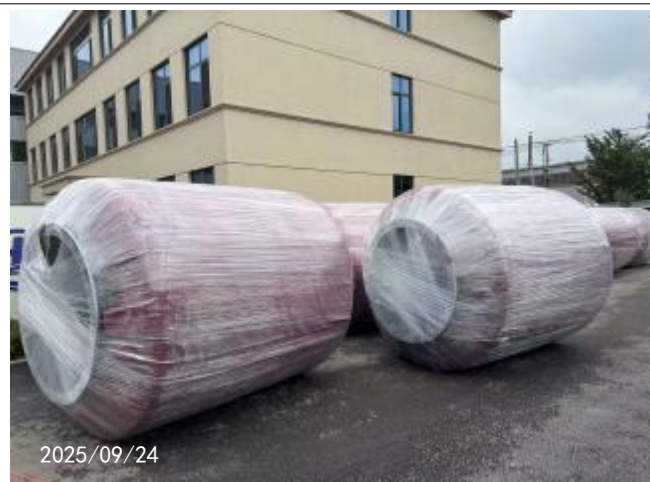
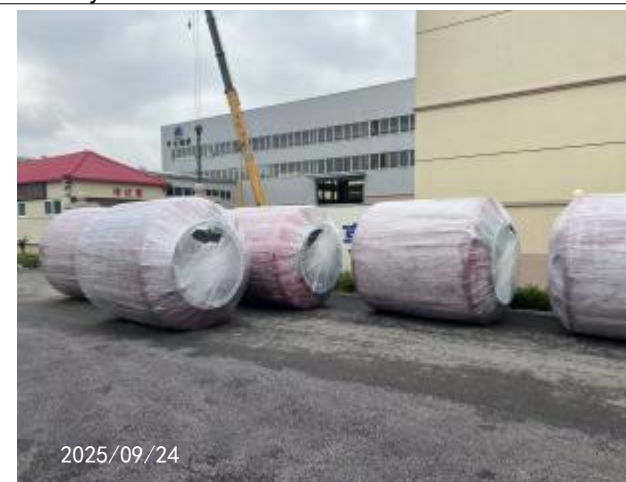
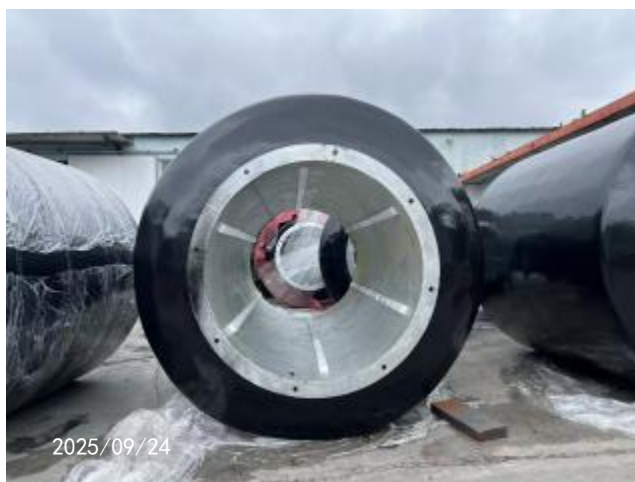
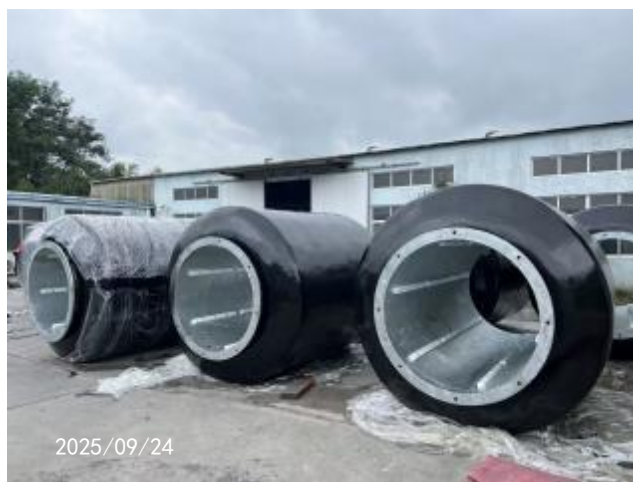
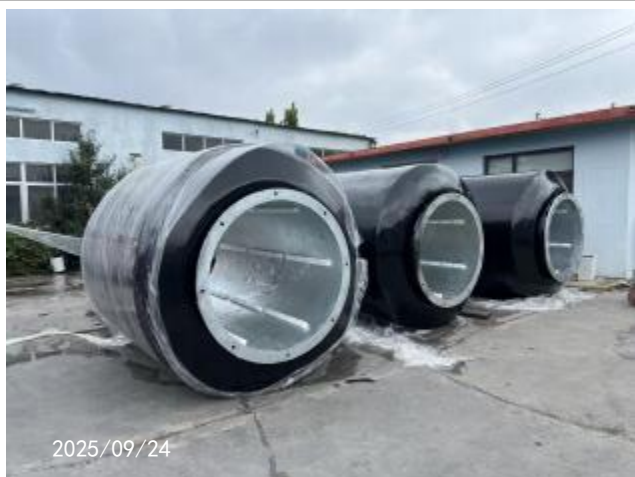
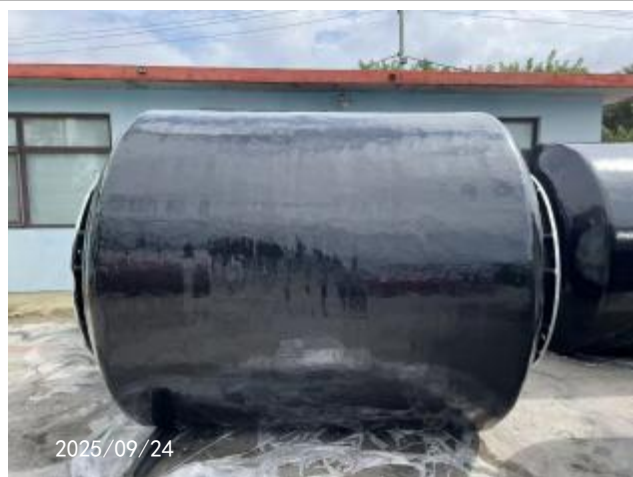
### B. Visual Quality

BV inspector found the above mentioned 1 piece of fender was in normal condition without obviously damages and scratches.

According to client's requirement, the above mentioned 18pcs fenders, BV inspector found the fenders in normal condition without damage and scratches.

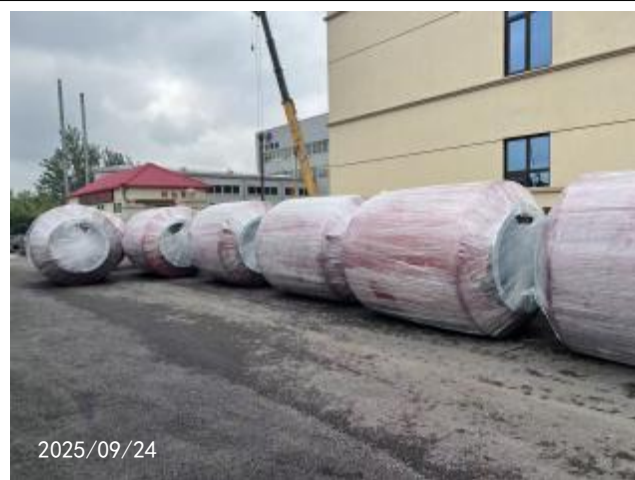
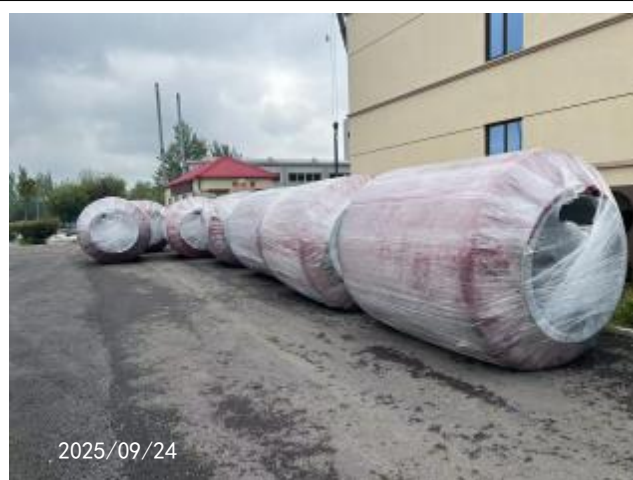
## C. Quantity & Packing

After verify the circumstance of inspection site, BV inspector checked the quantity and found the total quantity was complied with the packing list provided by client.

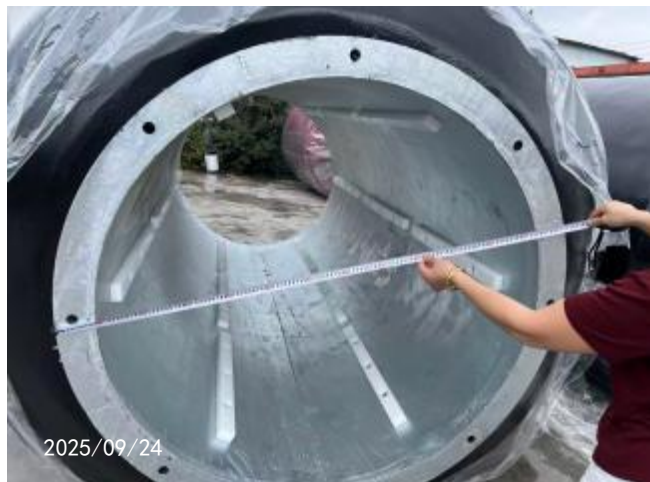
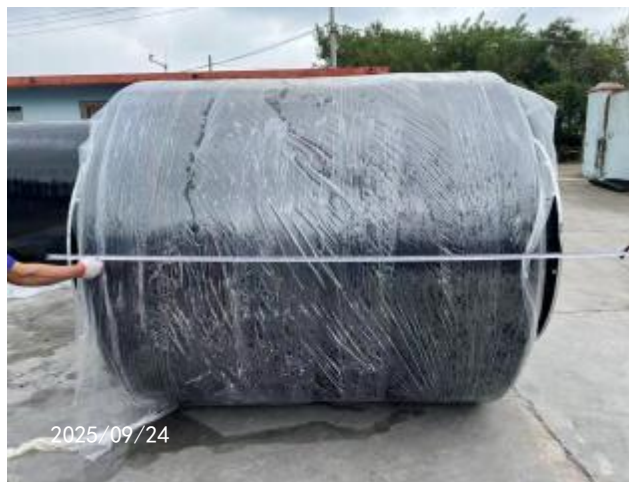
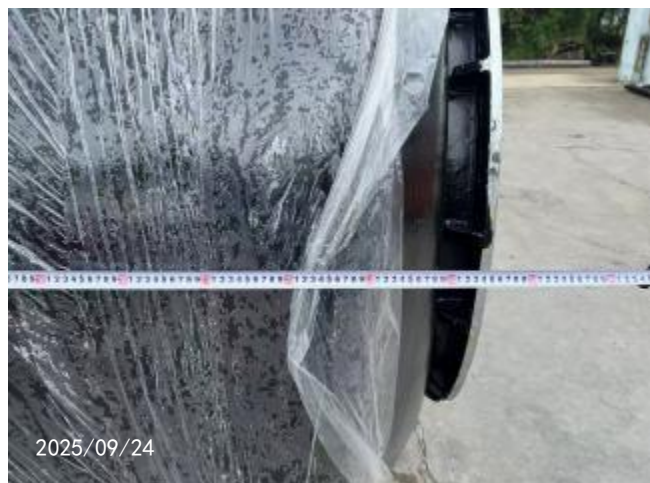
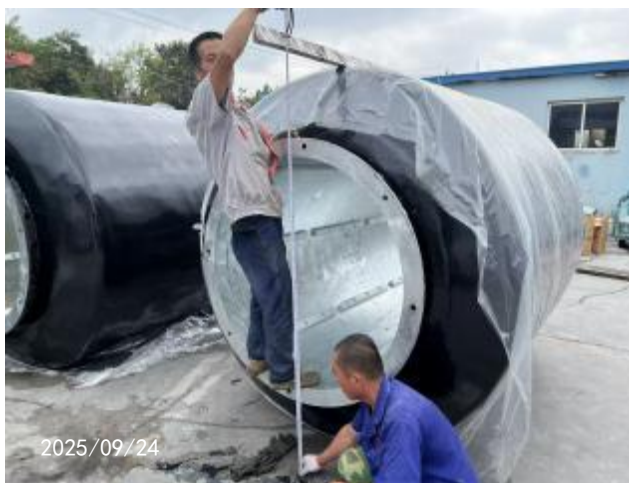
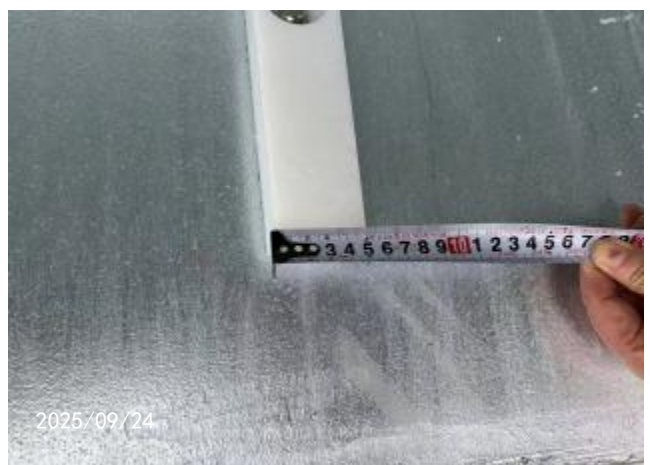
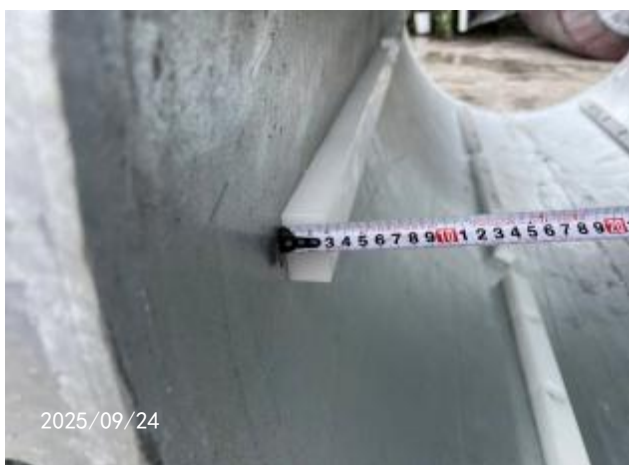
## D. Dimension

Fender Size: D2.03 X L2.4			
1	2.02		2.42
2	2.03		2.46
3	2.03		2.44

The measurement tools were provided by the factory without the calibration certificate, and the measurement was done approximately as shown in pictures hereunder. The result was for reference only.
