2015 Audi A4 Sedan (8K2) L4-2.0L Turbo (CAED)

FRENOS - INDICADOR DE DESGASTE DE PASTILLAS DE FRENO ENCENDIDO, PASTILLAS POR ENCIMA DEL LÍMITE DE DESGASTE

46 15 05

2038056/2

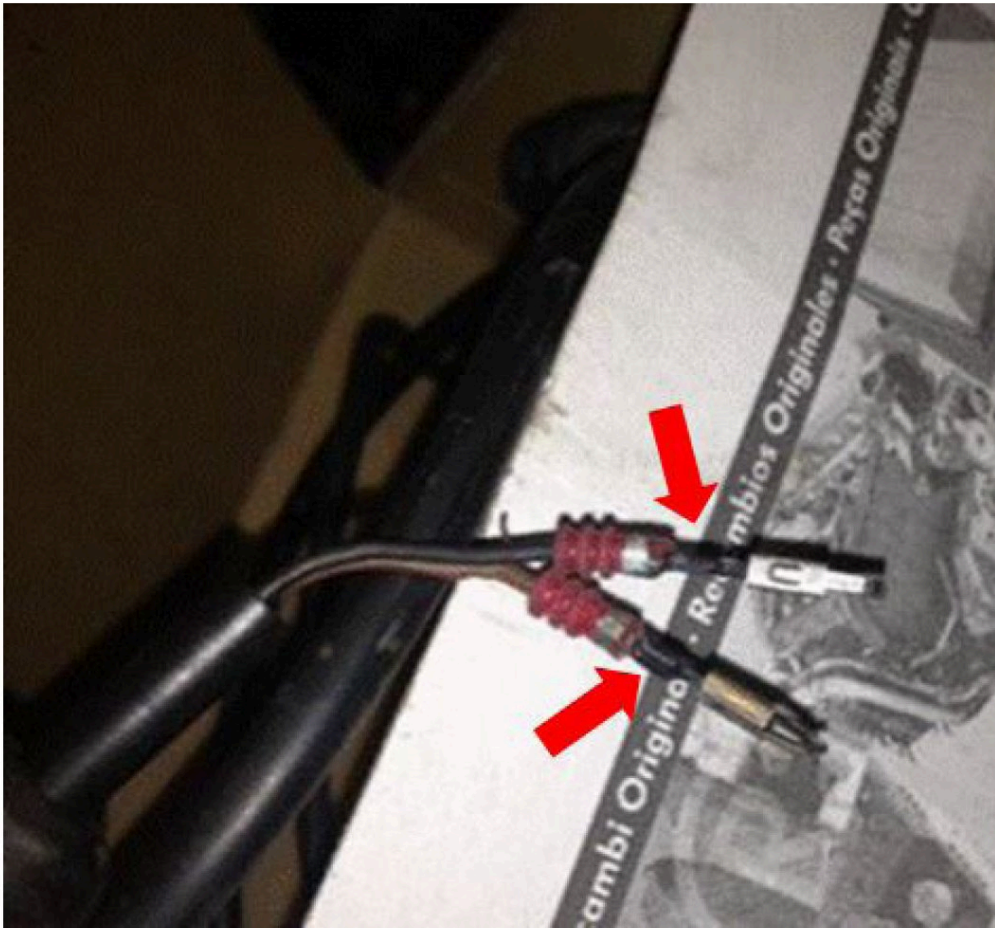
Reemplaza el Boletín de servicio técnico Grupo 46 número 14-94 de fecha 11 de agosto de 2014 por las razones que se enumeran a continuación. Información del vehículo Estado Antecedentes técnicos La entrada de agua en la carcasa del conector del indicador de desgaste de las pastillas de freno puede provocar la oxidación de las clavijas. Esta oxidación puede aumentar la resistencia de contacto en el conector, lo que puede generar la advertencia Solución de producción No aplicable. Servicio 1. Desconecte el conector eléctrico del indicador de desgaste de las pastillas de freno (en el arnés). Use VAS 1978 B para quitar ambas clavijas del conector lateral del arnés. 2. Si hay corrosión presente en las clavijas (depósitos negros) (Figura 1), reemplace el indicador de desgaste de las pastillas de freno afectado y el arnés de cableado para el sensor de velocidad y el indicador de desgaste de las pastillas de freno (consulte ETKA). Garantía Información adicional Todas las piezas y referencias de servicio proporcionadas en este TSB (2038056) están sujetas a cambios y/o eliminación. Consulte siempre el departamento de repuestos y los manuales de servicio para obtener la información más reciente.

Figure 1. Corrosion (black deposits) on connector pins.
