Andora "D" Building Sewer

22817 LAKEVIEW DR

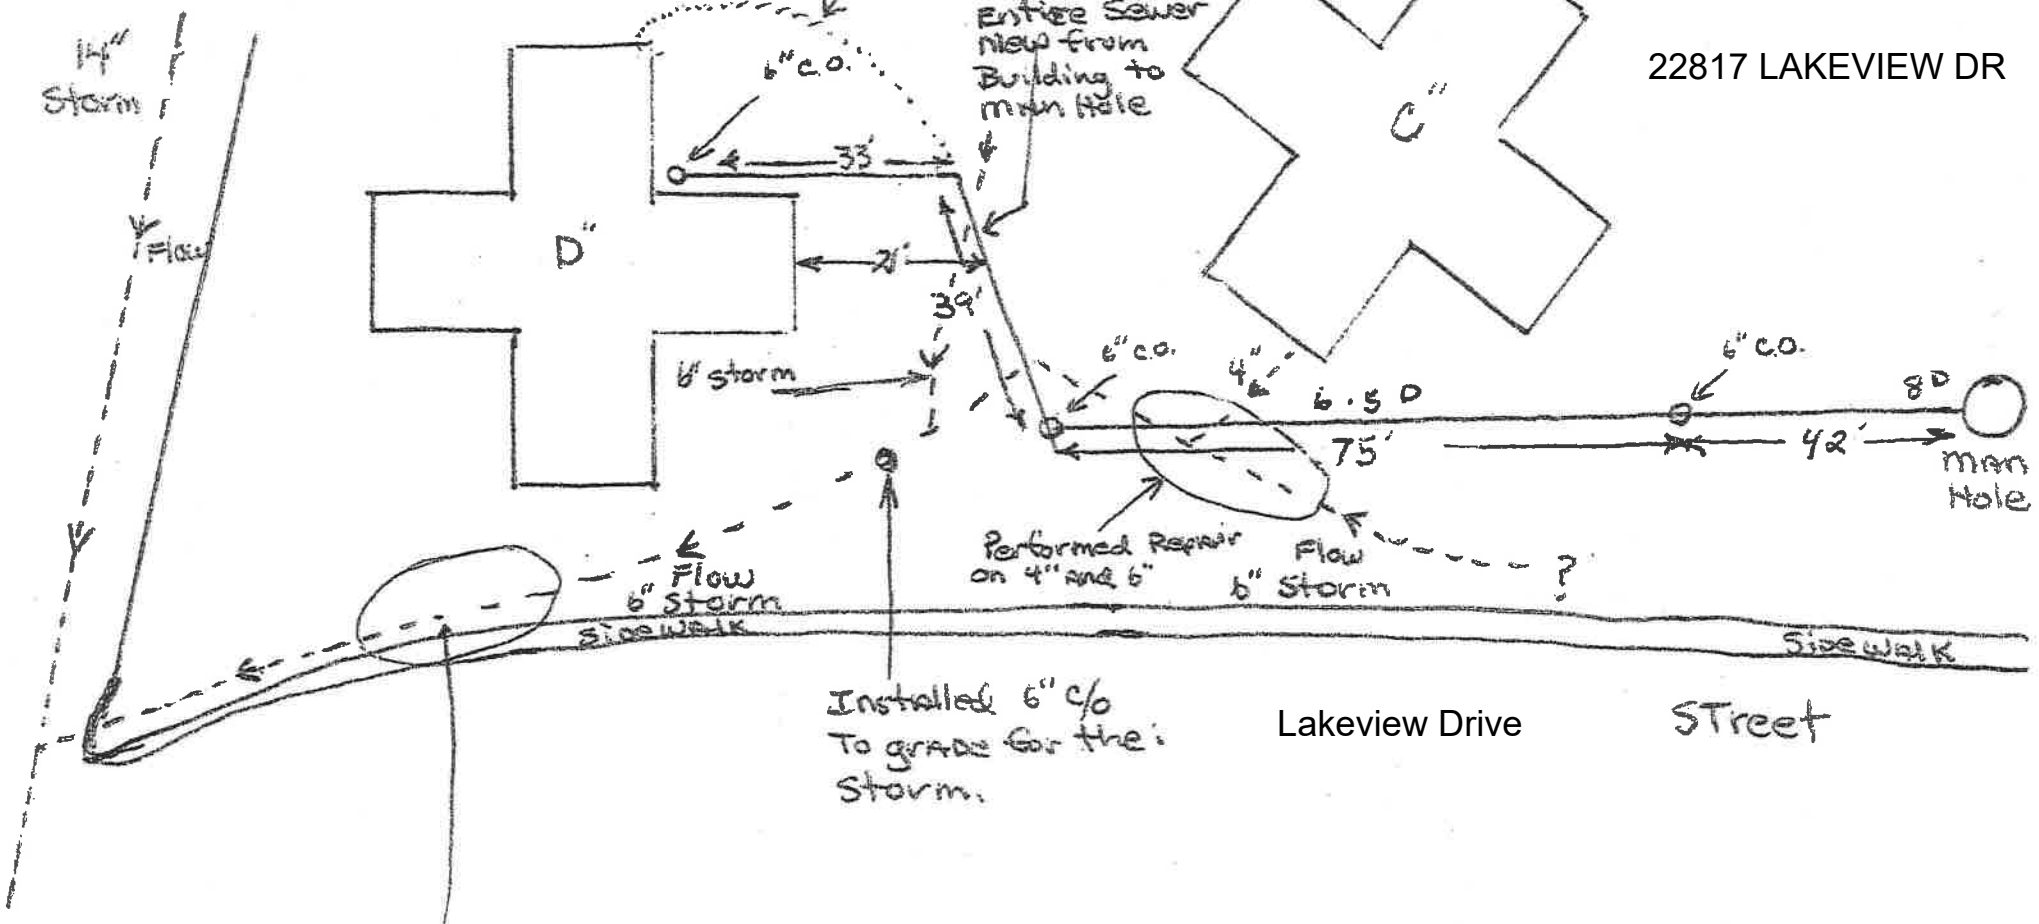
Performed Repair on 6" collapsed Pipe. And Cleared line of rocks and Dirt. This storm line has been Damaged for a considerable Amount of Time.

The new sewer has $\frac{1}{8}$ " per ft Drop on the run, or flat the entire length of the sewer.

All clean outs have a meter Box installed over them. Per City.
