Installation Monitoring Report

Date: May 5, 2025

Project	NW 2050 Cypress Point	Job Number	24064	RGC Number	N/A
Address	7511, 7531, 7651 Minoru Boulevard Richmond, B.C.	Inspector	Matt	Report Number	01
		Weather	Sun/16°C	Time	1:30pm
Contractor	Flynn Canada Ltd.	Crew Size	7	Red Seal	3
				Apprentices	2

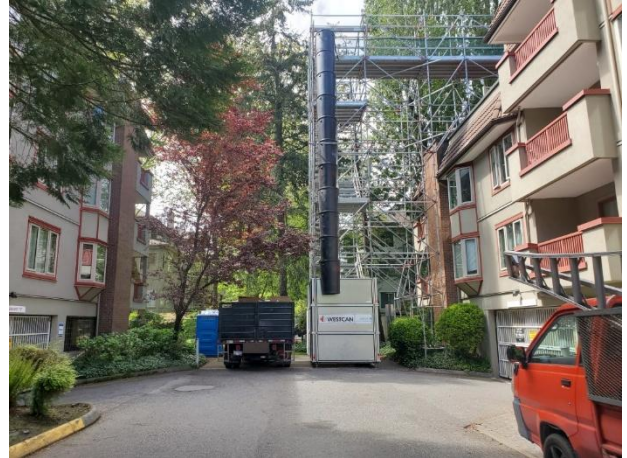
1.1 **Building B**

Scaffolding tower is set in place at the Southwest corner on noted building.

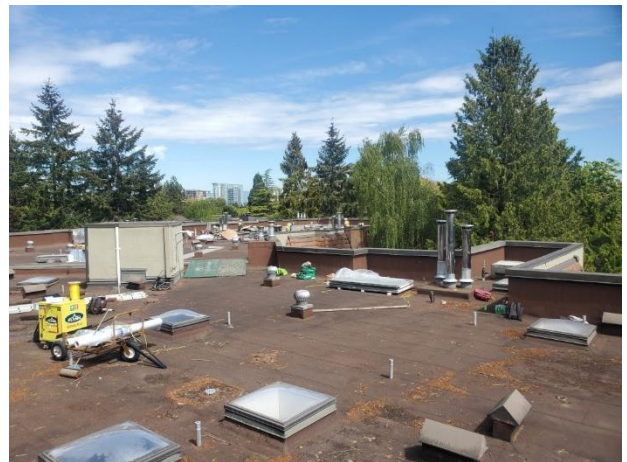
1.2 **Building B**

Crew have begun application on the Northeast corner of the noted building.

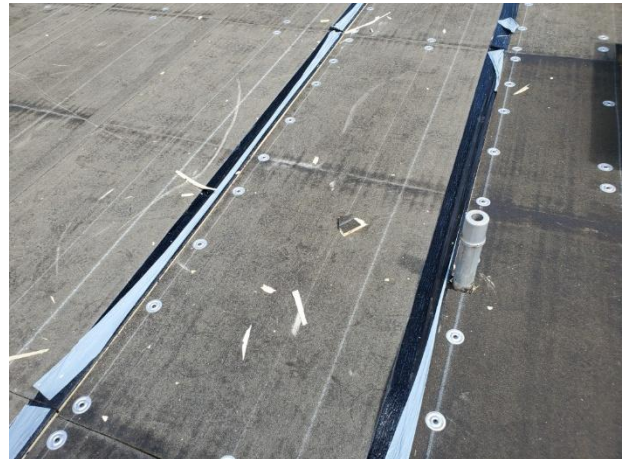
1.3 **Building B**

The specified Soprema 2 in 1 smartboard sanded with 1/2" HD is on site and being applied in place.

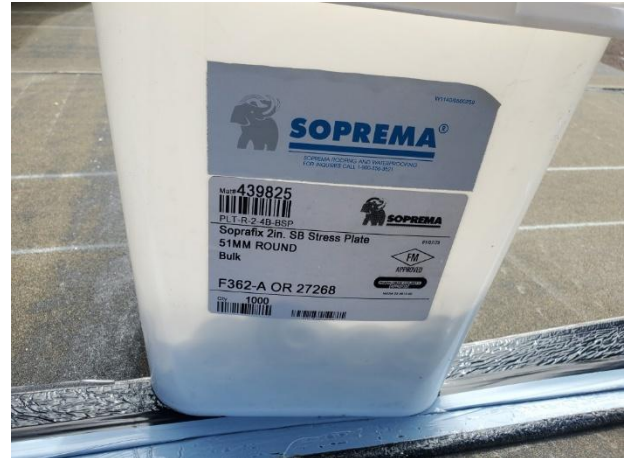
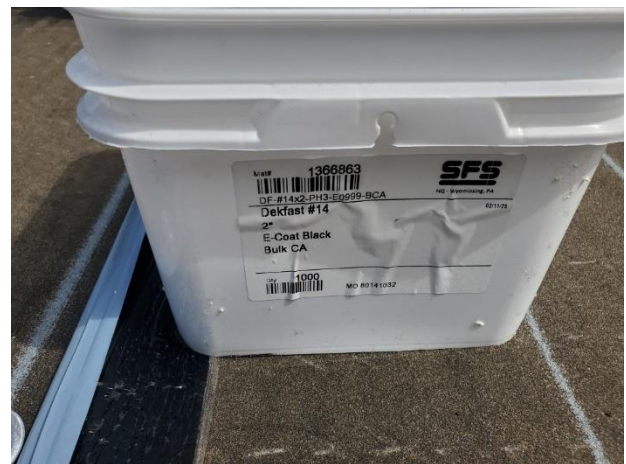
1.4 **Building B**

Approved manufacturers 2" barbed seam plates and #14 2" Dek fast screws are being used to secure the 2 in 1 smart p board.

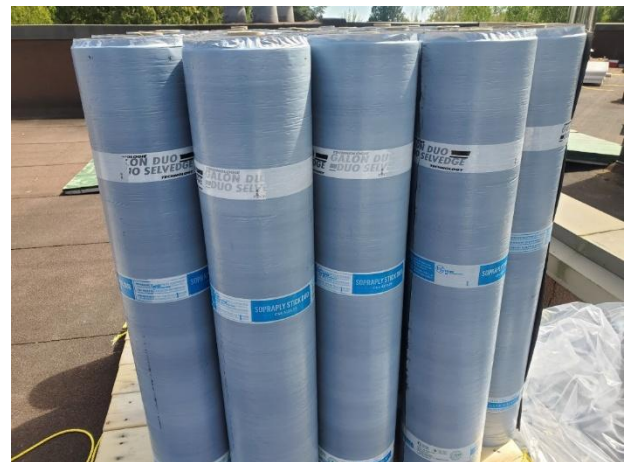
1.5 **Building B**

Sopraply Stick DUO cold applied base membrane is on site to be applied as independent base stripping and base membrane target patches at vents.

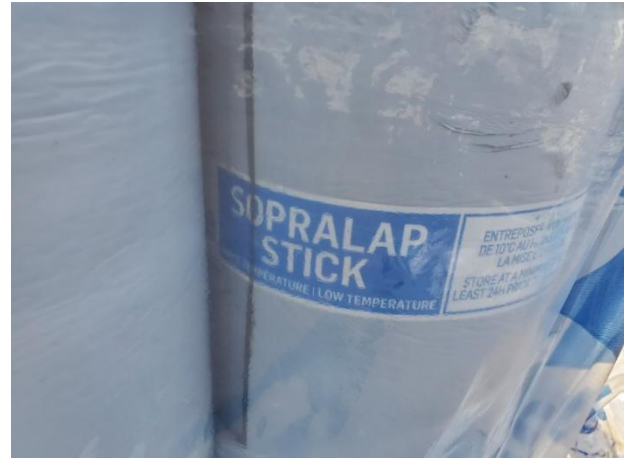
1.6 **Building B**

The 12" SopraLap stick is on site to be applied over the end joints of the 2n1 smart board. This is acceptable.

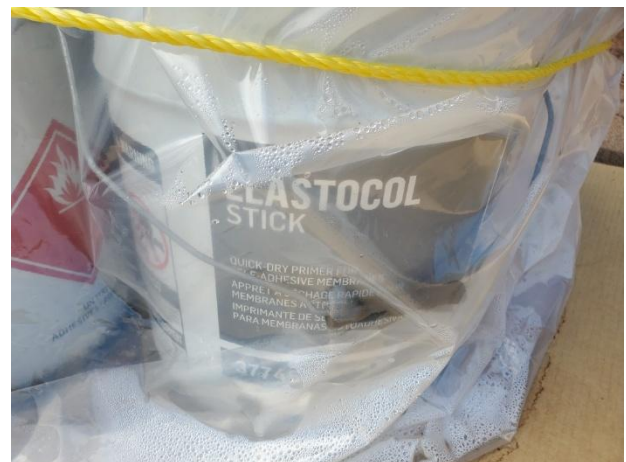
1.7 **Building B**

The membrane manufacturer approved Elastocol stick adhesive primer is on site for the base layer applications and wall details.

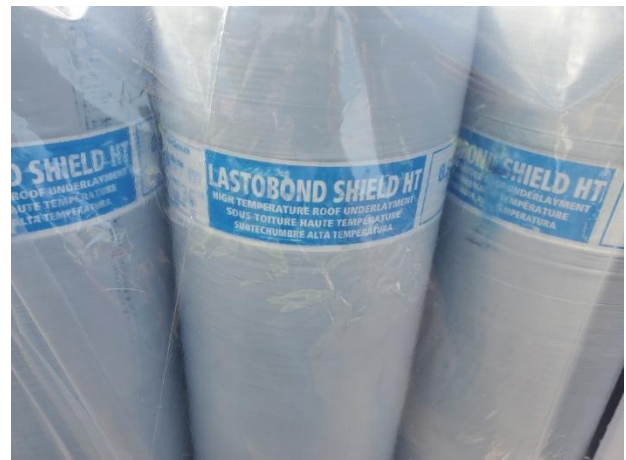
1.8 **Building B**

An approved high temp self-adhering membrane to be applied on the high parapet walls is on site.

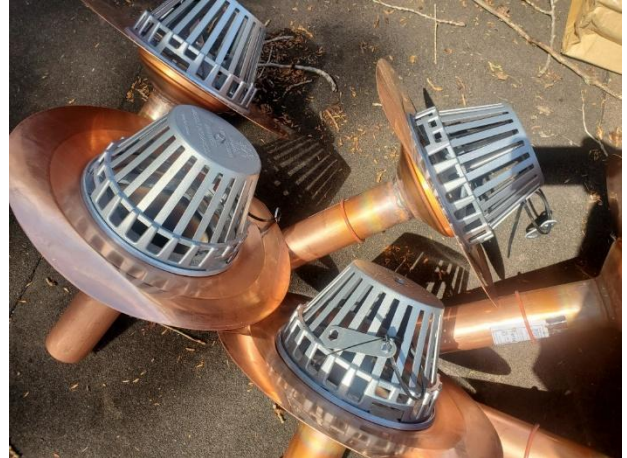
1.9 **Building B**

The 3" copper spun bowl drains with integral clamping rings are on site to be installed at drain sump locations.

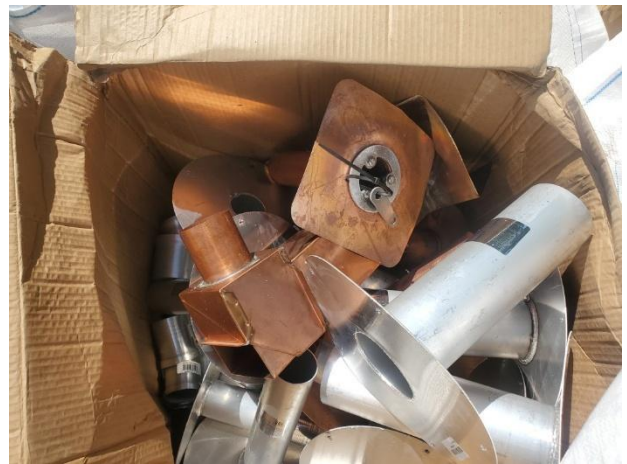
1.10 **Building B**

Approved roofing components and protrusion flashing are on site to be applied.

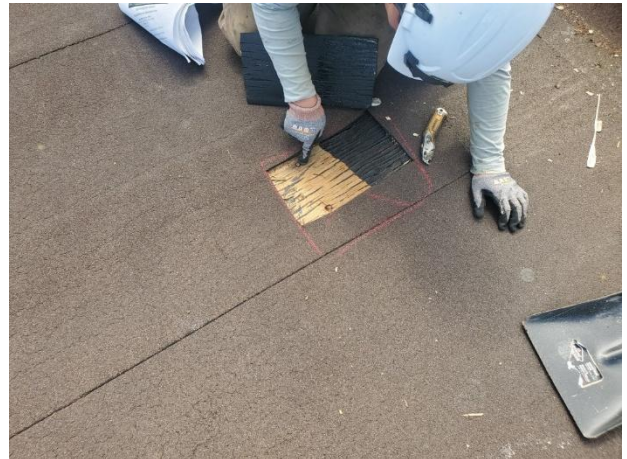
1.11 **Building B**

The roofing contractor is cutting out blisters and checking locations for deterioration.

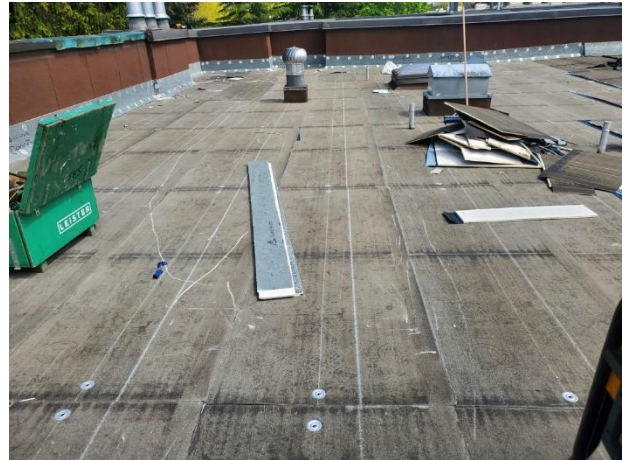
1.12 **Building B**

The Soprema 2 in 1 smartboard sanded is being laid out in a uniform manner. Seams and end lap cover strips remain detailed.

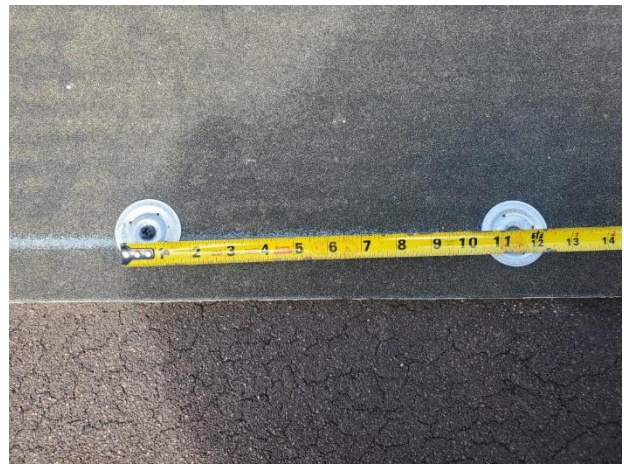
1.13 **Building B**

Screw and plate placement, found meeting the wind-up lift calculations.

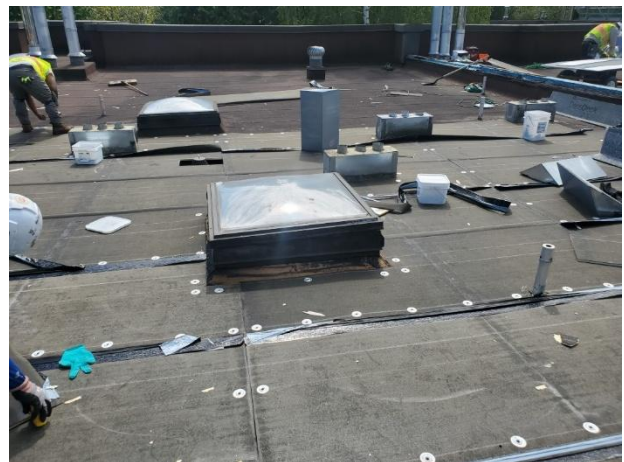
1.14 **Building B**

Membrane has begun to be removed from the base and sides of skylight curbs as per spec.

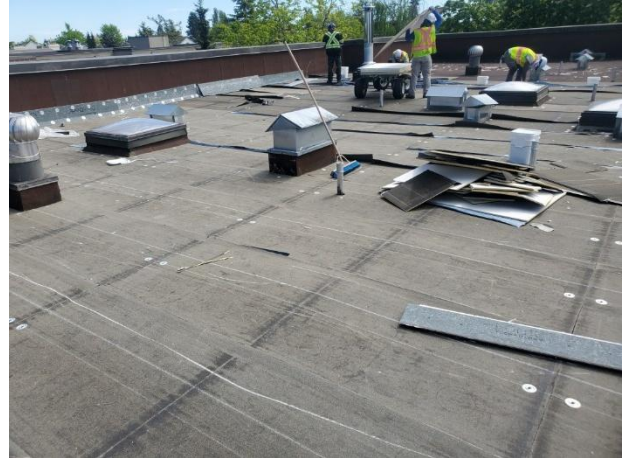
1.15 **Building B**

Vent curb details remain to be removed and detailed as per specifications.

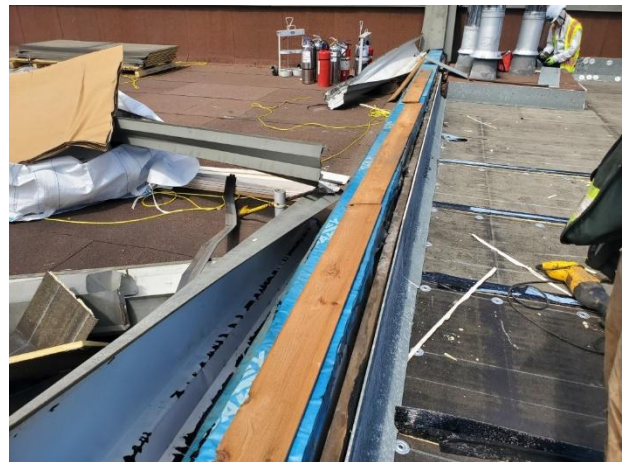
1.16 **Building B**

Fire wall detail discussed with foreman.
