Installation Monitoring Report

Date: May 9, 2025

| Project | NW 2050 Cypress Point | Job Number | 24064 | RGC Number | N/A |
| Address | 7511, 7531, 7651 Minoru Boulevard Richmond, B.C. | Inspector | Matthew | Report Number | 03 |

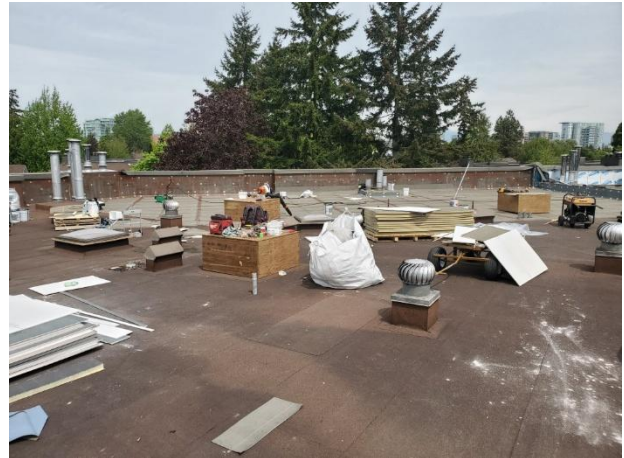
3.1 **Building B**

Crew have begun to lay out the Soprema 2n1 smartboard sanded with ½" HD ISO board along the North side on the center section of the roof.

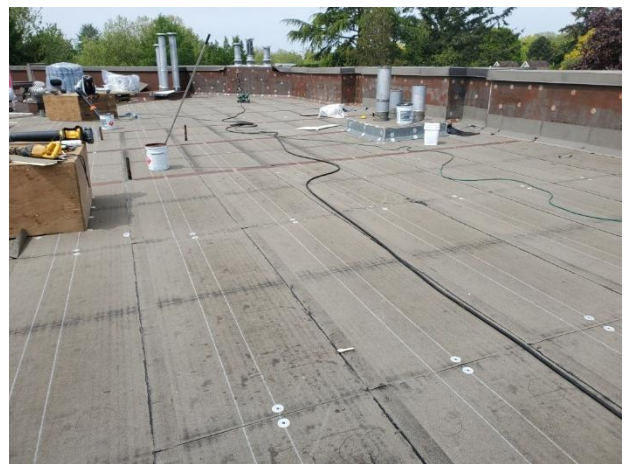
3.2 **Building B**

Overlay board is being secured with the 2" Barded seam plates and 2" #14 dek fast screws to the wind uplift pattern provided by the material manufacturers application instructions.

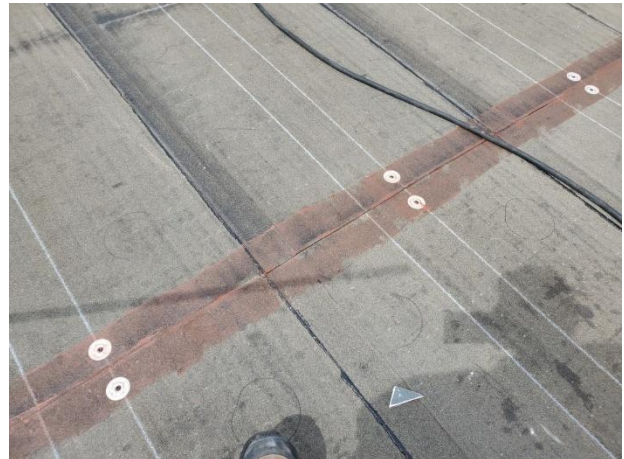
3.3 **Building B**

End joints are butted together and primed with an Elastocol adhesive stick primer to allow for 12" sopra lap to be applied.

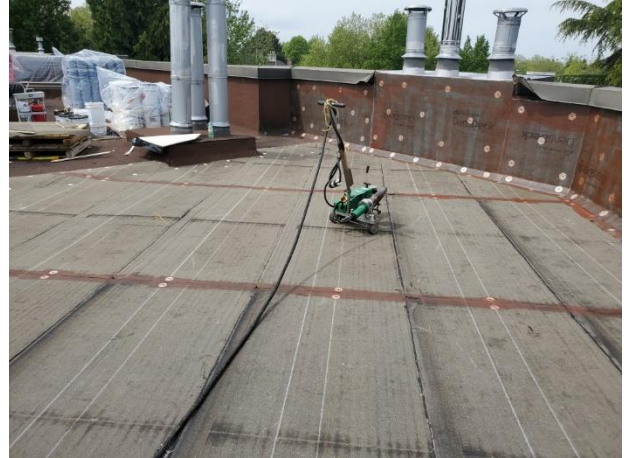
3.4 **Building B**

Seams are being heat welded closed with robot and held welders.

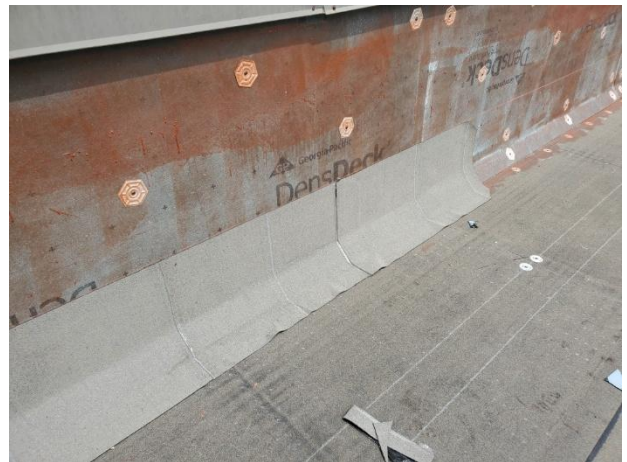
3.5 **Building B**

Sopraply stick DUO is being rolled into primed surfaces and seams welded closed.

Adhesion appears acceptable.

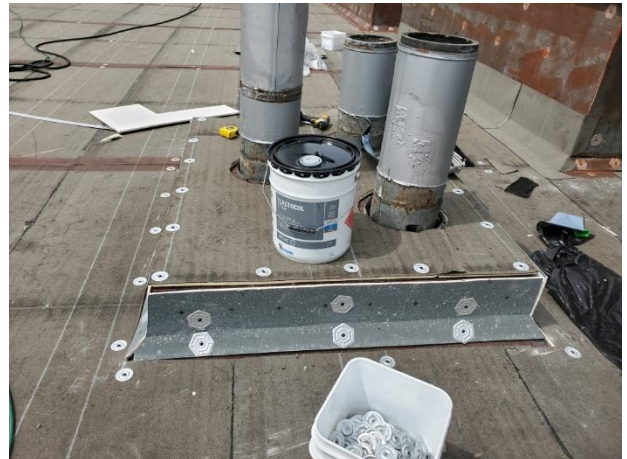
3.6 **Building B**

Multiple protrusion details are being worked on as per specifications.

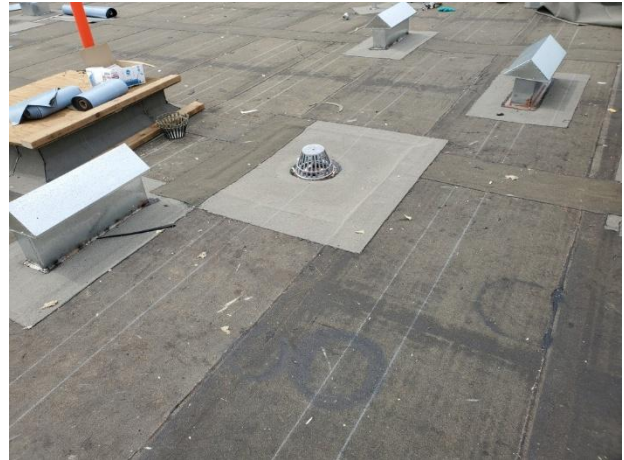
3.7 **Building B**

In the East roof section, protrusion details are being worked on.

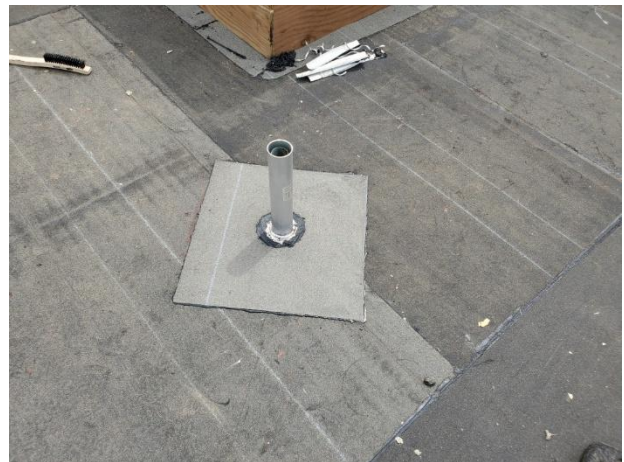
3.8 **Building B**

Aluminum pipe flashing is being fitted around the plumbing exhaust vents and roofed in with a patch of Sopraply stick DUO membrane.

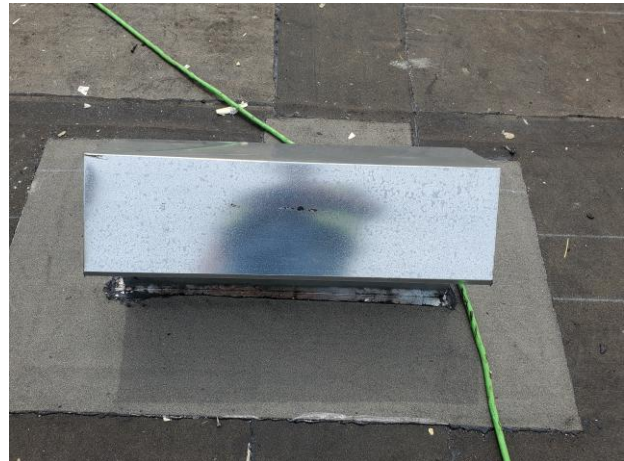
3.9 **Building B**

BUR vents are being applied around the dryer exhaust vents, insulation and vent details remain to be completed.

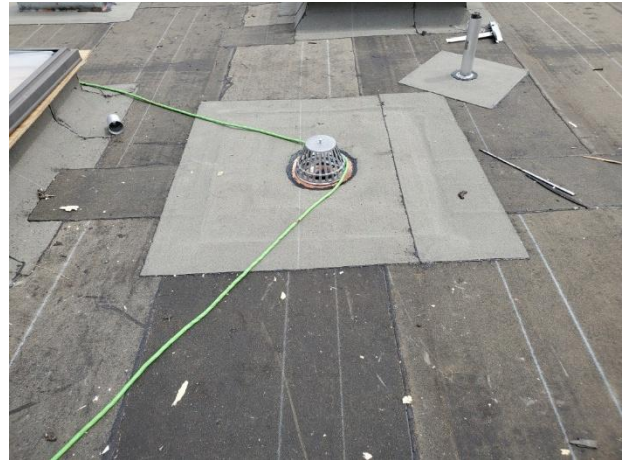
3.10 **Building B**

A 3' x 3' drain sump is being created prior to 3" spun copper clamping drains are being installed.

Foreman indicated the Furnco mechanical connections are in place at the outflow pipe.

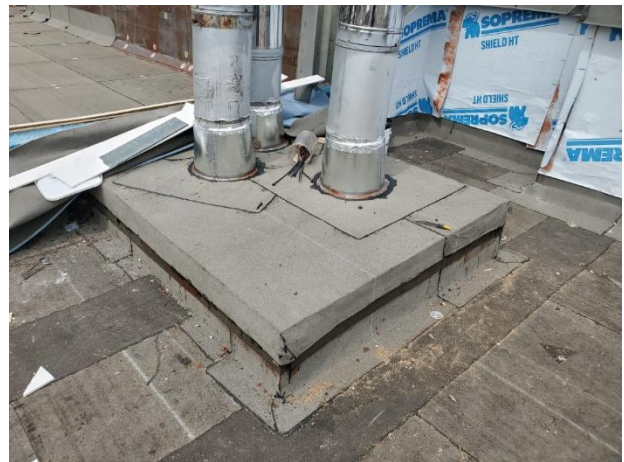
3.11 **Building B**

Previously noted deflection at the curb detail has been corrected.
