## Installation Monitoring Report

Date: July 23, 2025

<b>Project</b>	NW 2050 Cypress Point	<b>Job Number</b>	24064	<b>RGC Number</b>	53216
<b>Address</b>	7511, 7531, 7651 Minoru Boulevard Richmond, B.C.	<b>Inspector</b>	Matthew	<b>Report Number</b>	27
		<b>Weather</b>	Sun / 26°C	<b>Time</b>	10:30amm
<b>Contractor</b>	Flynn Canada Ltd.	<b>Crew Size</b>	16	<b>Red Seal</b>	6
				<b>Apprentices</b>	8

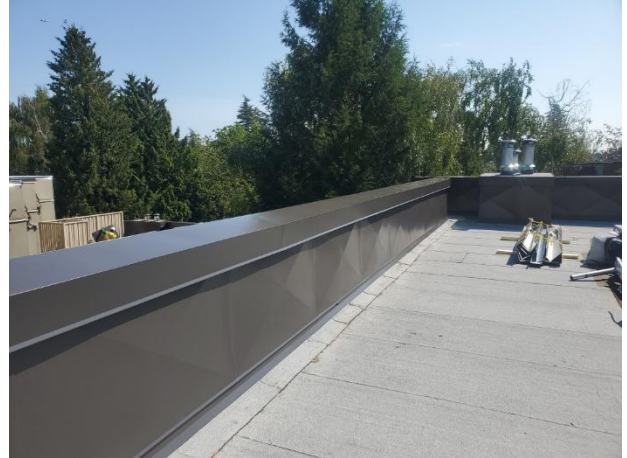
### 27.1 **Building C**

Installation of the 24ga cap and cross panel flashing continues on the main roof parapet walls.

Interior securement with color matching cladding screws and plastic standoffs to allow for the wall ventilation remains to be applied.

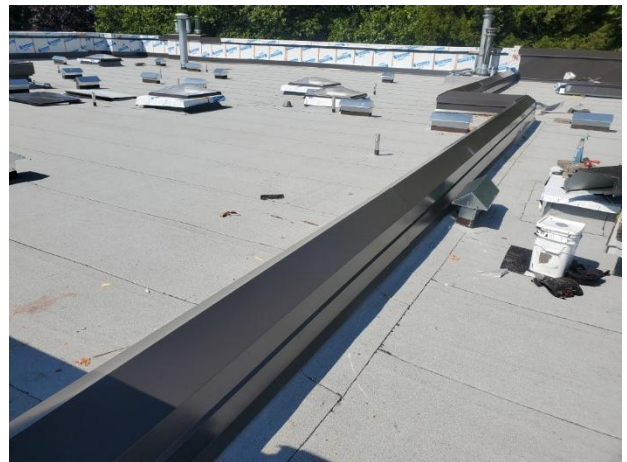
### 27.2 **Building C**

The fire wall flashing detail has been completed, foreman provided pictures showing the galvanized metal offset under the top capping.

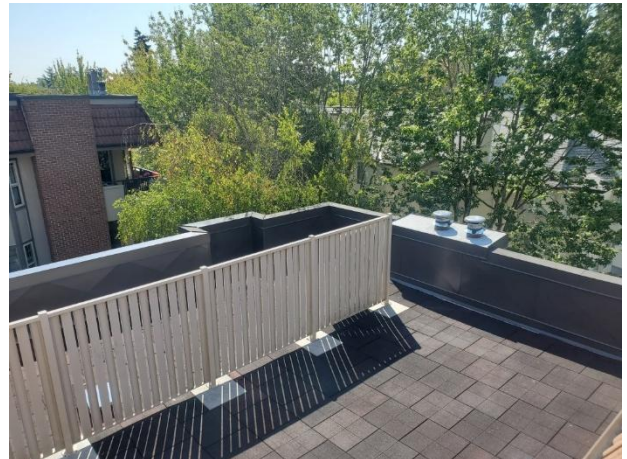
### 27.3 **Building C**

The flashing and privacy screens on the lower decks are nearly completed.

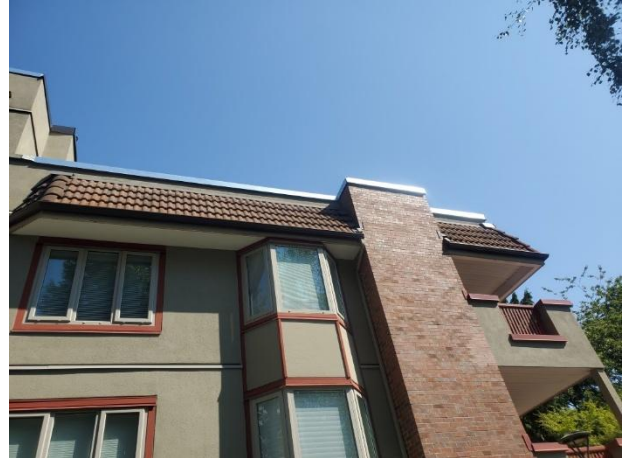
#### 27.4 **Building B**

A continuous 24ga wind clip is being applied to the parapet tops.

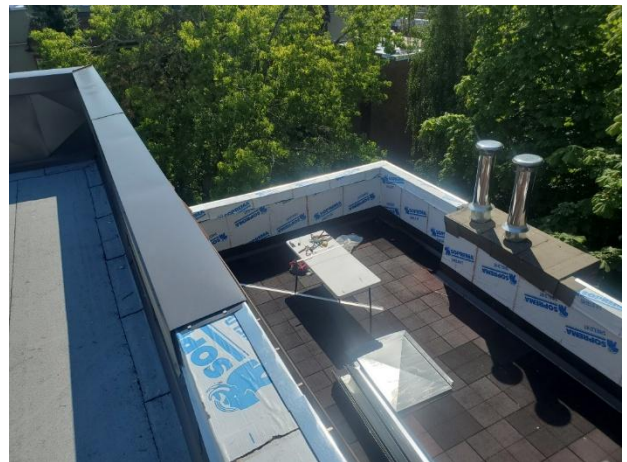
#### 27.5 **Building B**

Cap flashing is being hooked onto the wind clips and secured with pan head screws at s-lock details.

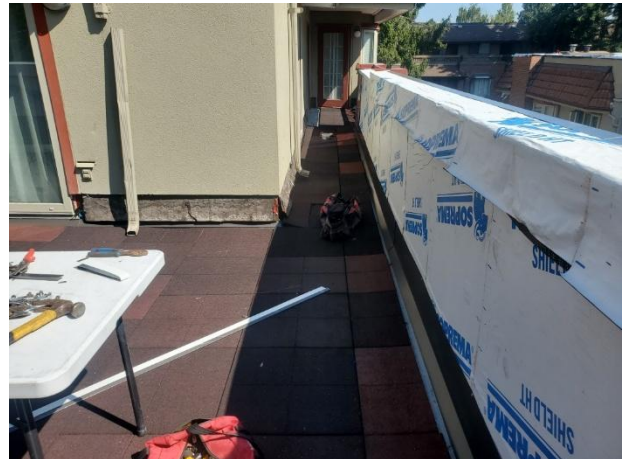
#### 27.6 **Building B**

Installation of the cross broken panels to the deck areas continues.

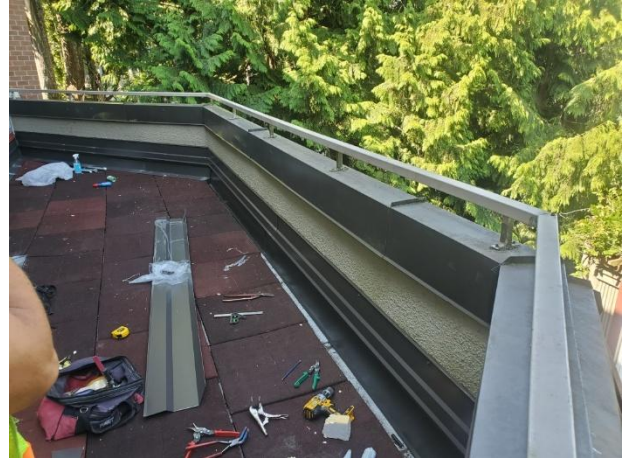
### 27.7 **Building B**

The double gumlip flashing install is being applied along the parapets on the deck 1<sup>st</sup> floor balcony at the Northwest corner of the building.

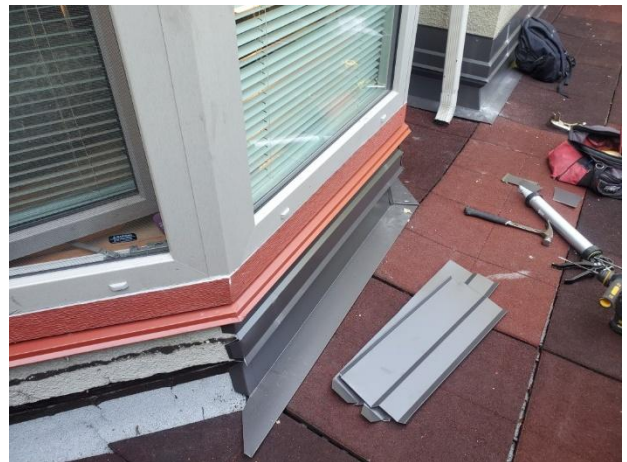
### 27.8 **Building B**

Base wall flashing is lapping onto the rubber pavers in an acceptable manner.

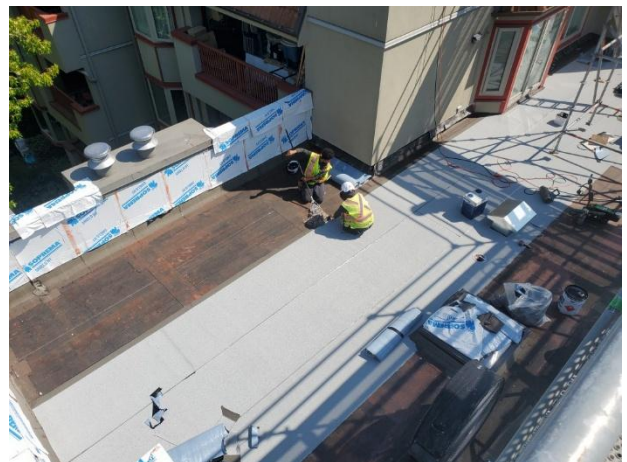
### 27.9 **Building A**

The installation of the Sopraply Stick Traffic cap to the lower decks continues.

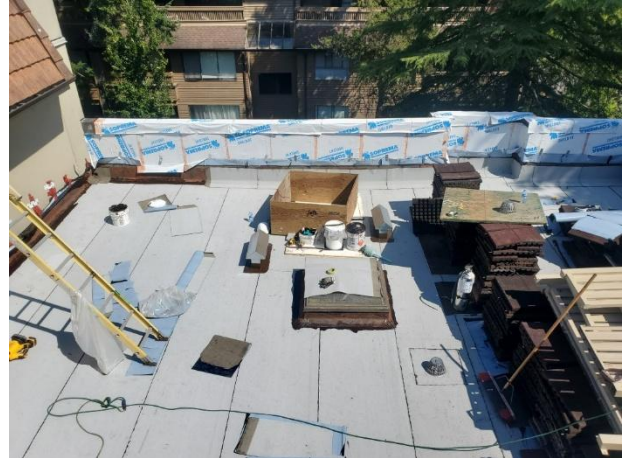
#### 27.10 **Building A**

Membrane seams are being heat welded closed, and membrane rolled into an Elastocal primed surface of the 2n1 board.

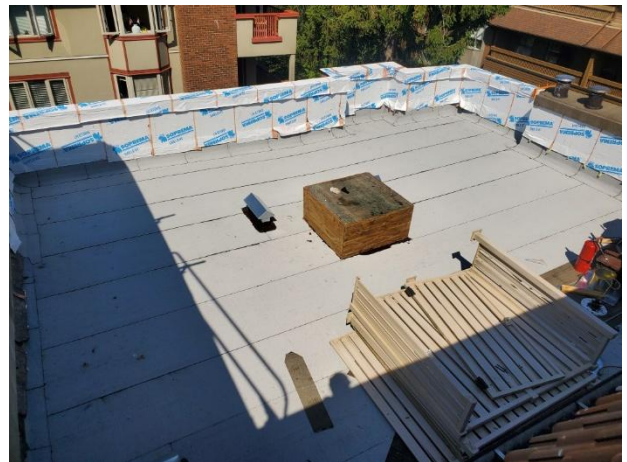
#### 27.11 **Building A**

Membrane application is nearly completed on the Northwest deck area.

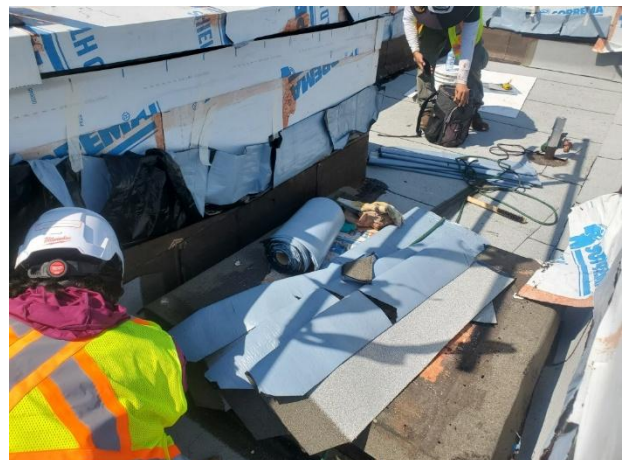
#### 27.12 **Building A**

Colpoly EF cement is being applied with a notched trowel prior to cap stripping install.

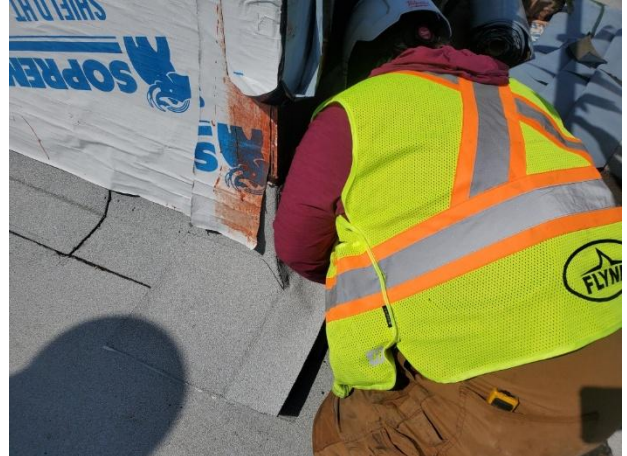
27.13 **Building A**

Cap stripping is being rolled into the primed surface and EF flashing cement.

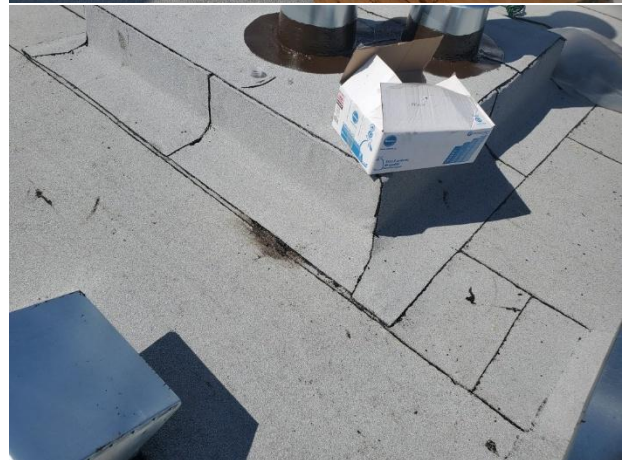
27.14 **Building A**

Seam welding appears acceptable.
