**BENUE TELEVISION CORPORATION,  
MAKURDI,  
BENUE STATE.**

**DILAPIDATION SCHEDULE:  
REHABILITATION/RENOVATION OF  
THE STUDIO BLOCK, GENERATOR  
HOUSE, GATE & GATE HOUSE AND  
PREMISES CARE CONDUCTED BY:**

**SALCORN CONCEPT  
LTD.**

**May, 2024**

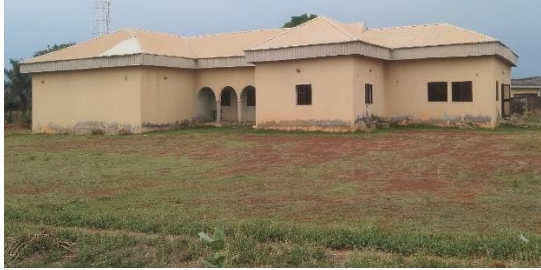
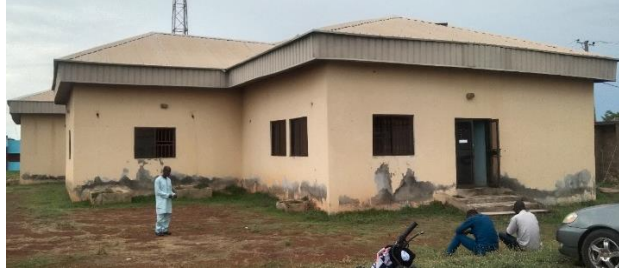
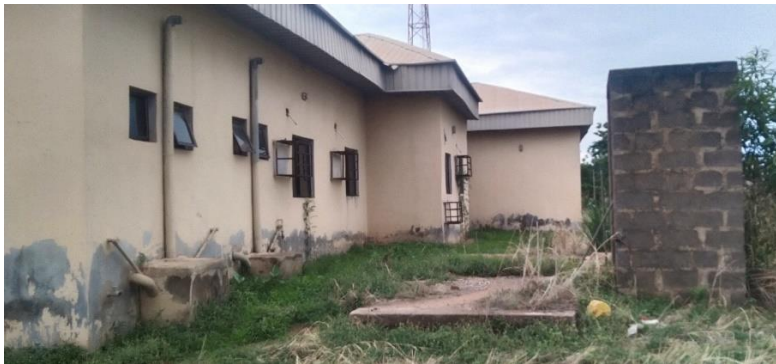
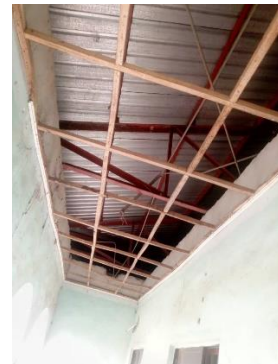
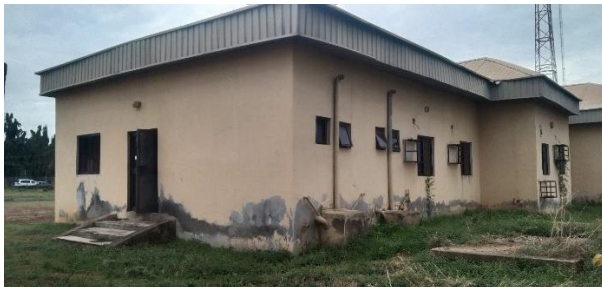
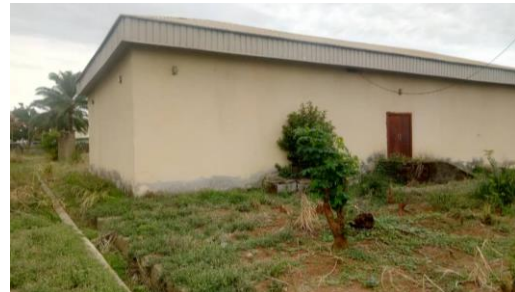
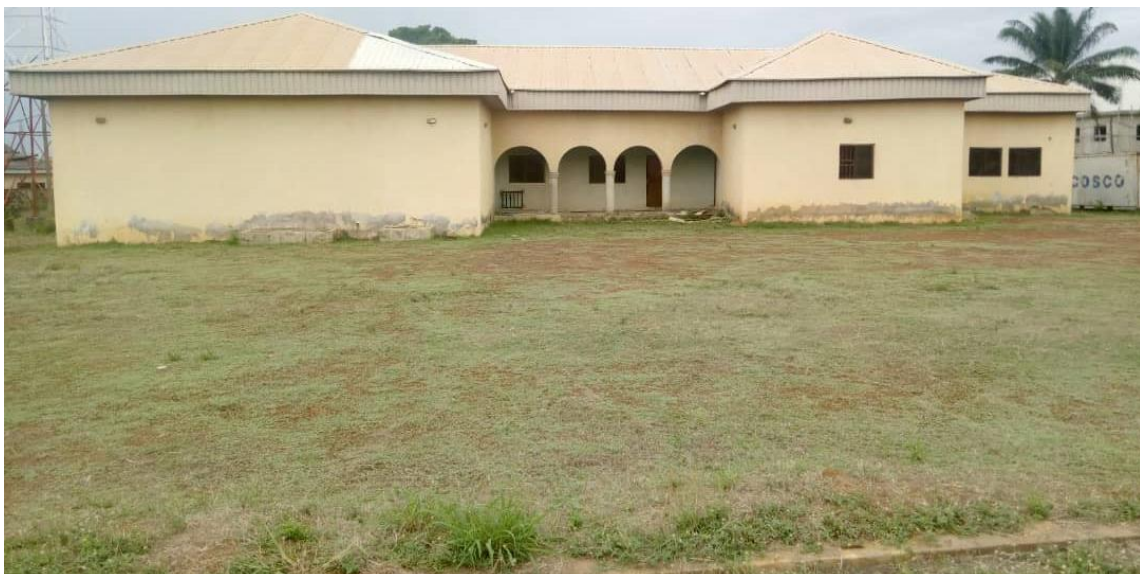
### PICTURES OF EXISTING STRUCTURE:

- i. Ground water rising through the damp-proof course (DPC) by the absence or failure of a damp-proof membrane (DPM) responsible for peeling of painting and warping of the PVC floor tiles.
- ii. Absence or failure of the anti-termite treatment in the foundation of the structure responsible for the infestation of the vulnerable timber materials and furniture by invading termites.

- i. Leak clouds seen on the ceilings indicate a leaking roof, probably due to poor workmanship or inappropriate material use or both.

- i. All wooden door panels fail and look very unsuitable including 2No. entrance doors.
- ii. 2No. 1200 x 2100mm doors needed at Office No. 7 as a main entrance.
- iii. Need to introduce more light into the work stations 1 and 2, by creating 2no. 1500 x 1200mm high windows, one to each of them.

- i. The warped PVC floor tiles do not befit a public structure of nowadays.
- ii. Studio walls were not rendered even though a secondary finishing was used.
- iii. Termite infestation of the entire studio wall and ceiling finishes will be completely pulled down for new ones.
- iv. Generally, studio wall and ceiling finishes were archaic and calls for something better.

- i. All electrical works in the block will be altered as most of them are already vandalised.
- ii. Remaining sanitary appliances and their ancillaries are not good enough for use.
- iii. Ventilation and Fire prevention/fighting equipment to be considered 100%.

- i. General fumigation of the entire site to exterminate termites, reptiles and rodents currently taking refuge in the structure.
- ii. Introduce a perimeter apron to the foundation not more than 1.00m high, finished with 600 x 600 x 75mm thick pre-cast concrete slab on a 100mm thick plain concrete.

- i. Remove long span aluminium roof covering 100%.
- ii. Maintain existing structural steel roof carcass to receive new covering.
- iii. Re-install new 0.55mm thick oven baked long span aluminium roofing sheets 100%.

- i. Carefully break down walls to introduce 2No. 1200 x 2100mm high main doors and 1No. 1500 x 2100mm high Studio door; also, 2No. 1500 x 1200mm high slide windows to the Work Station Rooms 1 and 2 to admit more lighting and for the new glass wall screen to the Control Room.
- ii. Maintain all existing slide windows and steel doors
- iii. Build 225mm thick walls to close existing glass wall screen and other places necessary.
- iv. Remove carefully all wooden doors panels (12No) maintaining their steel frames
- v. Fix 10No. single and 2No. double door panels to existing steel frames.
- vi. Fix 2No. Studio doors (1800 x 2100mm high)
- vii. Fix 3No. Entrance doors (1500 x 2100mm high)
- viii. Fix double-glazed curtain wall to create lobby to Studios 1 and 2 (3.00 x 3.85mm high)

- i. Scrape PVC floor tiles, remove all acoustic wall and ceiling linings heavily destroyed by termites and cart away debris.
- ii. Fix 600 x 600 x 8mm thick floor tiles to floor generally.
- iii. Render studio walls internally and all new walls.
- iv. Fix the sound proofing ceiling to Studio and Control Rooms to receive suspended ceiling dropped by 300mm for Services ducts and pipes network.

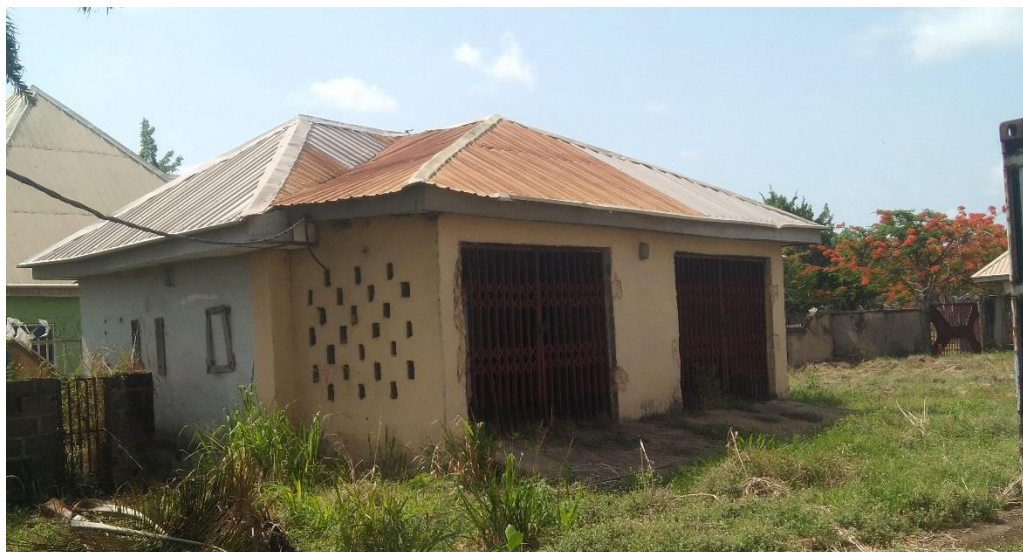
- i. This is still performing except for generator pads. This will need reinforced concrete pads measuring 3600 x 1200 x 150mm thick in two places; and minimal general amendment.

- i. Height of the head is too low. Wall height will be increased reasonably about 300 – 450mm to the existing 2700mm high. Normal finishes necessary.

- i. Leaking situation observed. This is to the joining that was not properly done and use of bad materials. Remove roof and ceiling and make new 100%.

- i. Change 2No. doors and 1No slide window.
- ii. Change the 2No. folding metal work protectors to door way size 3000 x 2100mm high.

- i. Render new walls normally.
- ii. Fix good floor tiles to floor area 100%
- iii. Fix asbestos ceiling.
- iv. General painting.

- i. All electrical and mechanical services to be considered new 100%
- ii. their ancillaries are not good enough for use.

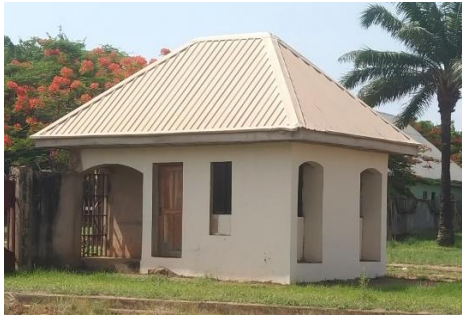
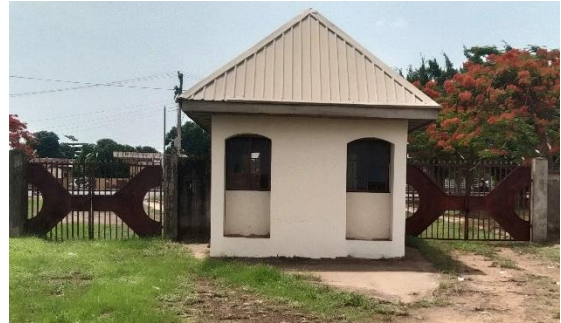
- i. This small block is relatively in good condition. It only requires updating finishes; Doors and windows and overhaul Services.
- ii. General painting.

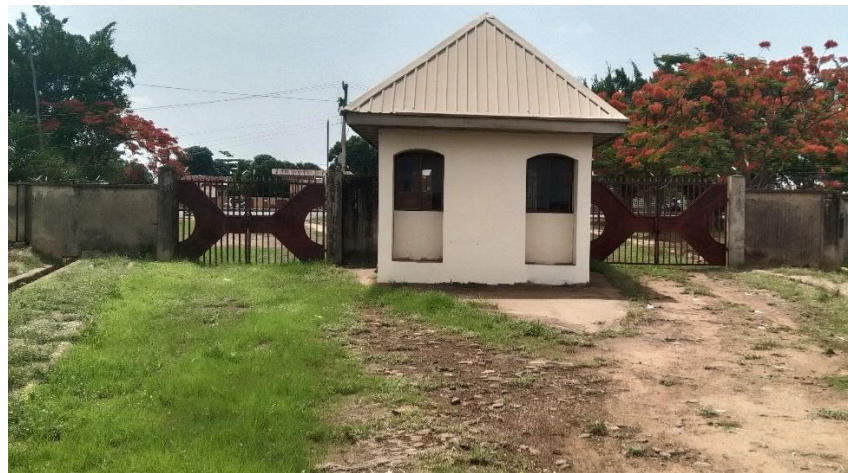
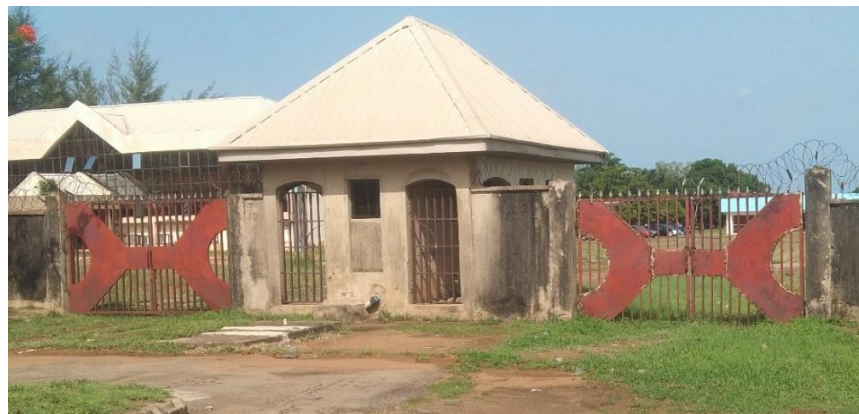
- i. These are equally in good condition and only to be maintained.
- ii. General painting.
