MINE CONFIGURATION AND ITS RELATIONSHIP TO SURFACE SUBSIDENCE¹

Jesse L. Craft and Thomas M. Crandall²

Abstract.--Careful evaluation of mine maps has been of considerable aid in understanding subsidence failure mechanisms above active and abandoned underground coal mines. This, in turn, aids the investigator in: (1) predicting what might happen in the future, and (2) designing proper corrective action to prevent additional subsidence events. Factors to be considered include accurate orientation of the mine map with surface features; pillar shape, size, alignment, and strength; percent coal extraction; overburden thickness and composition; location and orientation of barriers and unmined coal reserves; entry and haulageway size and alignment; water conditions in the mine; geologic structure; the presence of retreat mining in adjacent or nearby panels; and pillar alignment in association with retreated panels. Field investigations, including drilling programs, based on the evaluation of available mine maps have established clear relationships between surface effects of mine subsidence events and specific underground conditions causing the subsidence. These include: (1) coal barriers

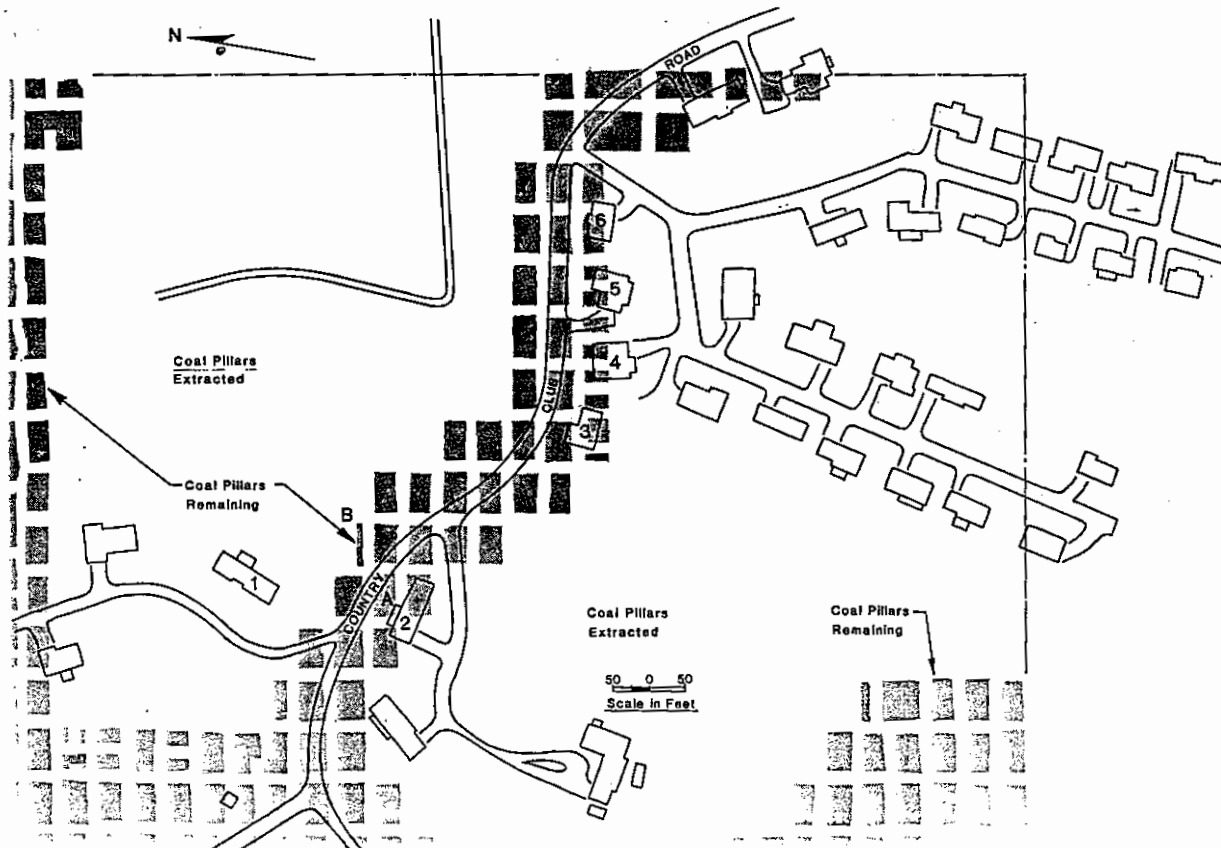
The subsidence incident began when residents of the home marked "1" on the mine map (fig. 2) heard a loud "explosion" followed by shaking of their homes. Cracks developed in the interior walls of the structure and continued to enlarge over the next few months until completion of an OSMRE stabilization project. Cracks also began to develop in other houses along Country Club Road following the initial subsidence event. An OSMRE emergency drilling program found that the overburden thickness averaged 275 ft and the mine area was flooded. The pillars between houses "1" and "2", and the smaller pillars between houses "3" and "5" were crushed.

Figure 2.--Surface structures and mine map, Country Club Road Subsidence Project, Fairmont, WV.

Based on the drilling evidence and the configuration of the pillars shown on the mine map, it appears the initial failure is attributable to a "bridged roof" between the offset of the pillars at point "A" and crushing of the thin pillar at point "B" (fig. 2). When the bridged roof failed, it caused failure of the pillars between house "1" and "2" and triggered adjustments of the overburden all along the pillar line. These adjustments resulted in additional pillar crushing, further consolidation or settlement in the already collapsed retreat area adjacent to the pillars, and, thus, considerable damage to the surface structures.

Remedial measures on this project were two-fold. A rock anchor system was installed at House "1" to stabilize the steep hillside (Mates et al. 1986). Cement grout was injected to fill mine voids and stabilize the existing pillars within the subsidence zone.

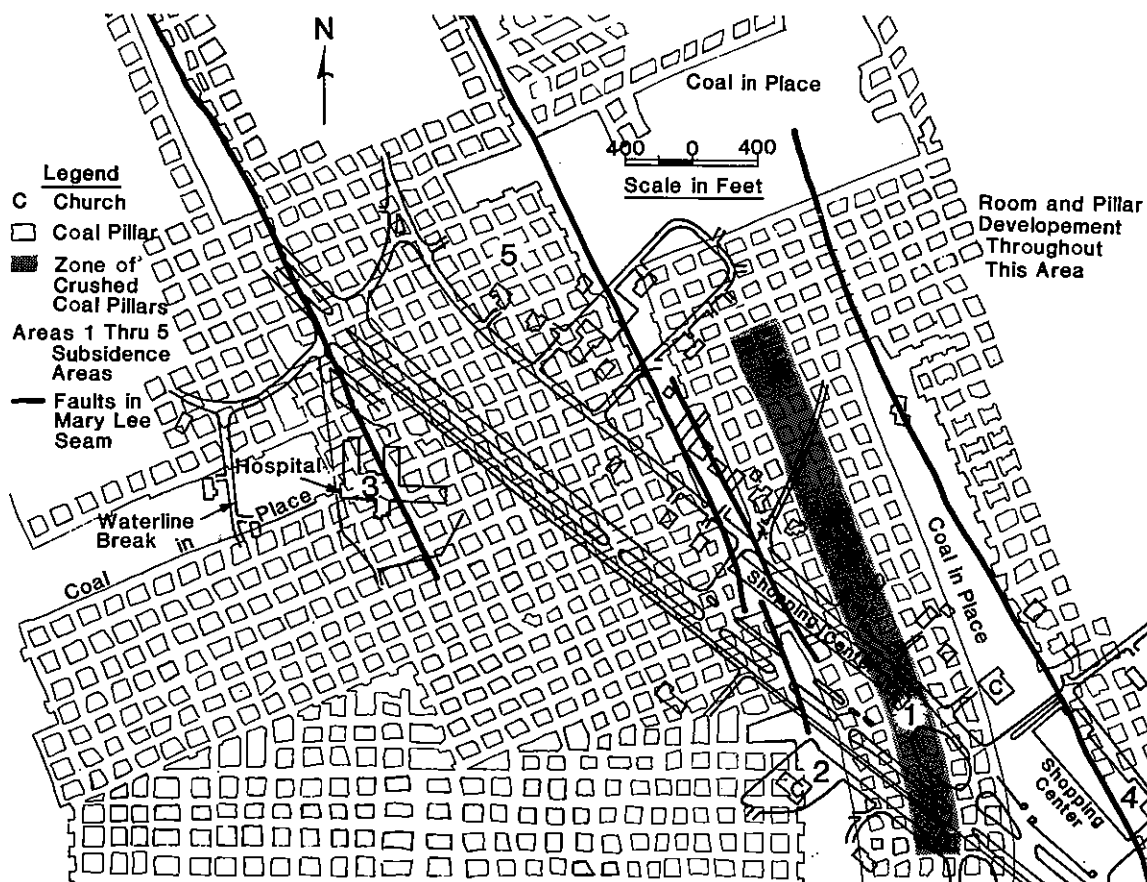
The geotechnical investigation focused on Area 1 (fig. 4). The Pratt Seam mine map shows no mining in the most disturbed part of the area. Examination of mine maps in the Mary Lee Seam revealed that mine development in Area 1 (fig. 3) was controlled by faulting, and that reported subsidence events were clustered along the coal left in place along and between the fault zones.

Figure 3.--Surface features and mine map of the Mary Lee Seam, Graysville Subsidence Project, Graysville, AL.

Pillar strength calculations (Morrison et al. 1987) indicated that the pillars within the fault block (table 2) have a safety factor of 1.2 and could carry the overburden load when the entire block of coal contained within the gravity fault block is involved in the support system. However, the calculation of the support within the panel yields a safety factor of 0.6 which indicates the pillars have marginal strength to carry the loads. Pillar strength estimates also indicated that panels on both sides of the faulted area have a safety factor of only 1.0. However, the area to the west of the fault block would be more prone to settlement/subsidence than the area to the east because of the narrower barrier rib and the interrupted panel design (fig. 3).

It was concluded that the barriers associated with the faults, and subjacent to the hospital, are acting much like a pair of fulcrum blocks, with a lever beam extending out over the large panels in both directions. The subsidence associated with Area 1 is the result of the development of a strain arch between the two fault barriers, as the overburden settled over the large panels. Subsidence occurred when horizontal friction at the center of the strain arch between the two fault barriers equaled zero, causing vertical loading and crushing of the center pillars.

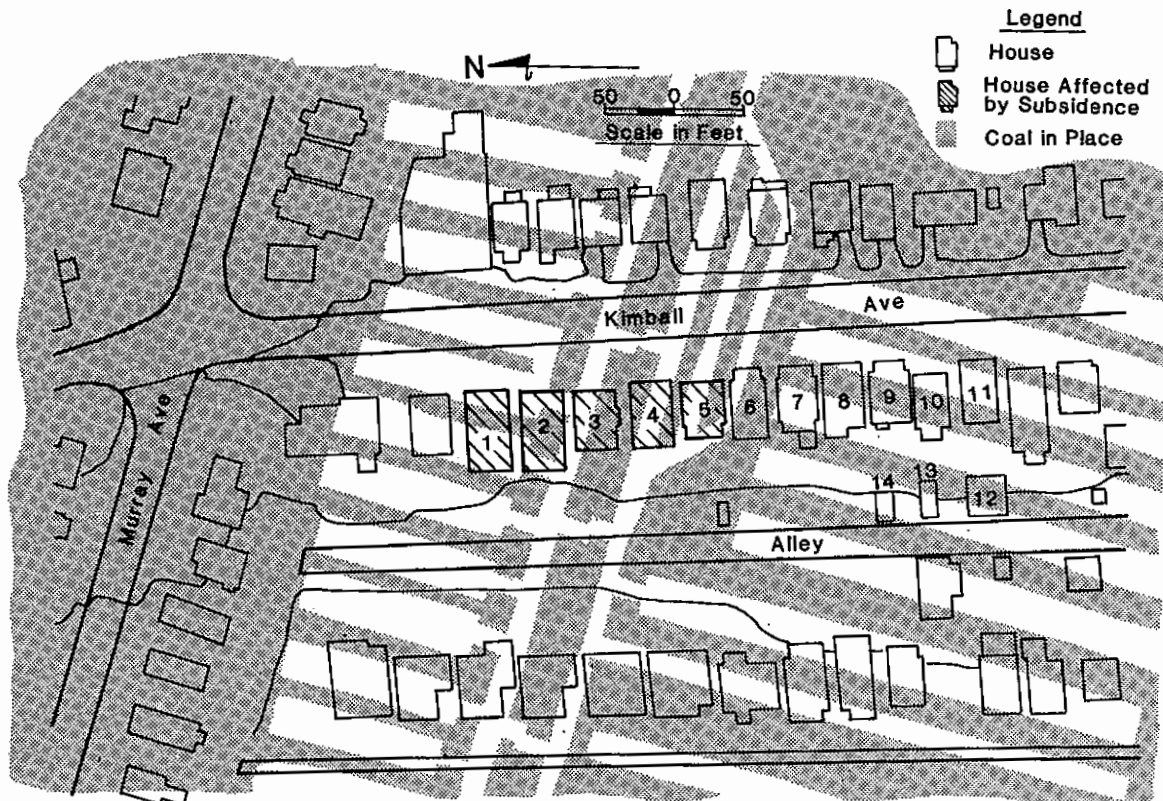
Figure 4.--Surface structures and mine map, Arnold-New Kensington Project, Arnold, PA.

Figure 4 is a mine map which also includes surface topography and location of homes. The map shows large coal pillars along a haulageway directly beneath the properties. Drilling authenticated the presence of the pillars and identified 6-ft open voids. Earlier drilling by the Pennsylvania Department of Environmental Resources encountered approximately 3 ft of light brown silt partially filling the void under the alley behind the center house (fig. 4, House 3). This material strongly resembled the Quaternary age Carmichaels Formation, a 90-ft- thick terrace

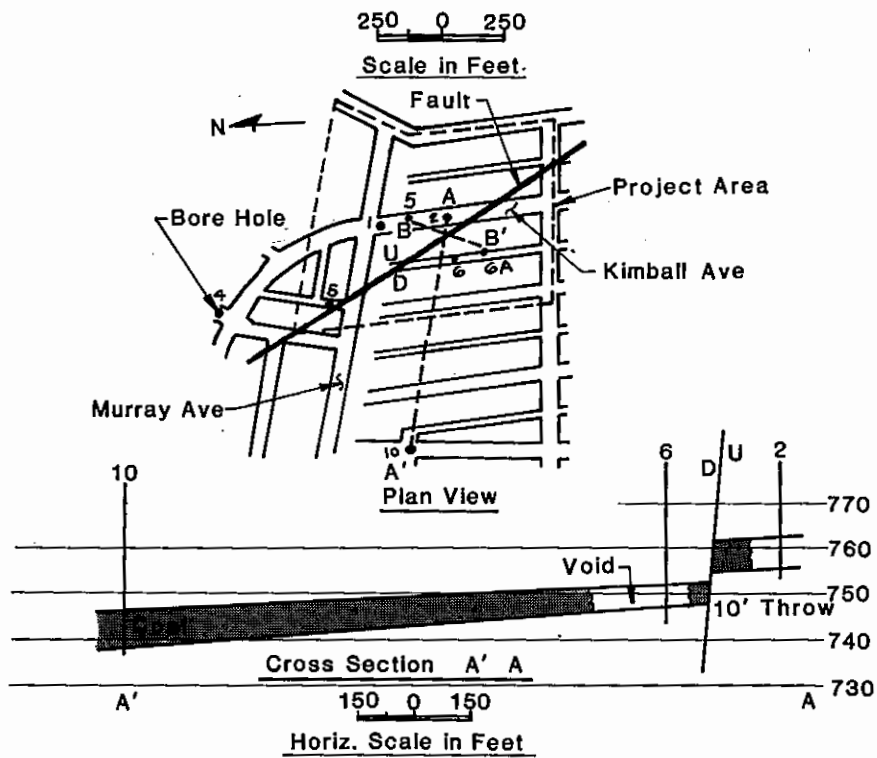
OSMRE subsequently implemented a drilling program in and around the problem area. The drilling in the immediate vicinity of the subsidence area identified a normal fault situated directly below the houses (fig. 6) with a vertical throw of 10 ft. The drilling program also established that the coal seam was 260 ft below the surface, and the base of the Carmichaels Formation was 90 ft below the surface. Silts of the Carmichaels Formation were recovered in one core hole at a depth of 245 ft. Borros anchors were installed both in front of and behind the houses at various depths to attempt to identify the zone of movement within the terrace deposits. Inclinator casing was also installed in front of and behind the houses to measure movement in the fill and the underlying Carmichaels Formation.

From the available information, it was concluded that surface subsidence was caused by the piping of silt from the Carmichaels Formation downward through open valley stress release fractures associated with the normal fault. A grouting program was implemented to seal the Carmichaels/bedrock interface and surface movement subsequently stopped.

Figure 6.--Plan map and cross-section A-A, Arnold-New Kensington Subsidence Project.

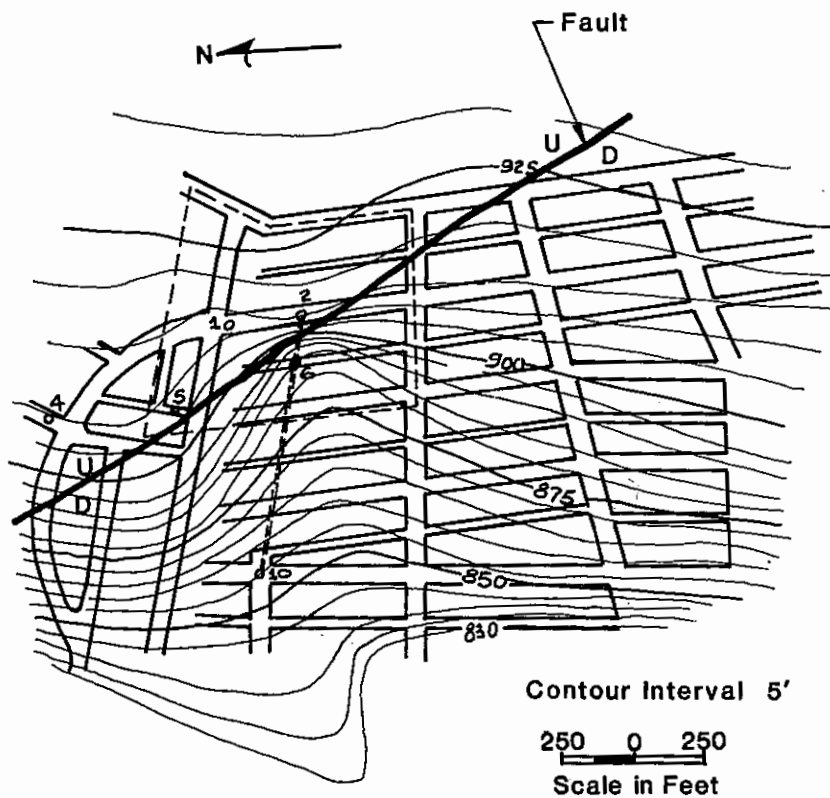
Information from Pennsylvania Department of Environmental Resources drilling was plotted on a map and the Carmichaels Formation/bedrock contact was contoured (fig. 7). Also plotted on this map is the trace of the near-vertical fault as defined by the OSMRE drilling program. This map

indicates a pre-Carmichaels stream valley located at the center point of the surface depression and a nick point (waterfall) on the fault line. The sum of information indicated the development of surface geomorphology was fault-controlled with a strong possibility of valley stress release jointing exposed at the pre-Carmichaels interface.

Figure 7.--Bedrock topography underlying the Carmichaels Formation as reconstructed from drilling records, Arnold-New Kensington Subsidence Project (note nick point developed at the fault line).

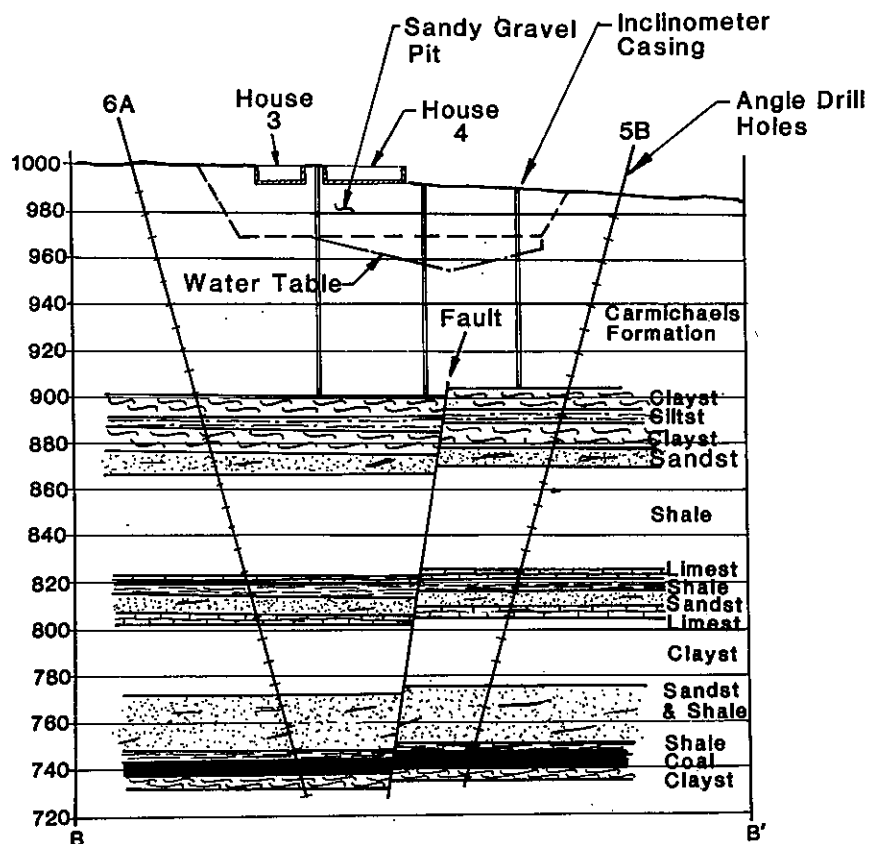
Figure 8.--Cross-section B-B, Arnold-New Kensington Subsidence Project. Cross section location shown on figure 6.
