# SAM D21 Family

## SAM D21 Family Silicon Errata and Data Sheet Clarification

The SAM D21 family of devices that you have received conform functionally to the current Device Data Sheet (DS40001882D), except for the anomalies described in this document.

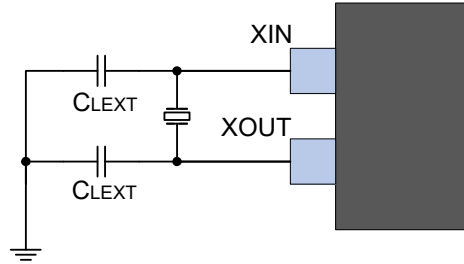
### 2.3 Schematic Checklist - Crystal Oscillator (Chapter 42 of the Device Data Sheet)

The load capacitor values shown in figure 42-6 and table 42-5 should not be used.  $C_{LEXT}$  should be calculated from the Load Capacitance Equation listed below. The corrected information is shown in **BOLD** type.
