Report ID:80

Name Of Building: Amalienborg

Report Overview

Date: 2016-04-29

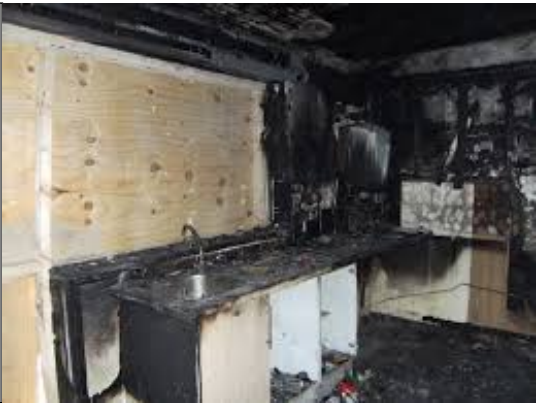
Estimated Time of Damage	Two Weeks ago
Where Damage Occurred	In the left Corner
Decription of Damage	A small Fire
Done Repairs	Nothing Yet
Damage Type	Fire Damage

Moist Scan Result	922 point moist
Moist Scan Area	Whole ground Level

Fire Damage

Recomendation	Needs fire cleaning
---------------	---------------------

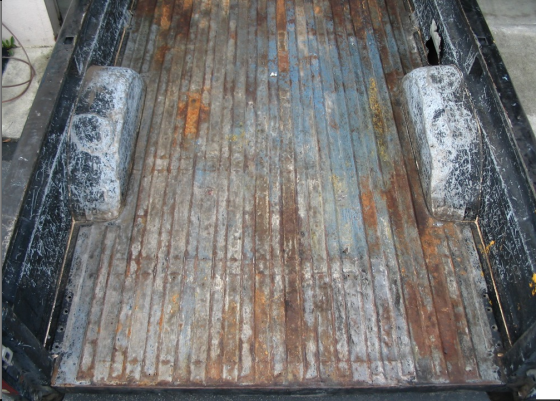
Estimated Time of Damage	Two Weeks ago
Where Damage Occurred	Under the bed
Decription of Damage	Weird Moist
Done Repairs	Cleaning some of it
Damage Type	Moist

Moist Scan Result	Still alot of moist
Moist Scan Area	Whole Room

Description	Moist Damage

Recomendation	A lot of fresh air
----------------------	---------------------------
