Report ID:79

Name Of Building: McDonalds valby

Exterior review of Building

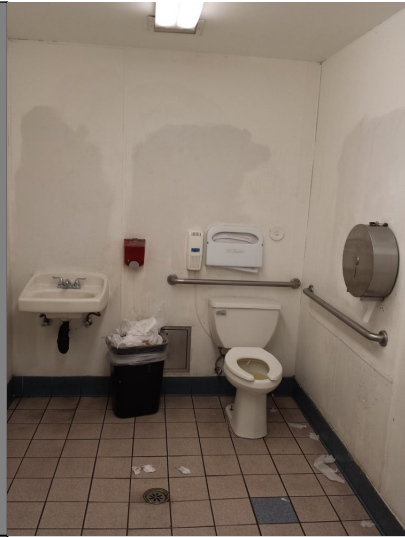
Toilet

Inspected Area	Remark
Floor	Floor is dirty
Window	
Celling	
Other

Recomendation	Needs better Cleaning
---------------	-----------------------
