## USB72x6/USB7252 Silicon Errata and Data Sheet Clarification

This document describes known silicon errata for the following USB72x6/USB7252 devices:

- USB7206
- USB7216
- USB7252

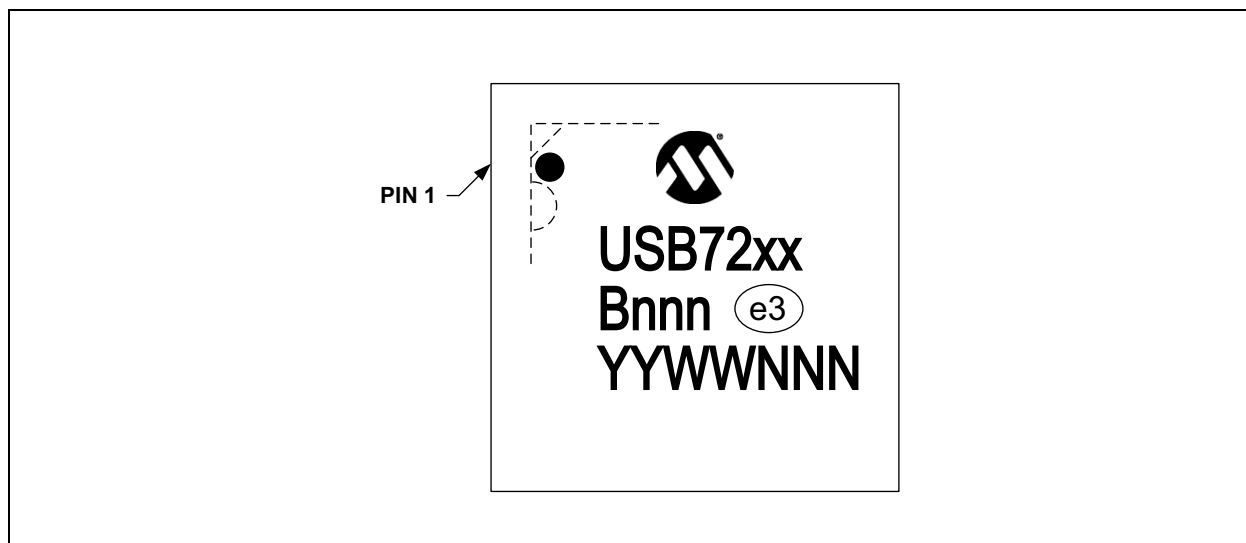
**FIGURE 1: TOP MARKING SILICON REVISION INDICATION**

The silicon errata discussed in this document are for silicon with silicon revisions as listed in [Table 1](#). Parts affected by these errata are marked in [Figure 1](#).

**Note:** [Figure 1](#) details the top markings of an example part and highlights the location of the silicon revision. Other top marking values may differ (lot codes, location of manufacture, and so on).

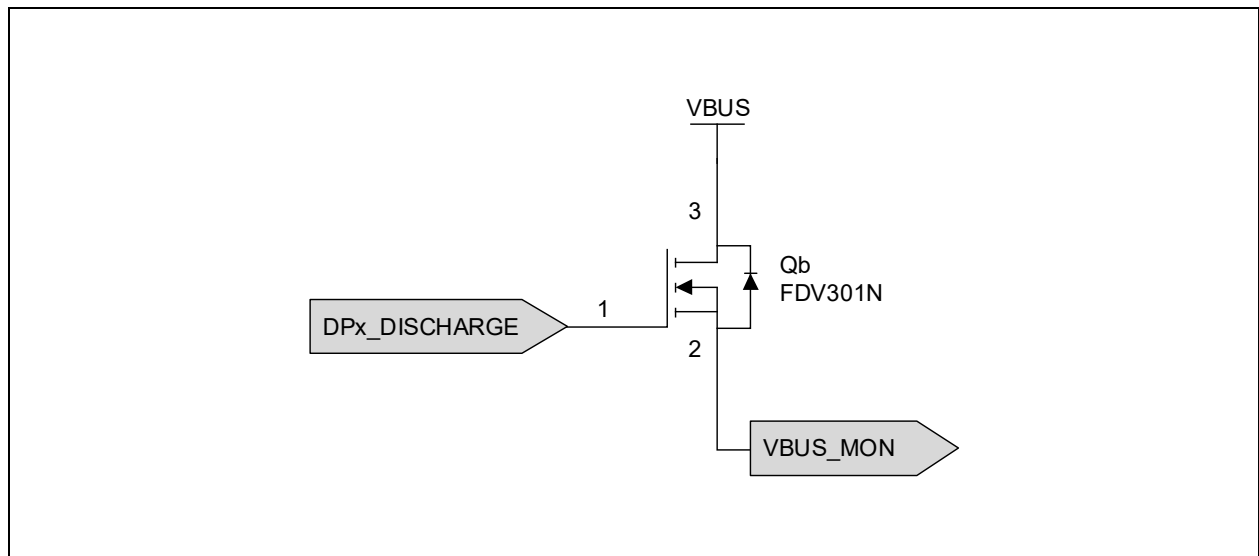
**FIGURE 2: TYPE-C DISCHARGE WORKAROUND FOR MODULE 3**

One requirement for USB-IF compliance certification of a system with an exposed Type-C port is the *Port Power On/Off* test. This test is part of the HUBCV suite of *Command Verification* tests for USB 2 devices. As part of this test, the hub must discharge VBUS, and then energize VBUS in response to CLEAR\_FEATURE and SET\_FEATURE commands from the test host.

Frequently, these ports will be implemented with electrolytic VBUS load capacitors, which retain a small residual charge that is released slowly compared to the timing of the discharge. In such cases, as energy is released from the capacitor the voltage can drift upward slightly after the discharge, which can cross the VBUS\_DET threshold for detecting VBUS high. In the sequence of the Port Power On/Off test, this can inhibit subsequent turning on of VBUS in response to commands from the test host and the test fails.

Type C ports that have a large electrolytic capacitor may require this workaround to pass the HUBCV Port Power On/Off test.

In reference designs for USB7216 and USB7252 devices, an N-channel MOSFET with a  $V_{GS}$  less than 1.0V is connected between VBUS and VBUS\_MON, with gate control from the DISCHARGE signal. This additional component creates an additional current path as the discharge is monitored by VBUS\_MON, which biases VBUS\_MON higher. This results in discharge to a lower voltage than what is otherwise achieved, and compensates for any residual energy that the capacitor releases after the discharge. At times other than the discharge, the MOSFET is turned off and does not influence VBUS.

No components of the reference design need to be removed; only the MOSFET is added.
