AI-171 Crash Analysis : A Physics-Based Hypothesis on Rearward Center of Gravity-Induced Deep Stall and Engine Power Loss

Yadu Krishnan
ORCID : [0009-0001-5832-8557](https://orcid.org/0009-0001-5832-8557)

July 10, 2025

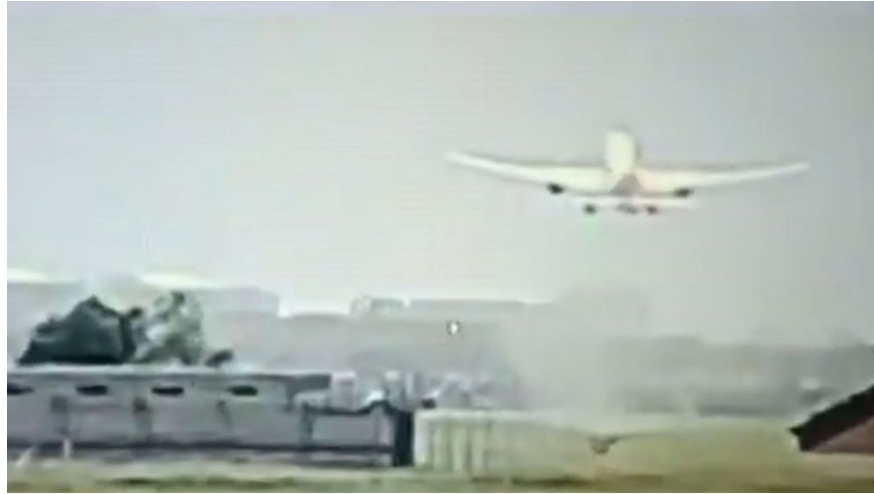
Figure 2: Still taken from the video captured by a CCTV surveillance camera at the Ahmedabad airport showing AI-171 taking off runway 23.

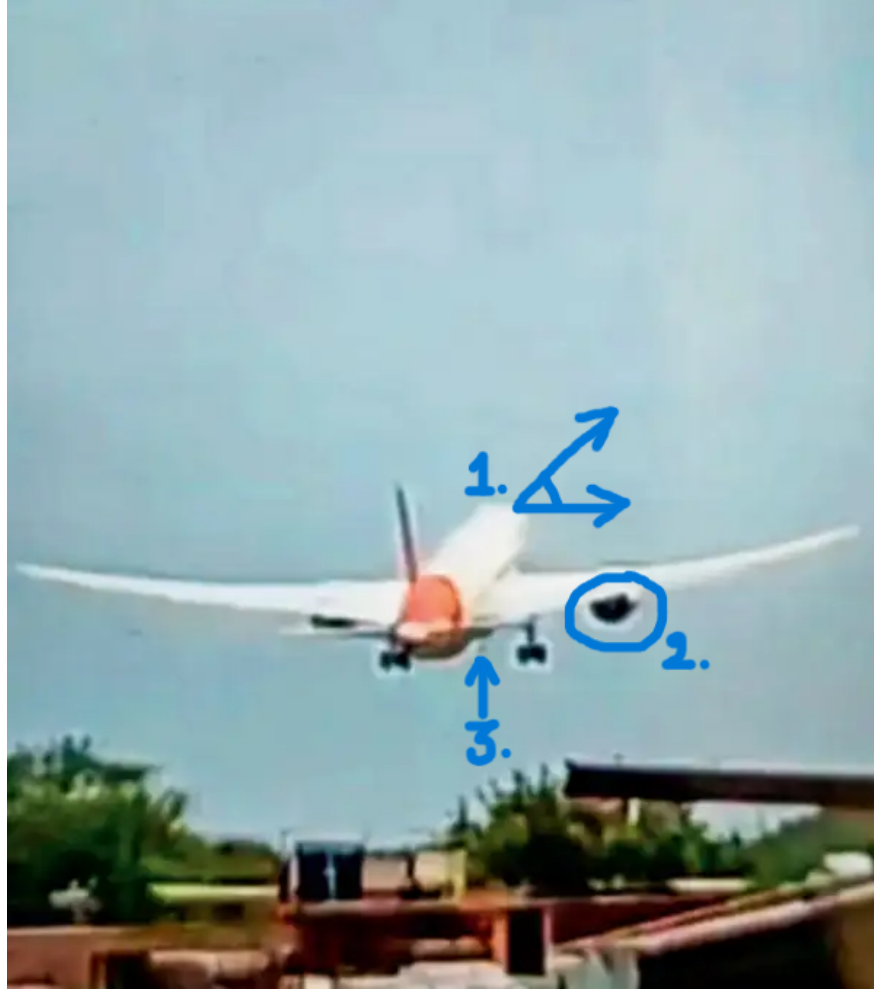
Figure 3: 1. Note the nose-up attitude of the A/C while losing altitude 2. The engines show no visual cues like flame or smoke 3. The Ram Air Turbine (RAT) is deployed, indicating engine failure.

The deployment of the Ram Air Turbine (RAT) (*refer to Fig. 2*) confirms that both engines lost electrical output, which is a highly abnormal event at this phase of flight. With the aircraft now in a deep stall and with insufficient elevator authority to pitch the nose down, recovery became impossible. The fact that the landing gear remained extended suggests that the aircraft never reached a stable climb profile, and the flight crew likely had no opportunity to perform standard post-lift-off actions.
