# RENESAS TECHNICAL UPDATE

| Classification of Production | MPU&MCU | | No | TN-SH7-494A/E | Rev | 1 |
| THEME | SH7760 type number change due to logical modification. | | Classification of Information | 1. Spec change<br>2. Supplement of Documents<br>3. Limitation of Use<br>④. Change of Mask<br>5. Change of Production Line | | |
| PRODUCT NAME | HD6417760BP200D<br>HD6417760BP200DV | Lot No. | Reference Documents | SH7760 hardware manual Rev 1.0 (ADE-602-291) | Effective Date | |

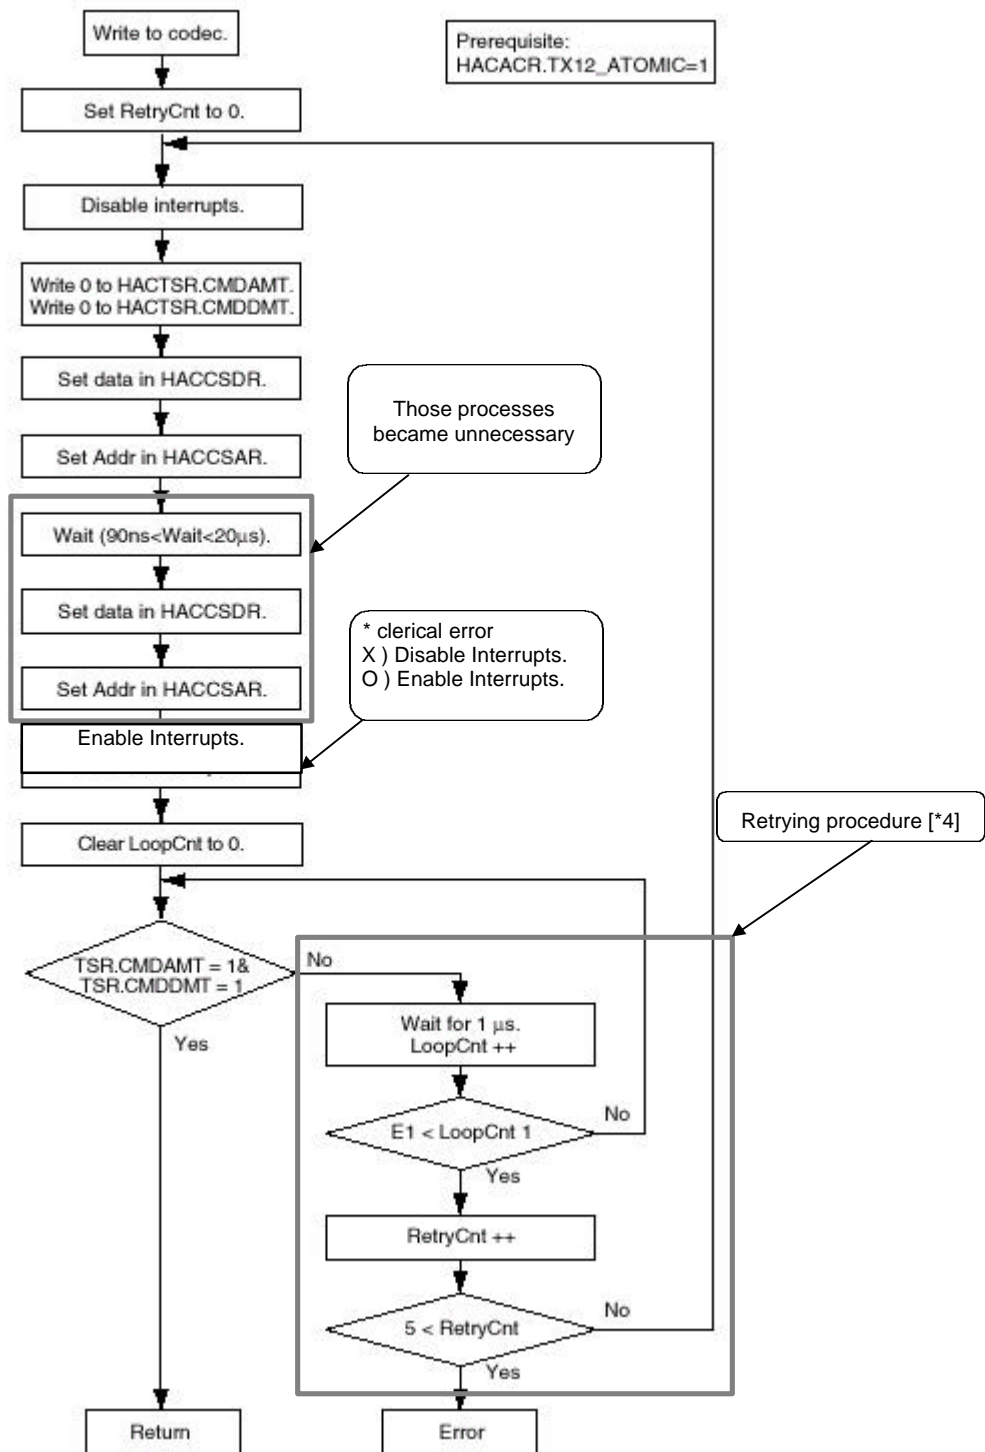
Figure 1. Modification for Figure 25.4 in Hardware Manual Rev 1.0

HD6417760BP200AD/ADV : There is no need to apply this restriction. Please see Figure 1 and 2.

(\*4) : Some CODEC devices may not complete accessing CODEC register within 1 slot time.  
In this case, please execute this retrying procedure.
