RENESAS TECHNICAL UPDATE

Classification of Production	MPU&MCU		No	TN-SH7-492A/E	Rev	1
THEME	Notice about The MMCIF transfer data block size in multiblock read command.	Classification of Information	1. Spec change 2. Supplement of Documents ③. Limitation of Use 4. Change of Mask 5. Change of Production Line			
PRODUCT NAME	SH7760	Lot No.	Reference Documents	SH7760 hardware manual (ADE-602-291)	Effective Date	
		All			Eternity

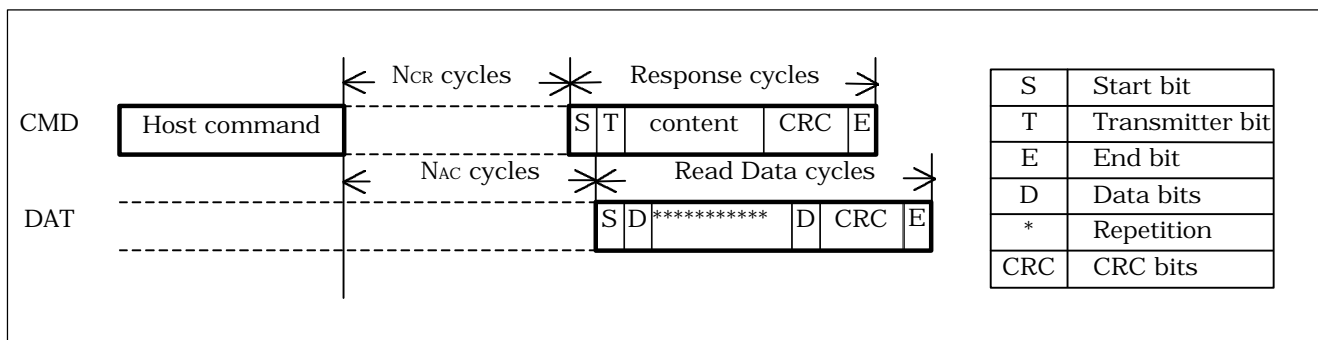
figure.1 Timing of receiving the command response and data

The MMCIF may not receive the command response correctly, when it finishes receiving the end bit of the first data block before receiving the end bit of the command response. It may occur after MMCIF sends CMD18 to the receive device.

- (1) The multiblock read command (CMD18) is sent.
- (2) The transfer data block size is setting to 1,2,4 or 8 byte(s).
- (3) The end bit of the command response is received after the end bit of the first data block is received.

- (1) The transfer data block size in Transfer Byte Number Count Register (TBCR) must be more than 16 bytes when CMD18 is transmitted.

- (2) Confirm that the end bit of the command response is received before the end bit of the first data block is received, if the transfer data block size is 1,2,4 or 8 bytes when CMD18 is transmitted.

Keep the below formula in order to confirm that the end bit of the command response is received before the end bit of the first data block is received.

$$\text{NAC cycles} + \text{Read Data cycles} > (\text{NCR Cycles} + \text{Response cycles})$$
