# Authorized Field Change

AFC G-06919

**Subject:** Engine Air Management System Upgrade for Certain International® 1652, 3200, 3300, 4200, CE Bus and RE Bus Models Built Between January 1, 2003 and December 31, 2003 with International® VT 365 Engines

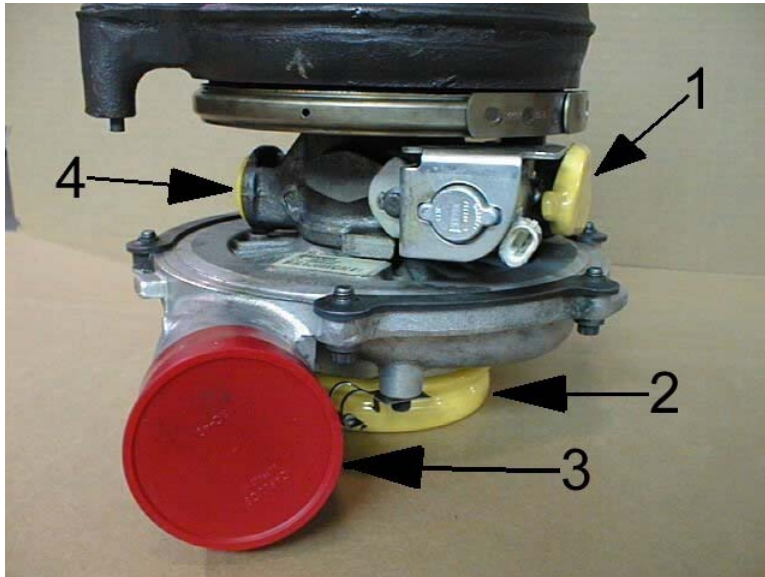
**Figure 3 Cover Compressor Inlet, Outlet, Oil Inlet and Oil Outlet with Cap Plugs (Arrows)**

1. Remove the turbocharger from the engine following the procedure in the VT 365 Service Manual.
2. Inspect the compressor and turbine blades for damage. If blade damage is present, the turbocharger cannot be reconditioned.
3. Cover the turbocharger outlet with 2 1/2 inch red cap plug cover and compressor inlet with large yellow cap (Figure 3).

1. Oil Inlet
  2. Compressor Inlet
  3. Compressor outlet
  4. Oil Outlet
4. Clean turbocharger oil inlet mounting surface and cover with a molded yellow cap plug (Figure 3).
  5. Place a yellow cap plug into the turbocharger oil outlet passage (Figure 3).
  6. Using a paint pen, mark the location of the V-clamp split on center housing and direction of stud with an arrow (Figure 4).

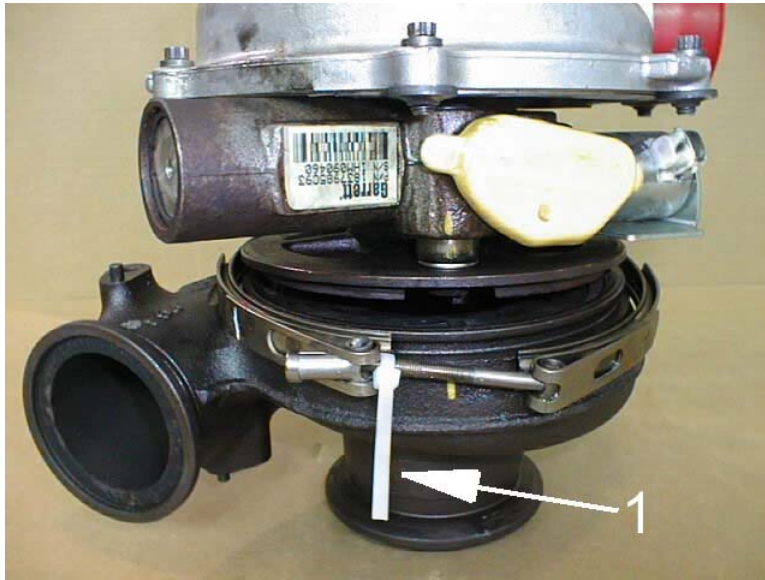
**Figure 6 Remove V-clamp**

8. Remove the V-clamp retaining nut completely from the clamp assembly (Figure 6). Move the V-clamp off of the groove. Use a cable tie strap to hold the V-clamp in the open position as shown in Figure 6.

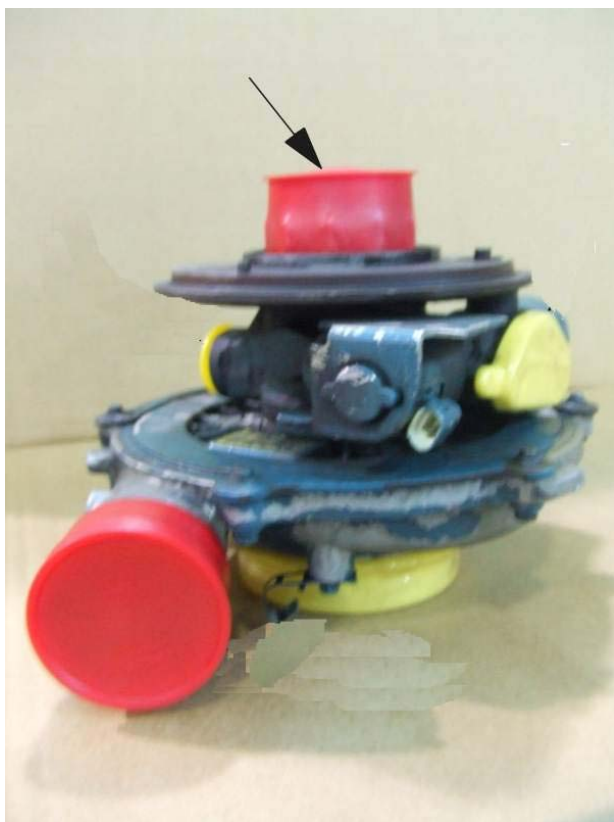
**Figure 7 Install a 2 1/2 Inch Red Cap (Arrow)**

9. Carefully separate the turbocharger housing from the center section with a hammer and brass drift. Inspect turbine wheel for damage:
  - If damage is found, the turbocharger cannot be reconditioned.
  - If no damage is found continue this procedure. Install a 2 1/2 inch red cap plug to protect the turbine wheel during cleaning (Figure 7).

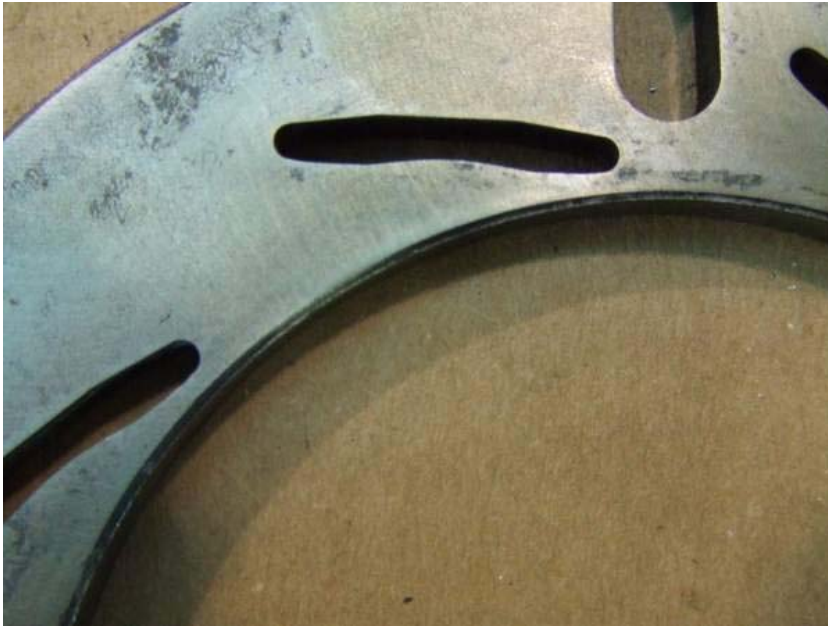
**Figure 8 Unison Ring can be Reconditioned**

10. Inspect the unison ring for cracks or excessive wear. If either is found, the turbocharger cannot be reconditioned (Figure 8 and Figure 9).

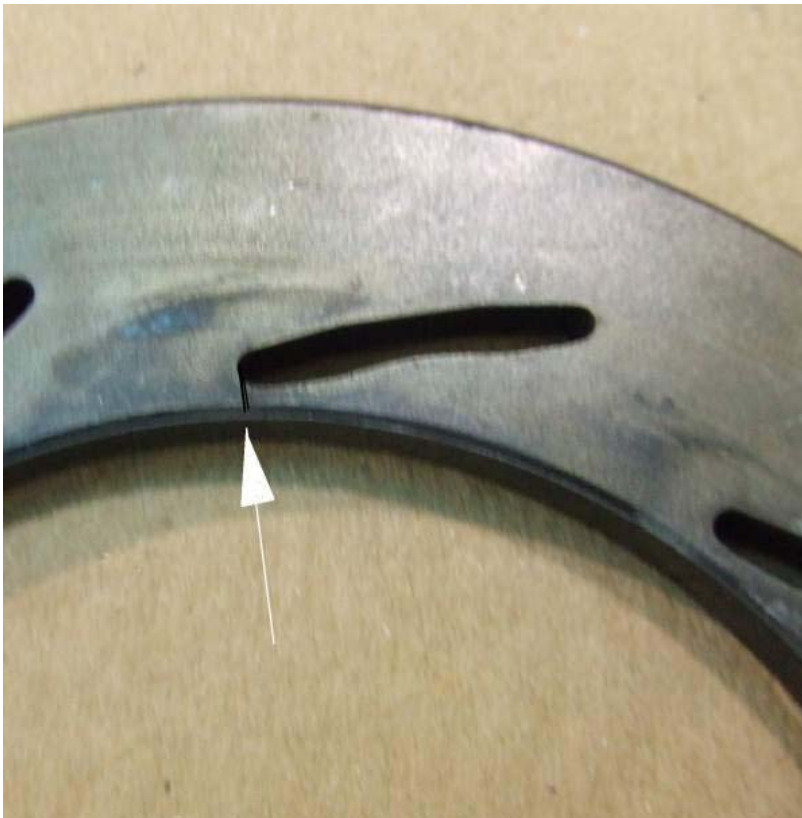
**Figure 9 Unison Ring Cannot be Reconditioned (Crack at Arrow)**

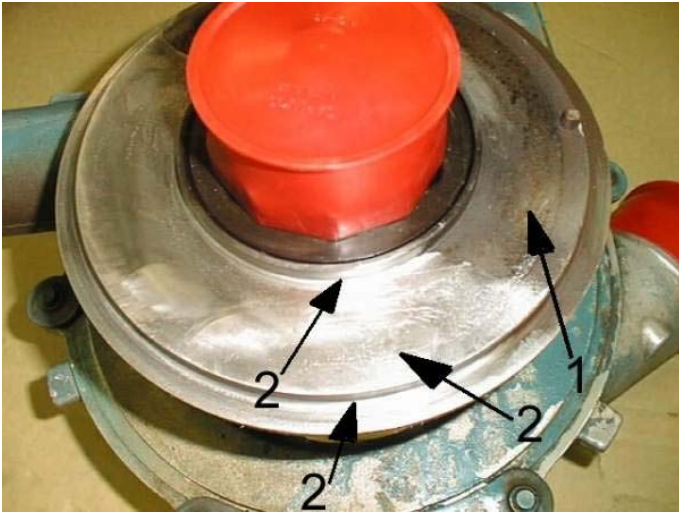
**Figure 10**

1. Un-Cleaned
2. Cleaned

11. Clean the center section (Figure 10):

- Using 2 inch 3M® cleaning pad, remove corrosion from surfaces that contain moving parts and mating housing joints.
- Using the least aggressive cleaning disc, clean surfaces until all corrosion and carbon has been removed. Take care to prevent damage or gouging the machined surfaces of the housings or unison ring cam.

12. Clean the pilot area of the center section that contacts the unison ring. Remove debris from the housing with brake cleaner and compressed air (Figure 10).

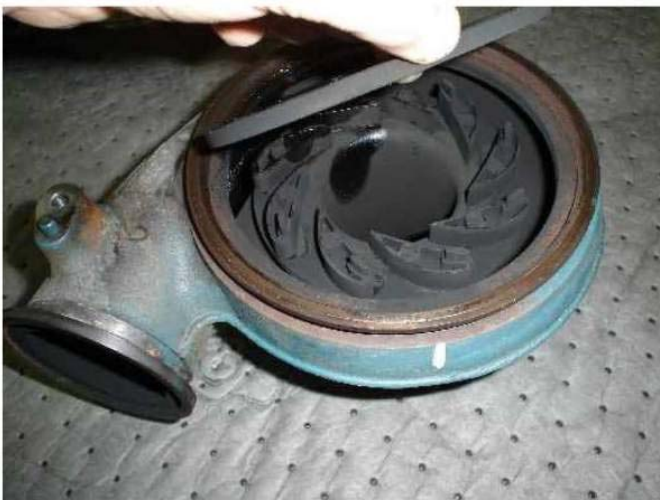
**Figure 11 Remove Unison Ring and Vanes**

13. Remove the unison ring and vanes from the turbine housing (Figure 11).
14. Using 2 inch 3M® cleaning pad, remove the corrosion from the surface of the unison ring (Figure 12) and the inner diameter of the ring where it contacts the center section.
  - Remove debris from the unison ring with brake cleaner and compressed air.
  - Recheck for cracks after cleaning. Refer to Figure 9.

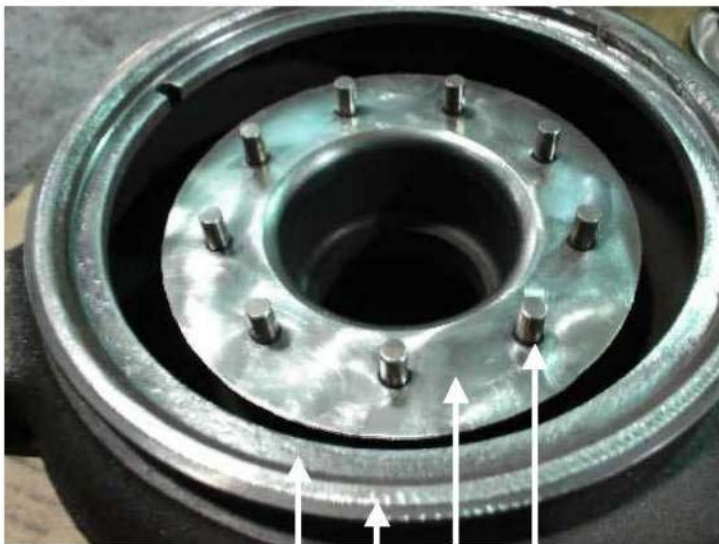
**Figure 15**

Areas to clean

16. Using the modified cleaning disc, remove corrosion from all surfaces that contain moving parts in the turbine housing and mating surfaces of the housing (Figure 15).

- Aggressively clean surfaces until all corrosion and carbon have been removed and bright shining metal surfaces are exposed.
- Take care to prevent damage to the machined surfaces and housing vane posts.
- Remove debris from the housing with brake cleaner and compressed air.

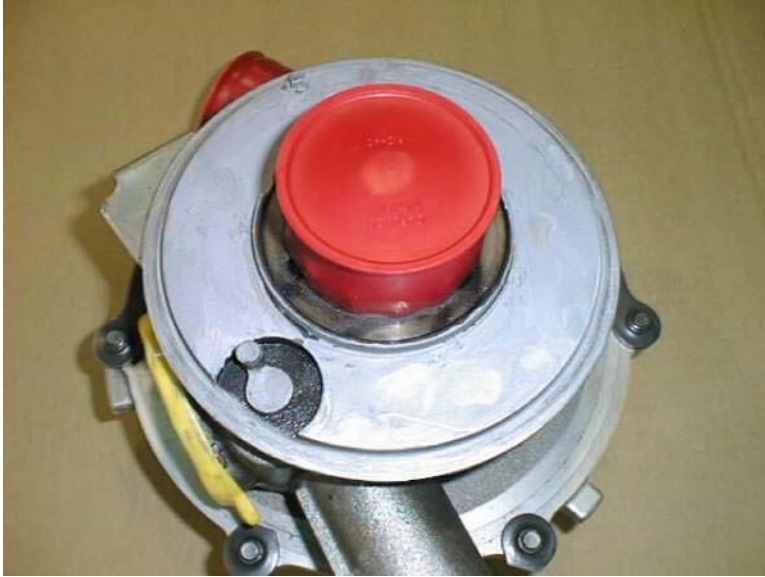
**Figure 16** Apply 5 Gram Packet Permatex® Anti-Seize

17. Apply a light coating using one 5 gram packet of Permatex® Anti-Seize lubricant to the turbine housing and the second 5 gram packet to the center section, unison ring, and pilot diameters that have been cleaned (Figure 16, Figure 17, Figure 18).

- This procedure is to coat the surfaces, not lubricate the moving parts.
- Remove all excessive lubricant with clean paper towels.
- Do not apply Anti-Seize to the vanes or posts.

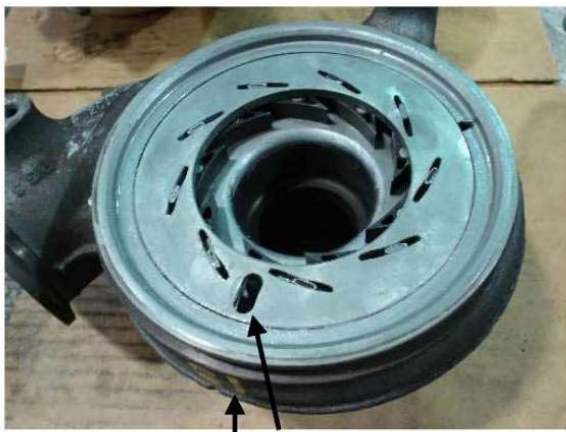
**Figure 19**

Align housing mark and  
Unison Ring Cam slot

- Remove the cap plugs from the compressor housing and center section.
- Index the unison ring onto the vanes.
- Verify free movement of the vanes and unison ring.
- Align the housing mark and unison ring cam slot (Figure 19).
- Position V-clamp on the turbine housing.
- Verify the V-clamp bolt is in the correct direction.

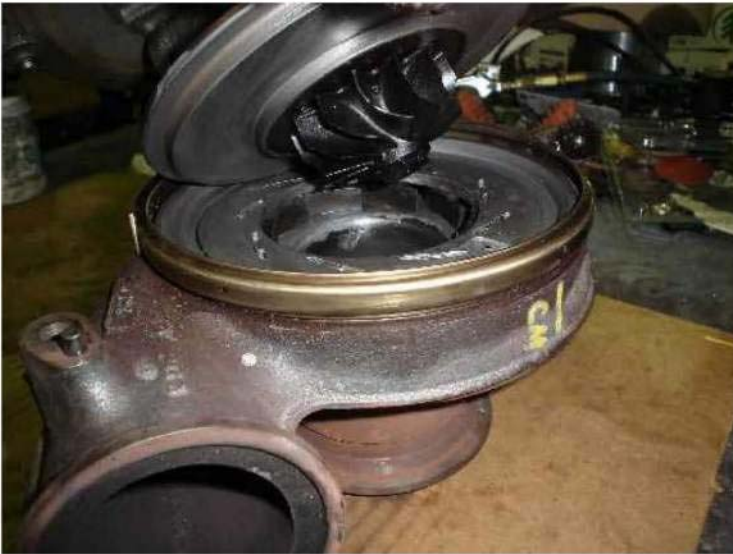
**Figure 20 Lower the Center Section onto the Turbine Housing**

19. Lower the center section onto the turbine housing (Figure 20), aligning the unison ring cam first, then the housing dowel.
