VEHICLE RECALL

G-03515
January 2004

SUBJECT: SAFETY RECALL (U.S., EXPORT)

**Air Compressor Discharge Tube on 3200 and 4200 Models
Built 10/01/2002 through 9/15/2003 with V-8 Engines and Air
Brakes or Air Operated Park Brakes (Feature Code: 04CAR) at
the Springfield Assembly Plant**

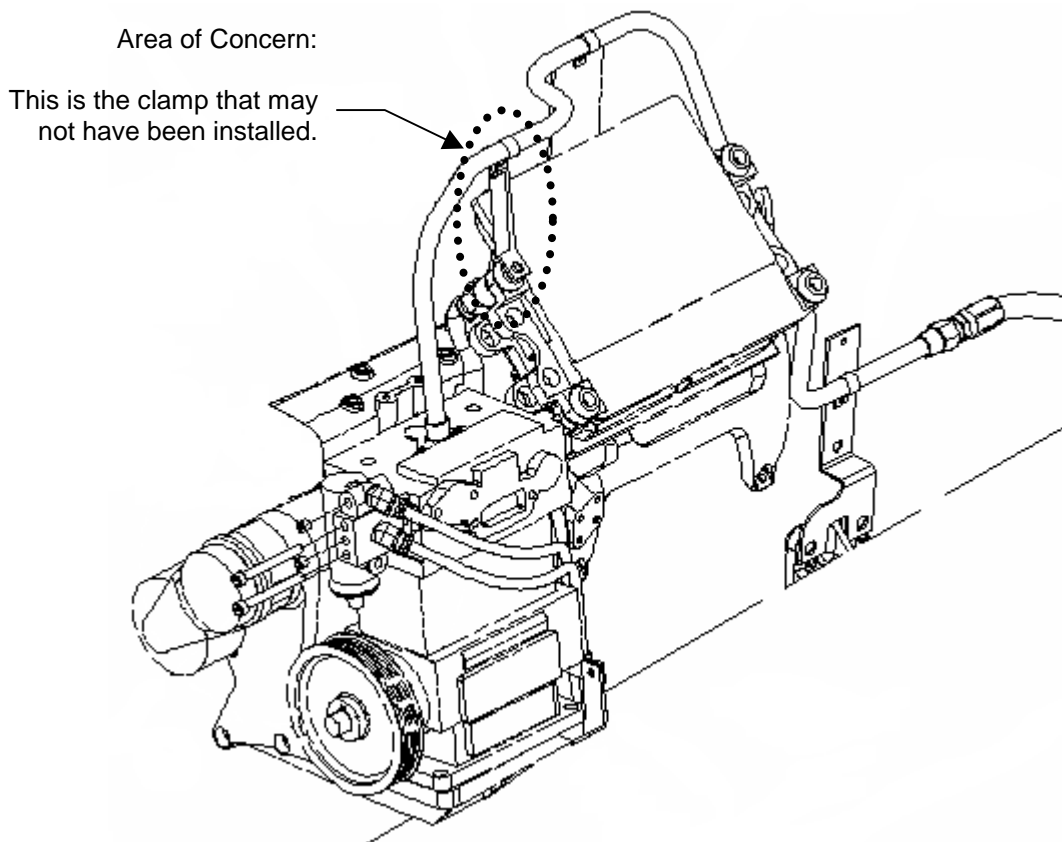
Figure 1

1. Open and secure hood.
2. Ensure copper air compressor tube is supported as shown in Figure 1.

3. If the vehicle **does not** contain the clamp as shown in Figure 1, skip down to **Installation Procedure** below.
4. If the vehicle **DOES** contain the clamp as shown above, then check for windlace. (See Figure 2)
 - a. If **NO** windlace is present, then skip to the **Windlace Installation Procedure** below.
5. If the vehicle **DOES** contain the clamp as shown above, **AND** contains the windlace, then **NO REPAIR IS REQUIRED**.

11. Install assembly on engine ECM as shown in Figure 1.

NOTE: Some minor rework to the extension clip may be required to properly fit pipe clamp.

If necessary, bend extension clip to meet discharge tubing.

12. Torque for the M6 fasteners is **6.5-8 LbF-Ft (8.7-10.7 Nm)**.

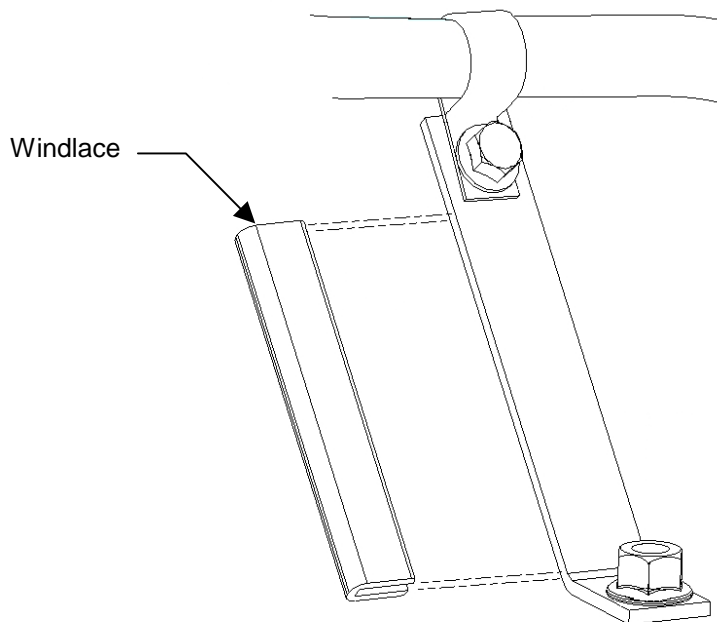
Figure 3

TO AVOID CHAFING AGAINST THE AIR COMPRESSOR CLEAN AIR INTAKE HOSE AND POTENTIAL COMPRESSOR FAILURES, INSTALL THE WINDLACE ON **ALL** VEHICLES THAT DO NOT HAVE IT.

1. Some vehicles were built with the extension clip assembly, but were **not** built with the windlace.
2. Install the windlace as shown in Figure 3.

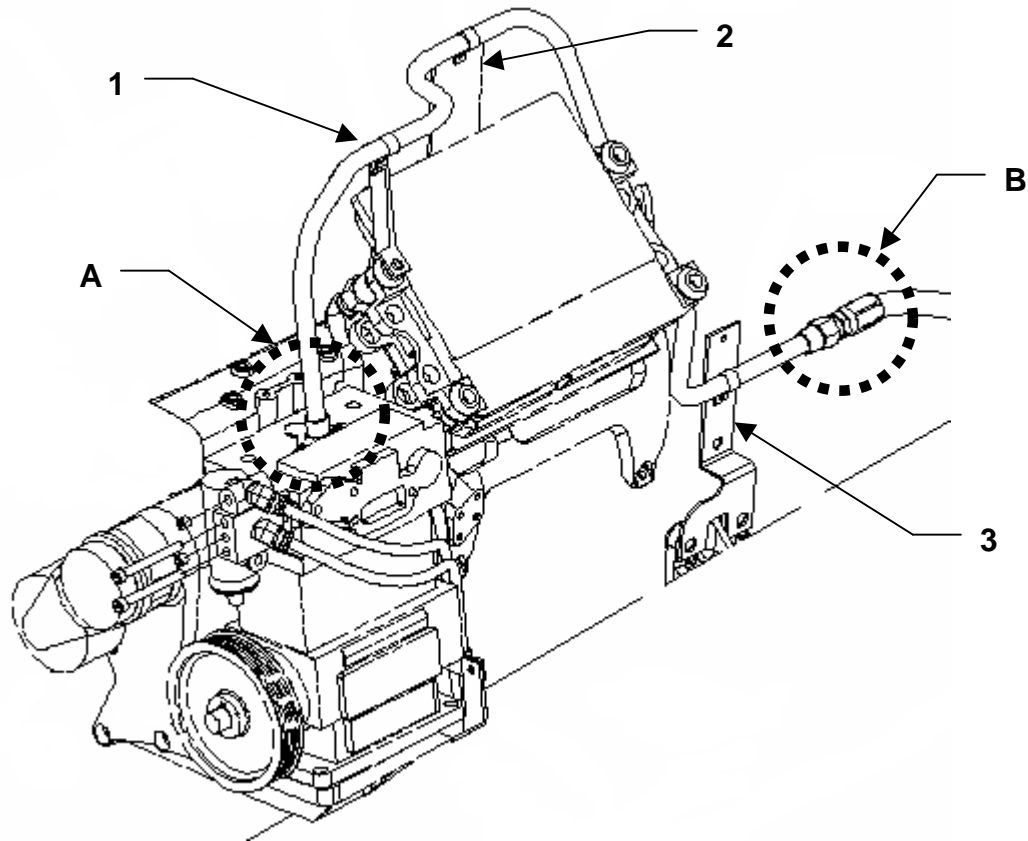
Figure 4

1. The air compressor discharge tube is secured to the engine by three (3) sets of extension clip assemblies. (**Figure 4**)

2. Deplete air system by depressing brake pedal or opening the air tanks drains until primary air gauge reads 0 psi.
3. Loosen compression fitting nut from air compressor discharge. (**Figure 4, area A**)
4. Remove chassis air supply hose from discharge tube. (**Figure 4, area B**)
5. Remove pipe clamps and pipe clamp hardware on extension clip assemblies 1, 2 & 3.
6. Remove tube and discard.
7. Install new tube into air compressor discharge and chassis air supply hose first.

8. Install pipe clamps and hardware. Torque to **6.5-8 LbF-Ft** (8.7-10.7 Nm).
9. Ensure all fittings are tight and not leaking.
