Authorized Field Change

AFC G-01913

Subject File: FRONT END SHEET METAL

Subject: Fender Extension Modification for 4300 and 4400 Models with 8000 Lb. Steer Axle, Code 02ADV, Built Between October 24, 2000 and October 17, 2001 to Eliminate Tire Contact when Maneuvering Tight Turns

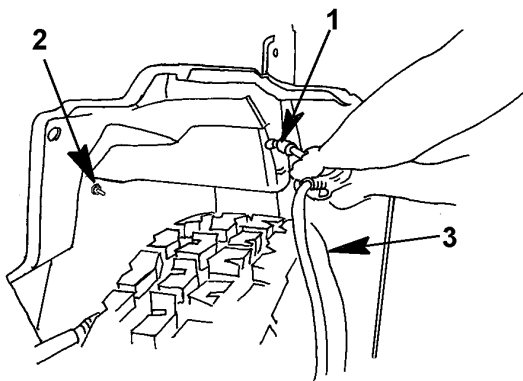
Figure 1 Removing Fender Extension- Drivers Side Shown

1. MOUNTING BOLTS (1)
 2. NUT ON MOUNTING STUD
 3. MOUNTING BOLT (NOT SHOWN IN VIEW)
4. Repeat Steps 2 and 3 for the other side.
 5. Remove two bolts from the cab mount bracket at the sled runner (Figure 3) and install the fender extension flap from Kit Number 8000827R91. Make sure the rubber flap is positioned to the outside, the metal bracket (Figure 2) against the cab mount bracket sled runner. Re-install the bolts and tighten to 88 to 106 Lbf-ft (119 to 144 Nm).

1. Unlatch and tilt the hood to the open position.
2. Remove the mounting bolts and nut from the fender extension (Figure 1).
3. Remove the fender extension.

11. Use a shop reciprocating saw or router to cut the fender extension following the pattern laid out in Step 10.
 12. Re-install the modified fender extensions. Install a washer from Kit 8000827R91 on the mounting stud, Item 2 in Figure 1, between the fender extension and the nut. Tighten the fasteners to 34 to 38 Lbf-ft (46 to 52 Nm).

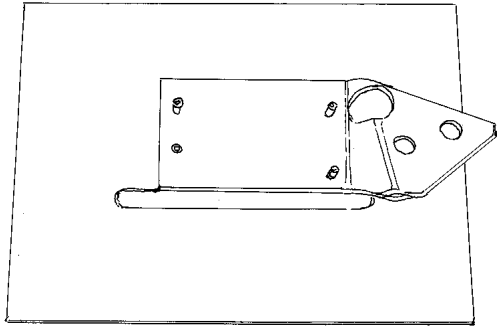
Figure 2 Rear View of Fender Extension Flap

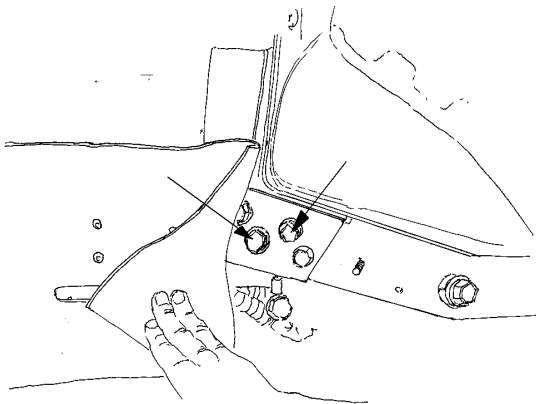
Figure 3 Fender Extension Flap Mounted to the Cab Bracket- Arrows Indicate Bolts (2) To Be Used

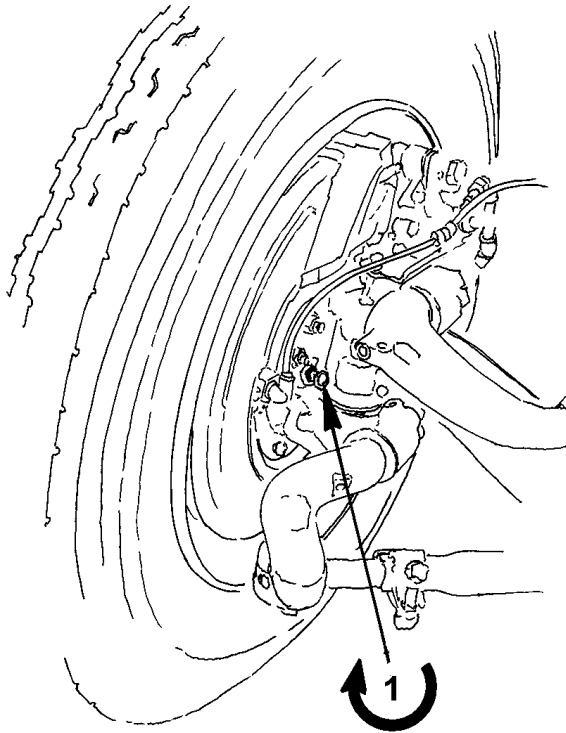
Figure 4 Axle Stop Adjustment

1. TURN CLOCKWISE

6. Repeat Step 5 for the other side.
7. If the vehicle was built between **July 17, 2001 and October 17, 2001** with 8000 lb. steer axles, the axle stops must be reset to 50 degree steer angle. Loosen the axle stop jam nut and turn the stop bolt inward (clockwise) 1 1/2 turns. Tighten the jam nut to 90 to 120 Lbf-ft (122 to 163 Nm) (Figure 4).

NOTE – One full turn of the axle stop bolt equals 2 degrees of turn angle.

CAUTION – Do not exceed 1 1/2 turns when adjusting the axle stop bolt from the original factory setting to avoid clearance problems with the tie rod, axle and axle attachments.

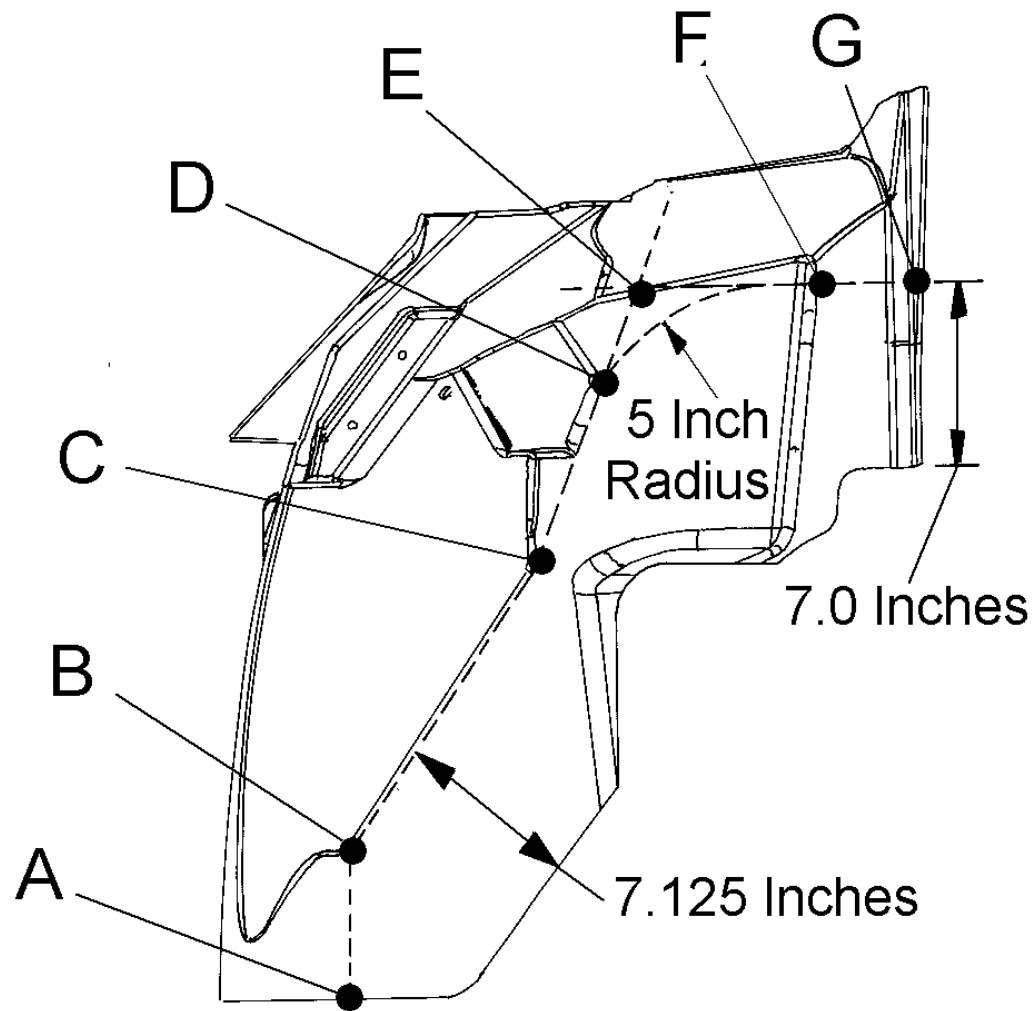
Figure 5 Fender Extension Layout- Drivers Side

8. Repeat Step 7 for the other side.
 9. Prepare the removed fender extensions for modification by cleaning the surfaces of all road debris.
 10. Use Figure 5 (driver side) and Figure 7 (passenger side) to layout or mark the area to be removed on the convex side (surface on the frame rail side or car line side) of the fender extensions.

- NOTE – The lines being marked will generally follow the contour break lines of the fender extension surface. Do not cut into the contour break lines to retain fender extension stiffness.**

- Set up the fender extension in car line position as shown in Figure 5 and Figure 6.
 - Locate and mark points B and C along the contour break line at 7.125 inches from the edge (Figure 5).
 - Locate and mark a vertical line from the bottom edge at point A through point B (Figure 5).
 - Locate and mark horizontal line E-G 7.0 inches from the edge as shown in Figure 5.
 - Locate and mark line C-E following the contour break lines as shown in Figure 5.
 - Locate and mark a 5 inch radius between line C-E and E-G (Figure 5). Points D and F are the tangent points or blend points of the 5 inch radius.

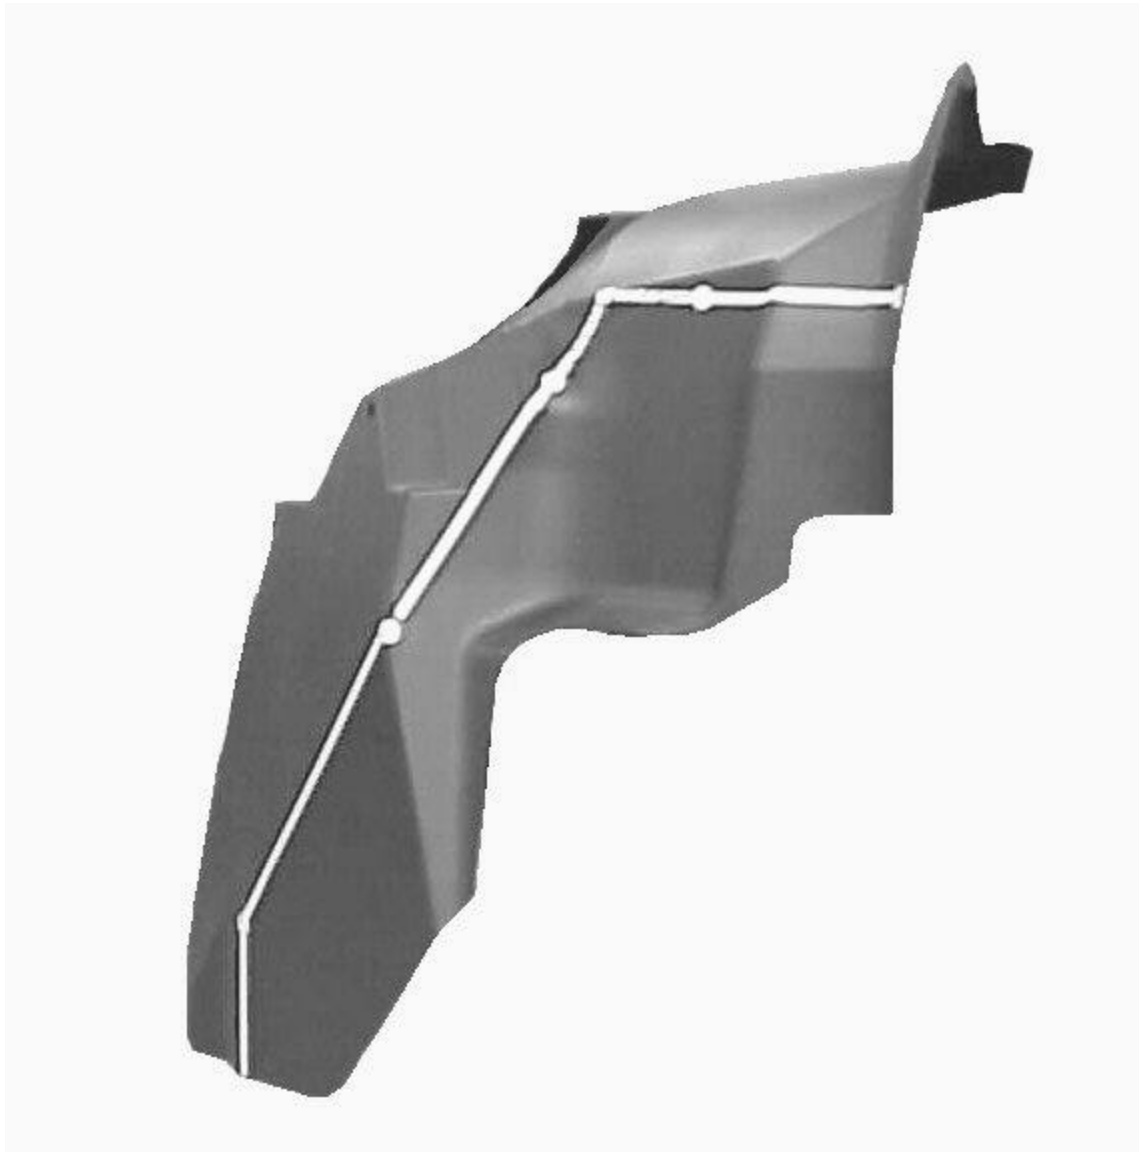
Figure 6 Fender Extension Ready for Modification

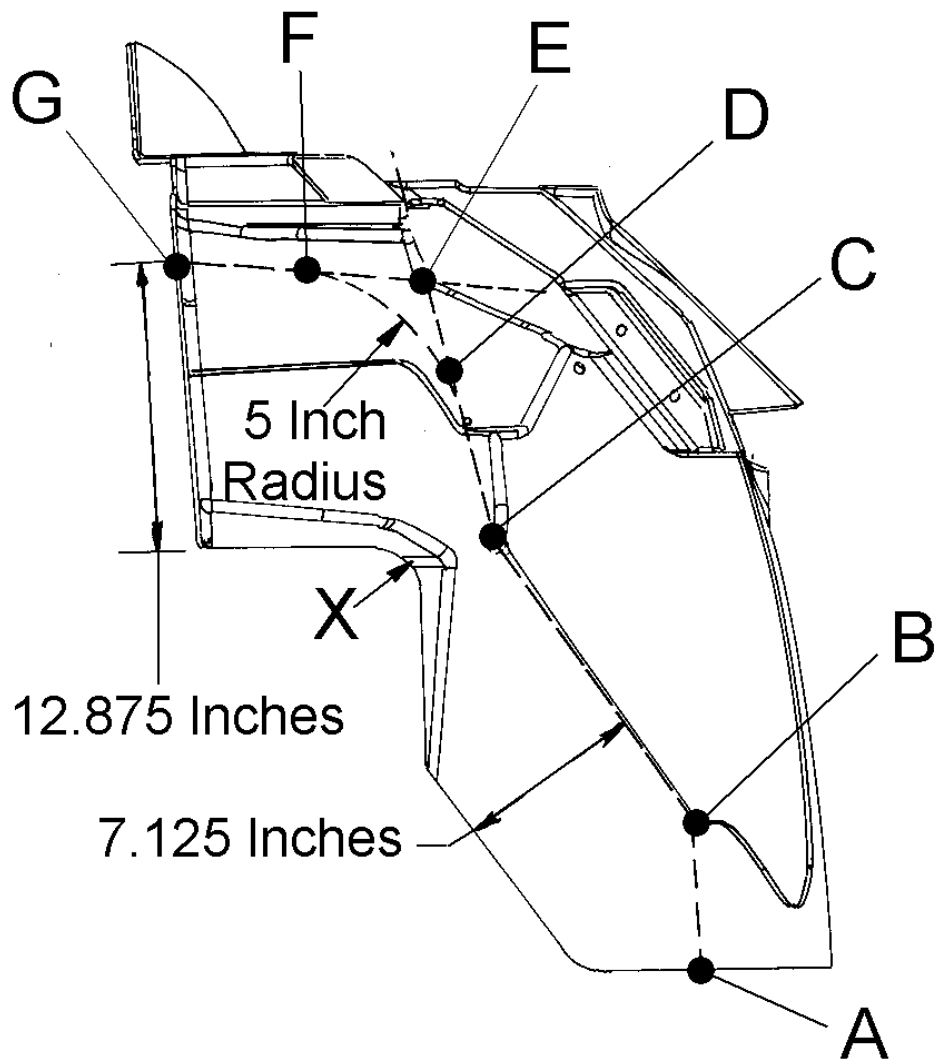
Figure 7 Fender Extension Layout- Passenger Side

- Set up the fender extension in car line position as shown in Figure 7 and Figure 8.
- Locate and mark line B-C along the contour break line at 7.125 inches from the edge as shown in Figure 7.
- Locate and mark a vertical line from the edge at point A to point B following along the contour break line (Figure 7).
- Locate and mark line C-E along the contour break line (Figure 7).
- Locate and mark point G, 12.875 inches from the edge as shown in Figure 7.
- Relocate point E, along line C-E, so that it is approximately 11 inches from the inside radius noted with a X in Figure 7.
- Mark a straight line between points E and G (Figure 7).

- Locate and mark a 5 inch radius between line C-E and E-G (Figure 7). Points D and F are the tangent points or blend points of the 5 inch radius.

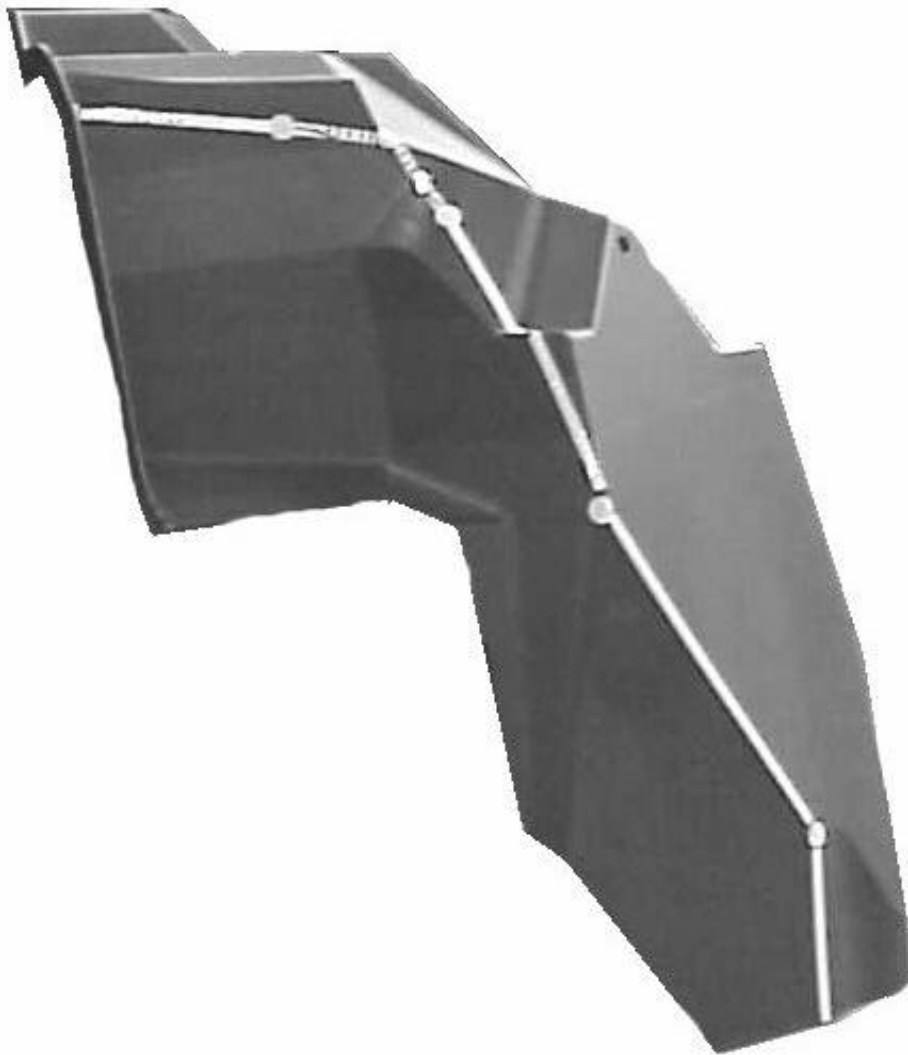
Figure 8 Fender Extension Ready for Modification
