Authorized Field Change

AFC G-07904

Subject: Hard Start/No Start or Excessive Smoke After Start

Engine Family: VT 275

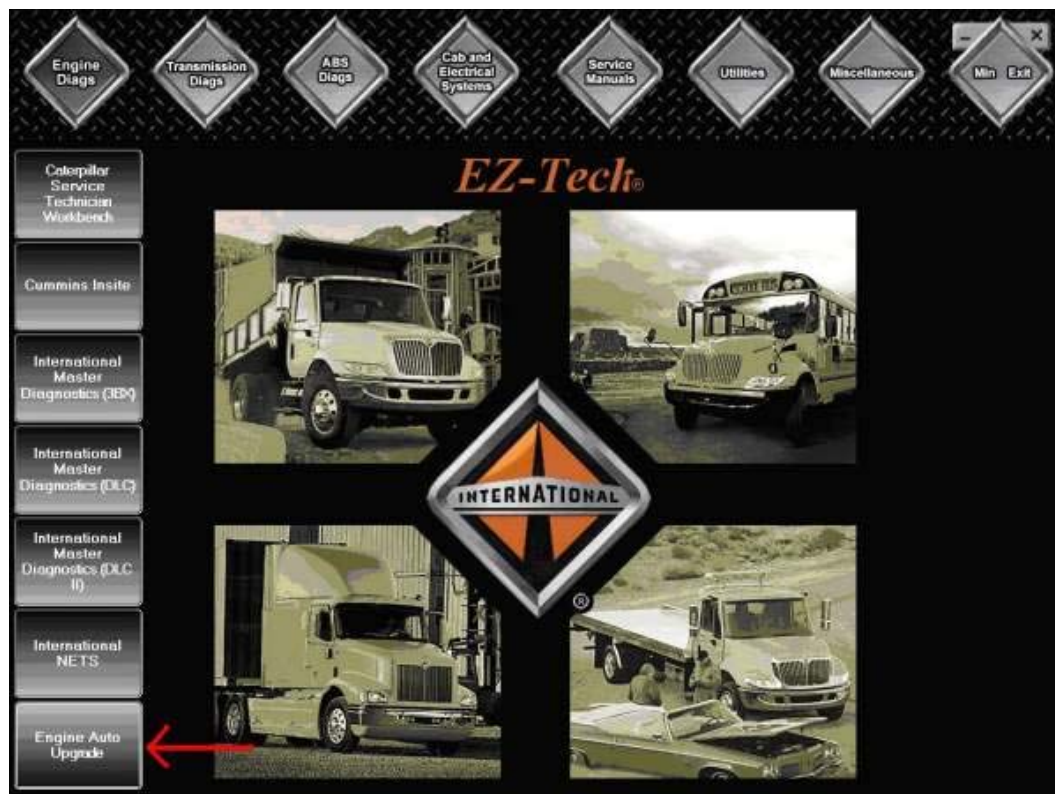
Figure 1

1. Launch DLC Auto Upgrade from Engine Diags on the EZ-Tech GUI (Figure 1).

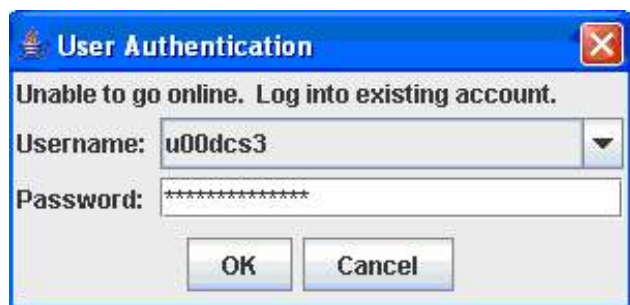
Figure 2

2. Log in to the DLC Auto Upgrade program with your username and password (Figure 2). (Requires DLB certified username permission level.)

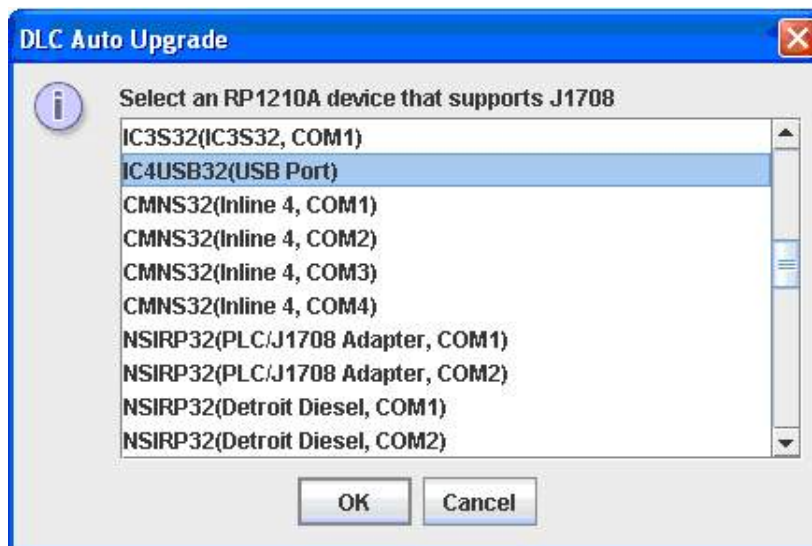
Figure 3

3. Select the cable that you will be using (Figure 3).

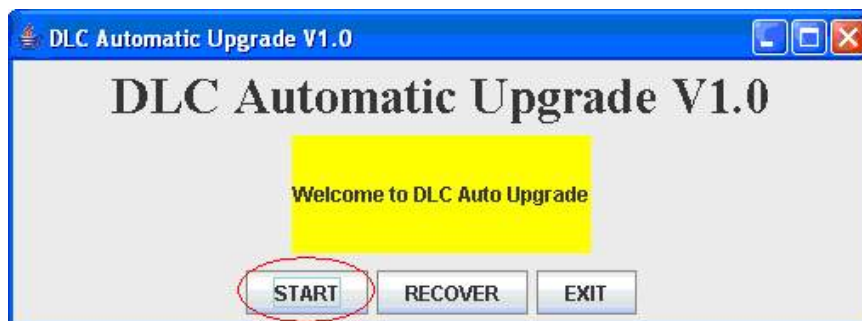
Figure 4

4. Connect the communication cable to the vehicle.
5. Connect the International Engine Reprogramming Harness with the switch in the **OFF** position. SFN 07-29 describes how to use and connect the harness.
6. Press the Start button (Figure 4).

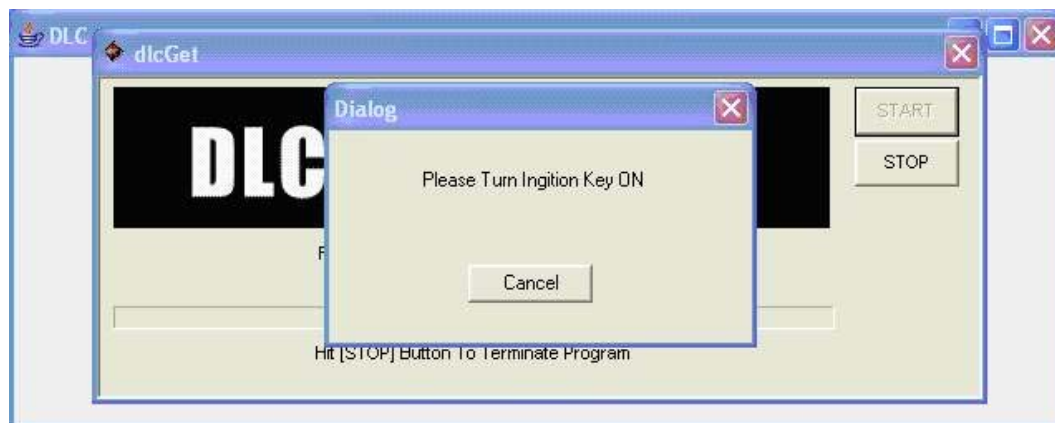
Figure 5

7. Turn the International Engine Reprogramming Harness ON when the DLC Auto Upgrade program prompts for the Ignition Key ON (Figure 5).

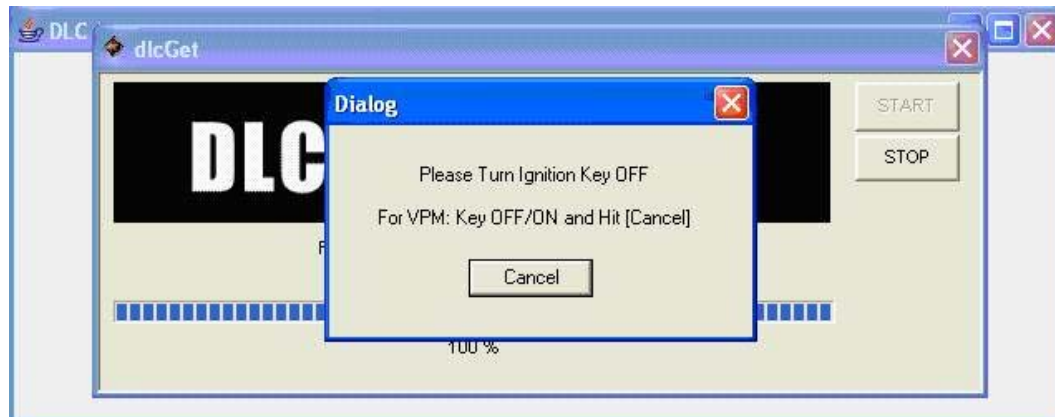
Figure 6

8. Turn the harness OFF when the program prompts for the Ignition Key OFF (Figure 6).

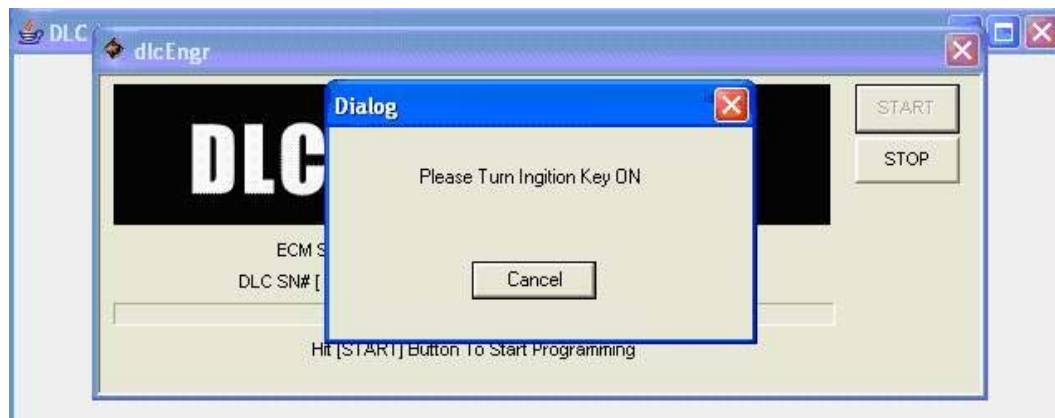
Figure 7

9. Turn the harness ON when the program prompts for the Ignition Key ON (Figure 7).

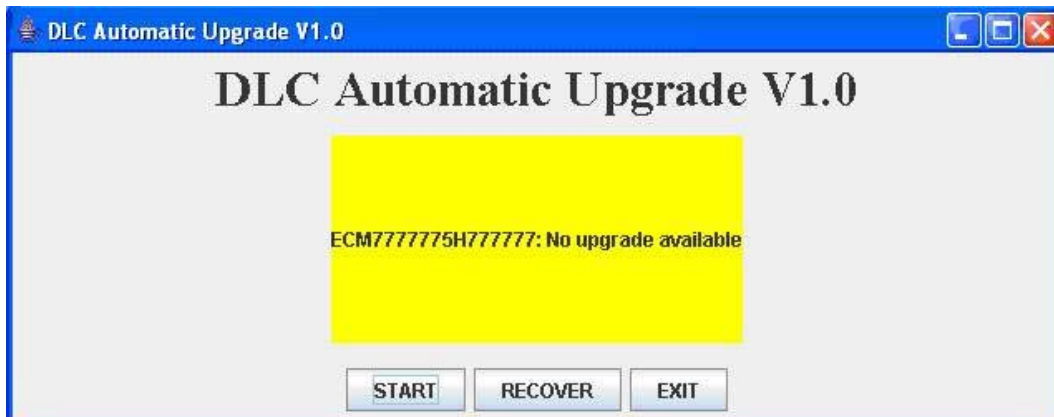
Figure 8

NOTE – If the calibration doesn't need updated, the program will say "No upgrade available" (Figure 8).

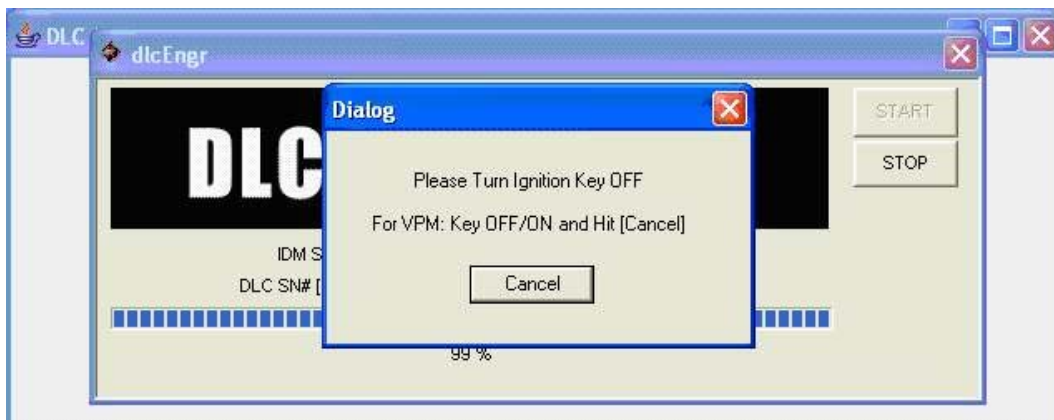
Figure 9

10. Turn the harness OFF when the program prompts for the Ignition Key OFF (Figure 9).

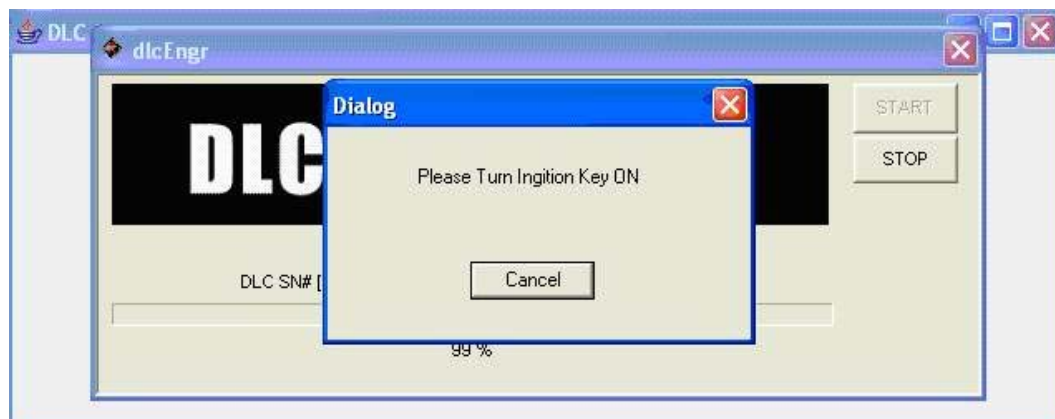
Figure 10

11. Turn the harness ON when the program prompts for the Ignition Key ON (Figure 10).

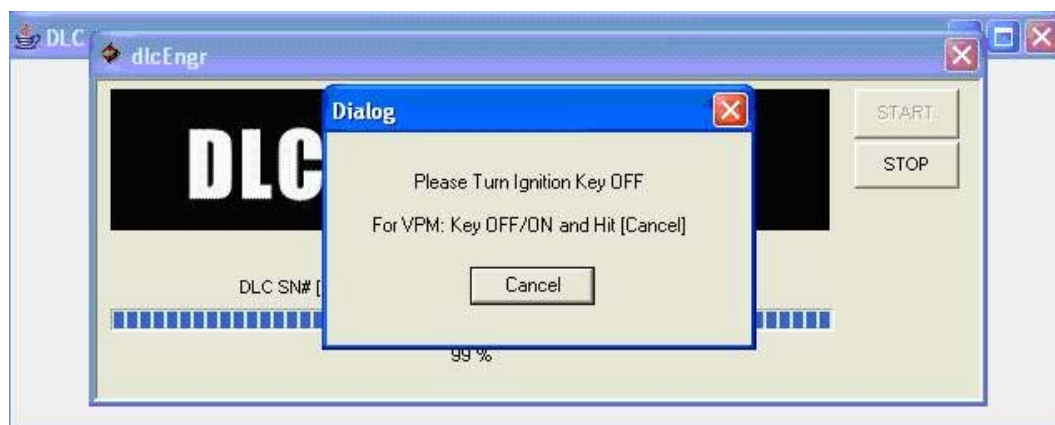
Figure 11

12. Turn the harness OFF when the program prompts for the Ignition Key OFF (Figure 11).

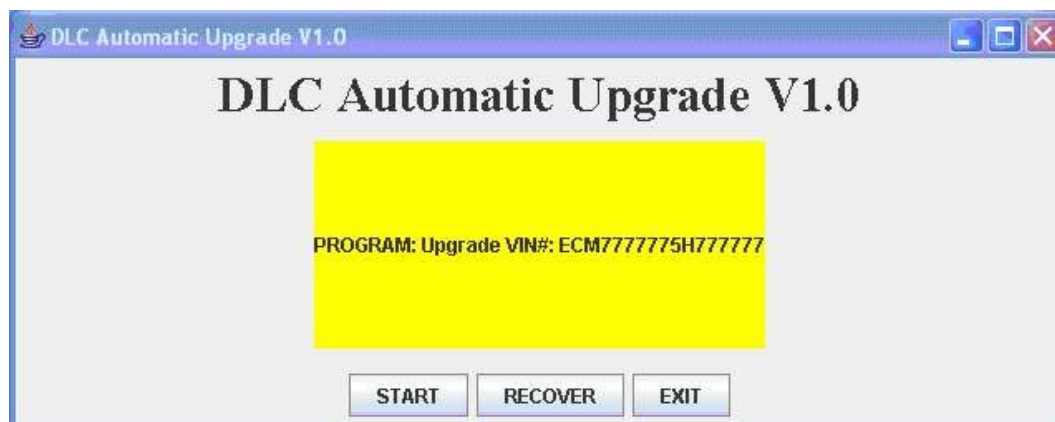
Figure 12

13. The update is complete (Figure 12).

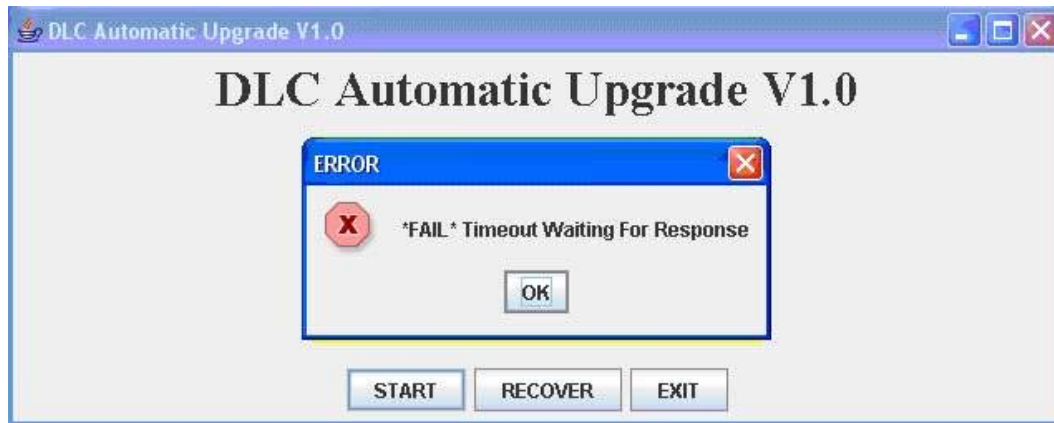
NOTE – If there is an error during programming you will have to fix the problem (i.e.; battery voltage, cable is accidentally disconnected, laptop's battery is low and the laptop turns off, etc.) select the VIN.exe file in the recover menu.

Figure 13 Example of Error

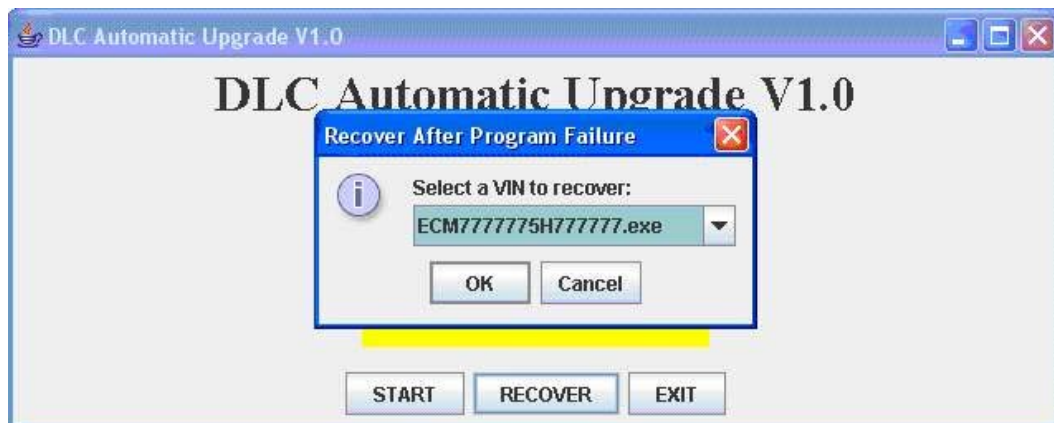
Figure 14 Select the VIN.exe and press OK
