# VEHICLE RECALL

**G-04509**  
**September 2004**

**SUBJECT: SAFETY RECALL (U.S., EXPORT)**  
**POWER STEERING PUMP MOUNTING STUDS on**  
**certain 1652SC, 3800, 4700SFC, RE and CE bus**  
**models built 2/04/2003 thru 2/27/2004 with T444E**  
**engines.**

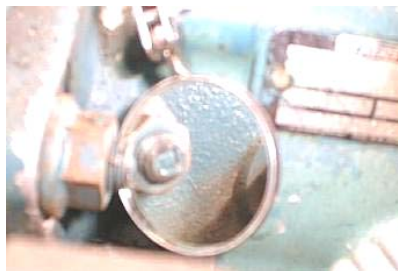
**Figure 1**

1. Open and secure hood.
2. Using a dental mirror, inspect the end of the studs for any manufacturer's marks.

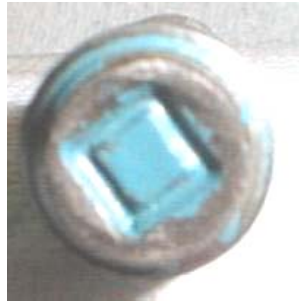
**Figure 2b**

3. If the mounting studs contain either of the following marks on the ends of the stud, **THEY MUST BE REPLACED**. Skip to step 5 for replacement procedure.
