Authorized Field Change

AFC G-05904 Revised

Subject: 8600 HPV Models Built Before November 22, 2004 May Develop Cracks Along the Rear Bottom Edge of the Fender Extension

Model: 8600

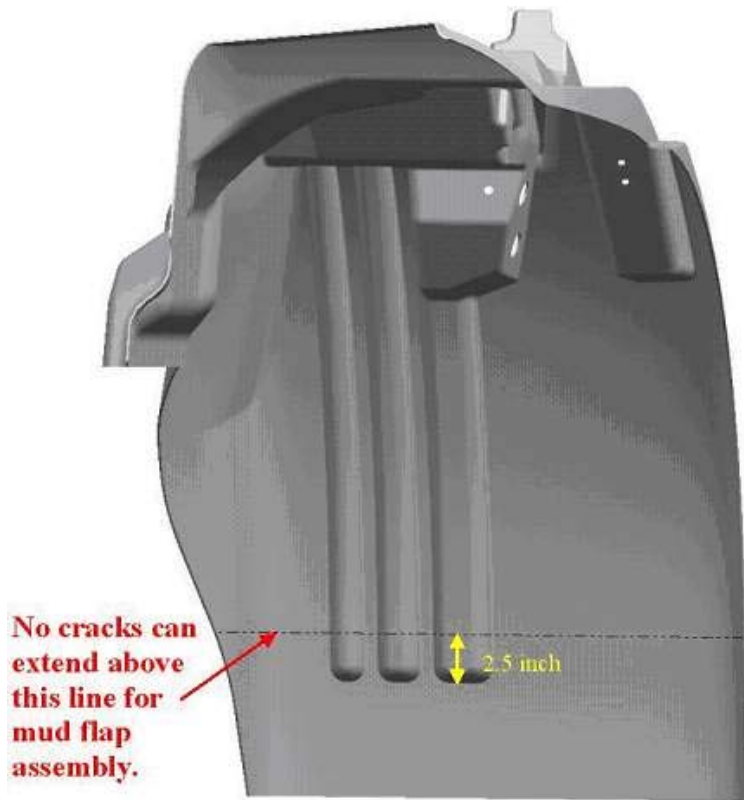
Figure 1 Fender Extension

8600 HPV Models, built before November 22, 2004, may develop cracks in the fender extension along the rear bottom edge under normal usage (Figure 1).

Depending on the extent of the cracks, the fender extension may be repaired or may require replacement.

1. The fender extension on both the driver and passenger side should be washed or wiped clean of road dirt.
2. Inspect the fender extension on both sides of the vehicle for cracks.
 - A. If there are no cracks or if cracks only exist along the rear bottom edge of the fender extension and do not extend beyond the 2 1/2 inch guideline shown in Figure 1, refer to Parts Information Table 1 for the appropriate kit and TSI-05-09-01R for the Service Procedure.
 - B. If cracks exist along the rear bottom edge of the fender extension and extend beyond the 2 1/2 inch guideline shown in Figure 1 and / or other cracks are present, install a new fender extension(s) (Table 2). Refer to Service Section S09008 for the Remove and Install Procedure and Parts Information Table 1 for the appropriate fuel tank or fuel tank, air tank kit to be installed.
